Field campaign

Topic	Mulsanne - Auxiliary coolant pump hose replacement (SC12/16)
Market area	Russische Föderation (5RU), Russian Federation 935 Volkswagen Group RUS (6935), United Kingdom E01 Bentley UK (6E01), Germany E02 Bentley rest Europe (6E02), Australia E04 Bentley rest Asia and Australia (6E04), United States E05 Bentley USA and rest America (6E05), United Arab Emirates E06 Bentley Middle East and Africa (6E06)
Brand	Bentley
Transaction No.	2029557/1
Campaign number	E776
Note	
Type	Workshop Campaign
US code

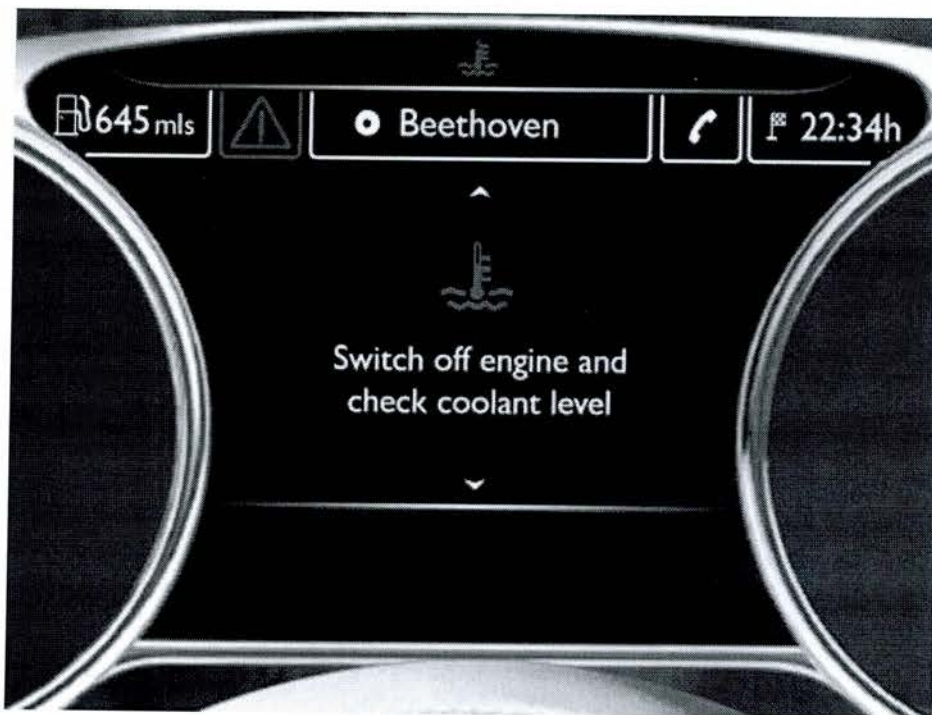
In the event of a coolant hose failure the following red, priority one, warnings will be displayed

Low coolant warning symbol

accompanied by three audible warnings and a displayed message "Switch off engine and check coolant level"

Coolant temperature gauge will indicate a rapid raise in temperature the needle moving into the 120-125°C red segment

Coolant symbol

and message displayed Coolant temperature too high

The four hoses through which engine coolant flows in the auxiliary pump (V51) circuit have an internal upper pressure specification that is less than the systems peak operating pressures. This may in high ambient conditions lead to hose failure and subsequent coolant loss.

The pressure specification of this hose group has been increased and new hoses released under new part numbers.

The cars applicable to this campaign must have original hoses removed and replaced with the new specification parts. The removed hoses must be rendered unusable before disposal

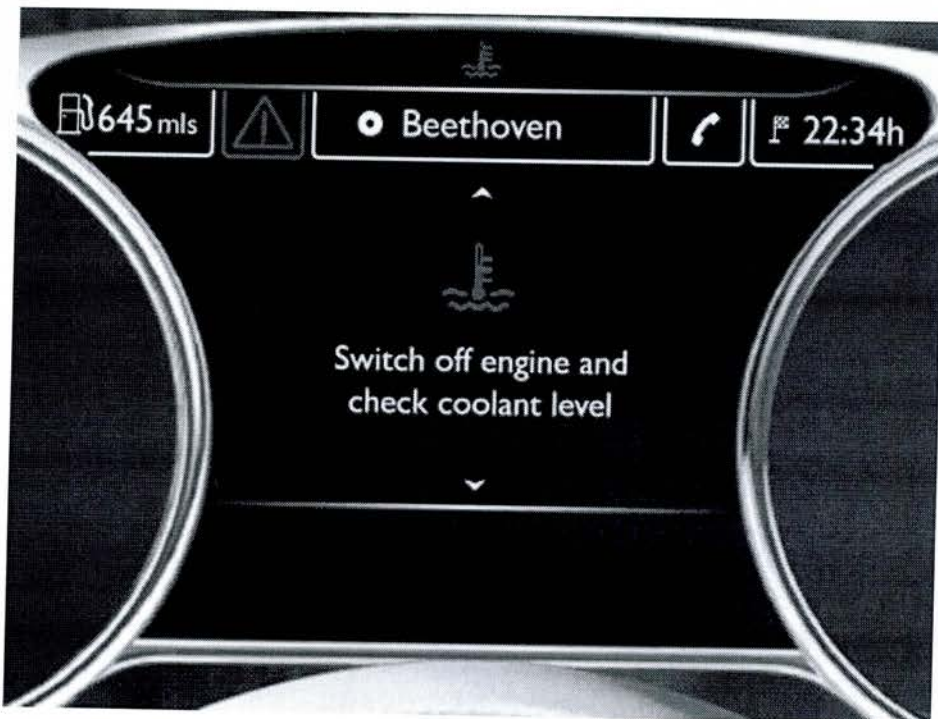
In the event of a coolant hose failure the following red, priority one, warnings will be displayed

Low coolant warning symbol

accompanied by three audible warnings and a displayed message "Switch off engine and check coolant level"

Coolant temperature gauge will indicate a rapid raise in temperature the needle moving into the 120-125°C red segment

Coolant symbol

and message displayed Coolant temperature too high

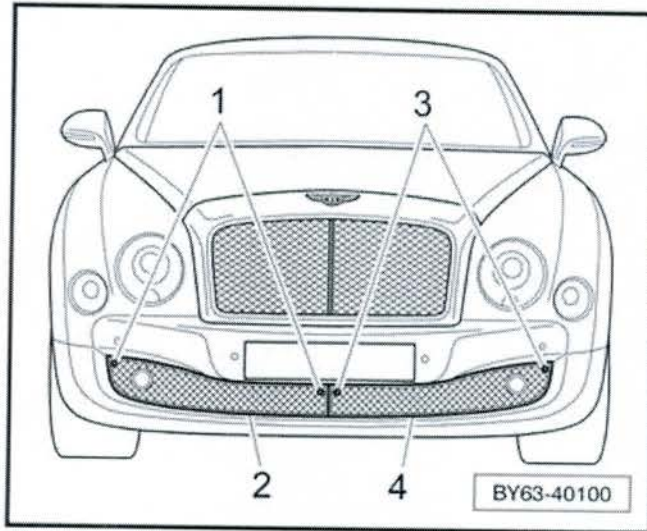
Figure 2

- Remove the fixings (1) and remove the right hand bumper grille (2)
- Remove the fixings (3) and remove the left had bumper grille (4)

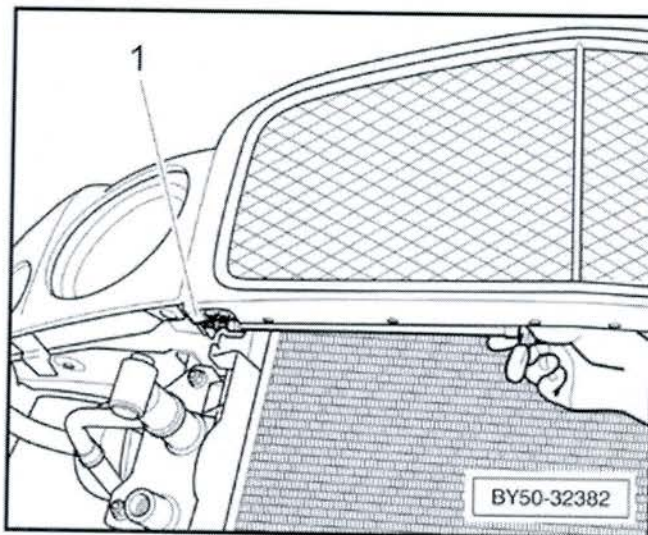
Figure 3 Note: Image shows bumper removed, this is only for illustration purposes

- Working through the front bumper grille aperture, remove the right hand fixing -1- securing the lower corner of the radiator. Carry out the same operation on the left hand fixing (see Figure 3)

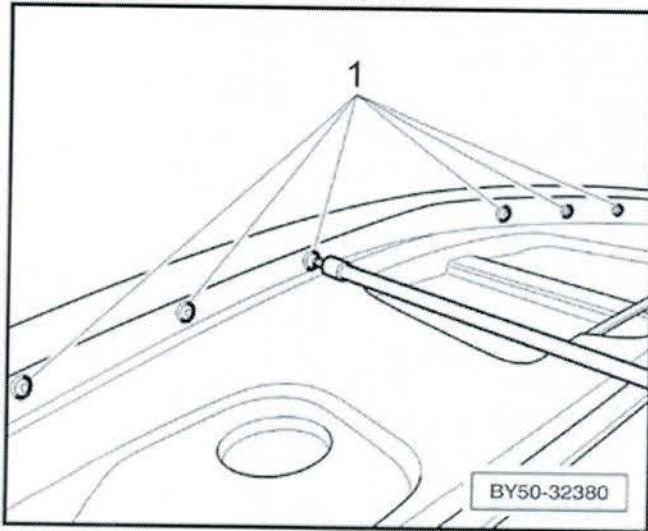
Figure 4

- Remove the fixings securing the top of the radiator shell (see Figure 4)

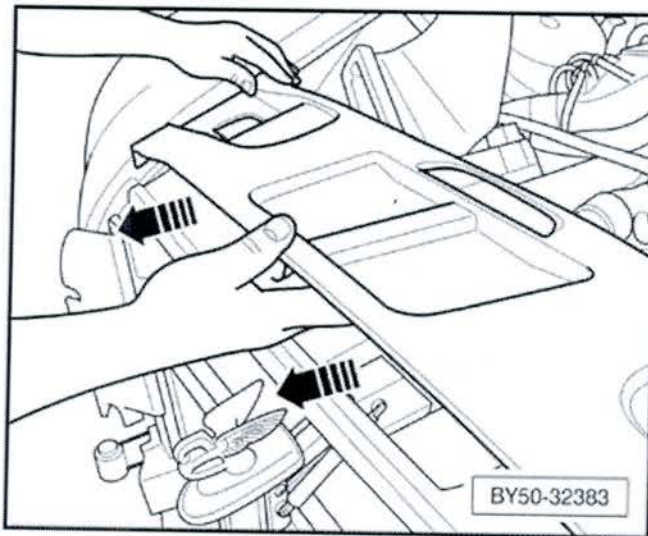
Figure 5

- Partially remove the bonnet seal
- Pull the plastic bridge moulding towards the front and remove the moulding (see Figure 5)
-

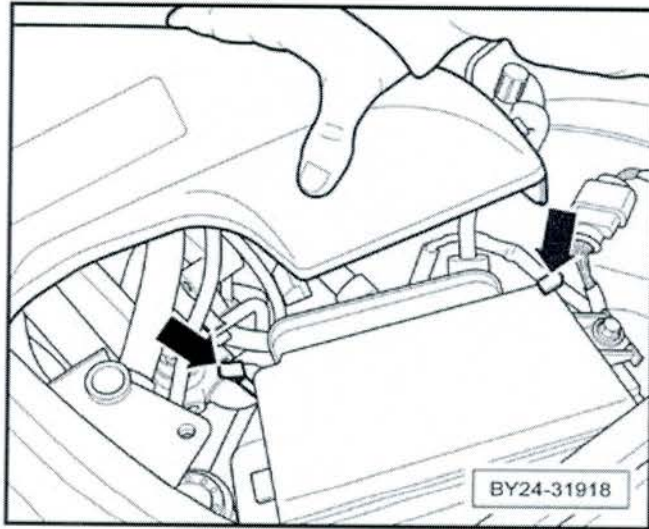
Figure 6

- Release the two spring clips – arrows- on both sides of the intake air duct and partially lift out from the air cleaner housing (see Figure 6)

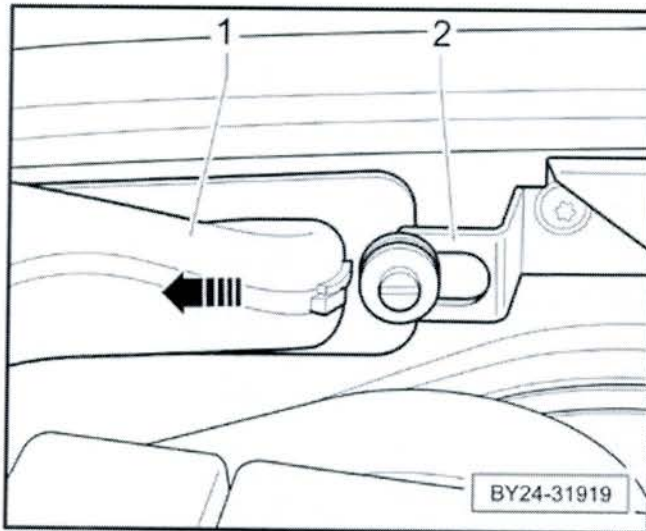
Figure 7

- Slide the duct inwards –1- to disengage from the forked bracket –2- (see Figure 7)
6. Using a soft lead pencil mark the position of the bonnet release mechanism prior to removal. Undo two torx fixings

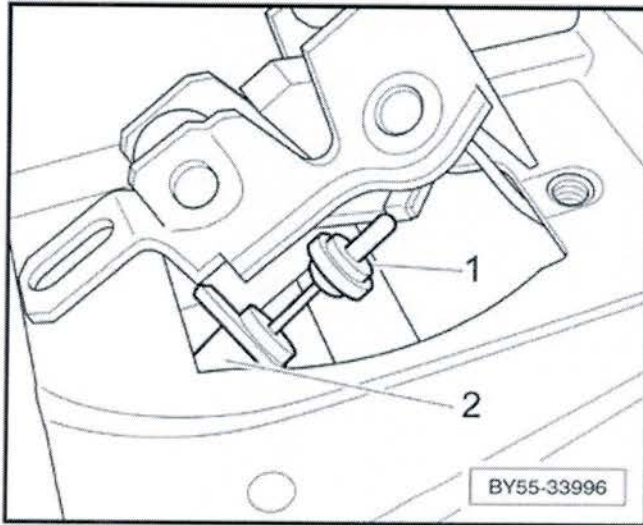
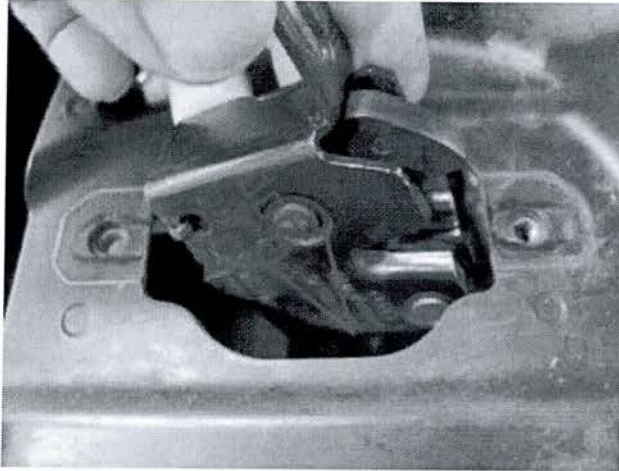
7. Partially lift the mechanism to access and unclip the white cable retainer –1- slide and remove cable –2- from the release mechanism, the mechanism can now be lifted and rotated so as to be passed through the hole in the bonnet crossmember (see Figure 8 and 8A)
8. **Note:** the release mechanism can remain electrically connected

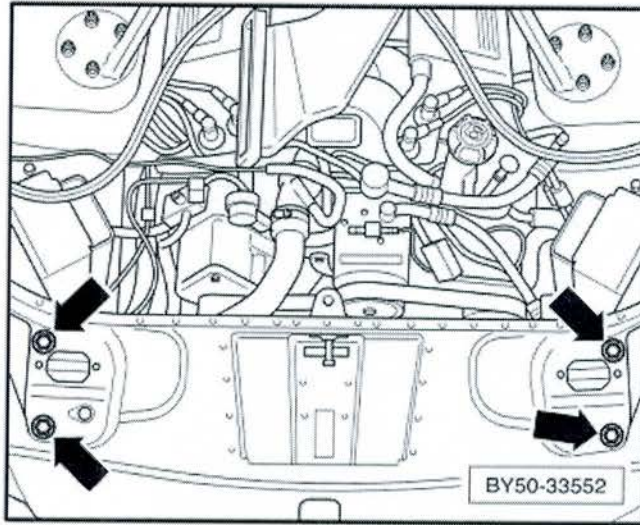
Figure 9

9. Remove the four bolts securing the crossmember –arrow-. Partially lift the crossmember, unclip the bonnet release cable from the underside before fully removing the crossmember

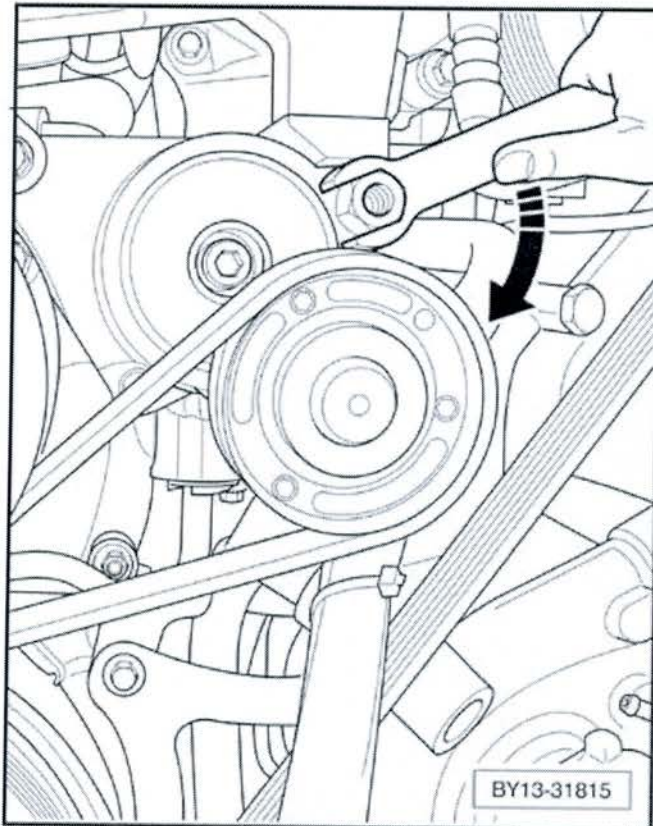
Figure 10

- Hold the belt tensioner pulley off the belt then slide the belt off the alternator pulley finally remove the belt from the other components (see Figure 10)

If the belt is to be re-used, inspect the belt for any signs of degradation.

Do not allow any engine oil or coolant to come into contact with the auxiliary drive belt

If the belt is contaminated with oil of any kind it MUST be replaced

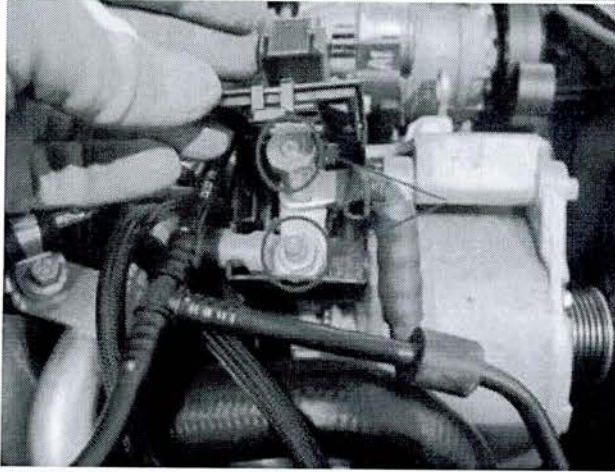
Figure 11

12. Disconnect both battery cables from the underbonnet charging post (see Figure 11)
13. Disconnect the low tension plug from the ignition coil attached to the charging post, coil A1

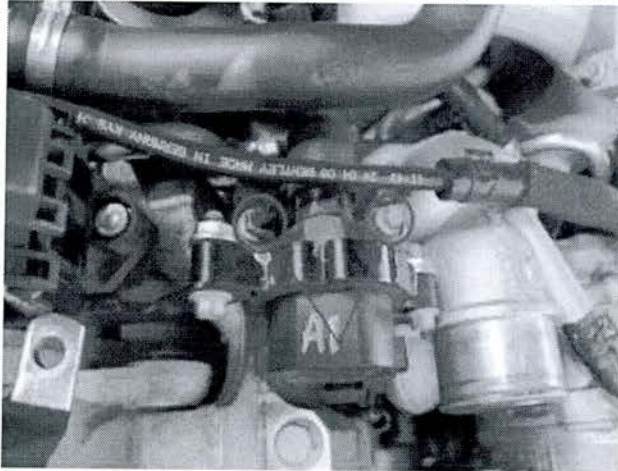
Figure 12

14. Remove the two fasteners securing the charging post bracket assembly and remove the assembly (see Figure 12)

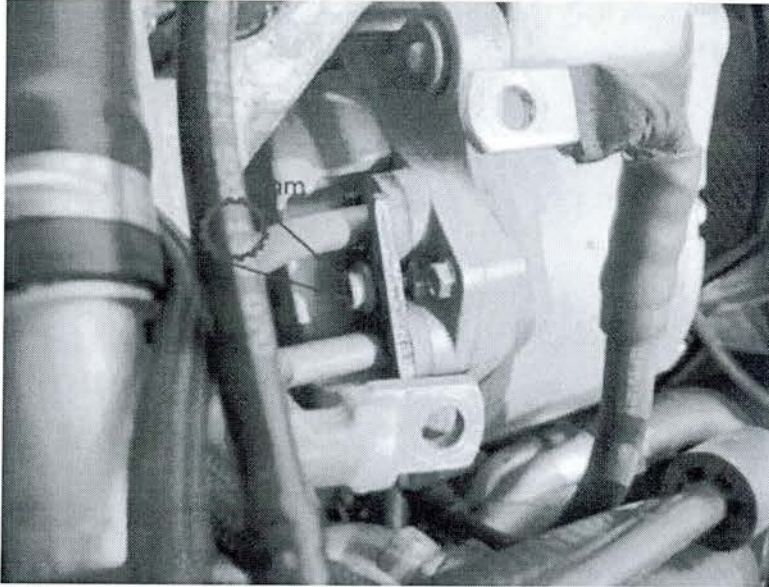
Figure 13

15. Disconnect the alternator coolant feed and return pipes (securing bolt is 8mm Multi point socket head screw) (see Figure 13)

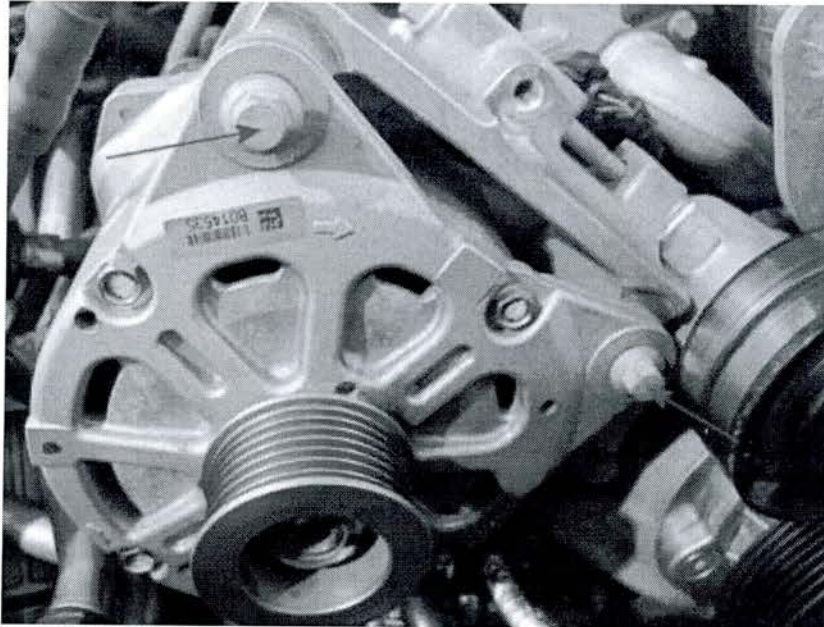
Figure 14

16. Loosen the two alternator retaining bolts then apply a sharp hammer blow to the head of each bolt, this will partially push back the dowel pins at the rear of the bracket before fully removing the two bolts (see Figure 14)
17. Rotate the alternator out of the support bracket disconnect the sensing plug located at the rear of the unit and remove alternator

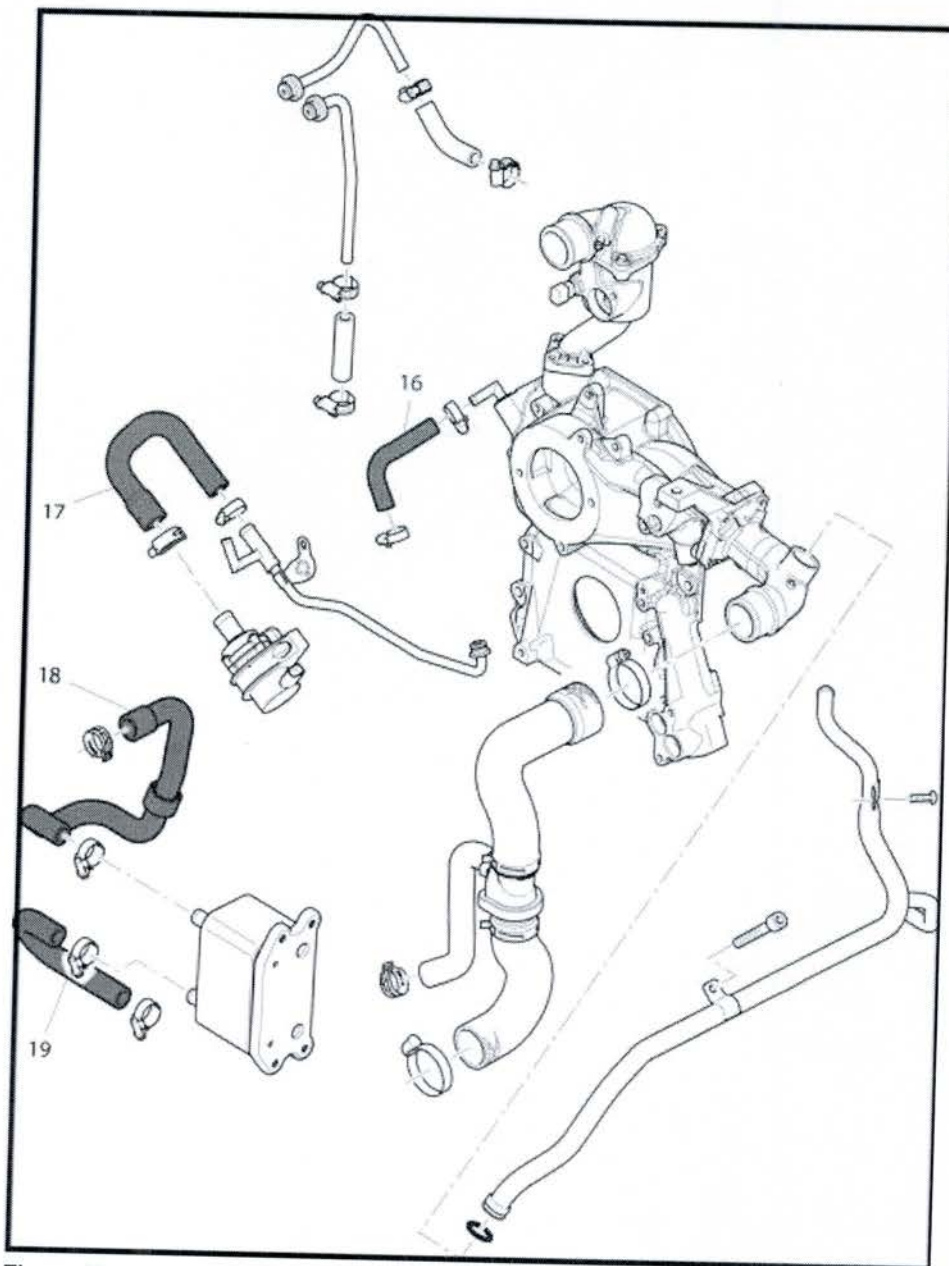
Figure 15

The four hoses shown in figure 15 are to be replaced

The following four hoses are to be replaced

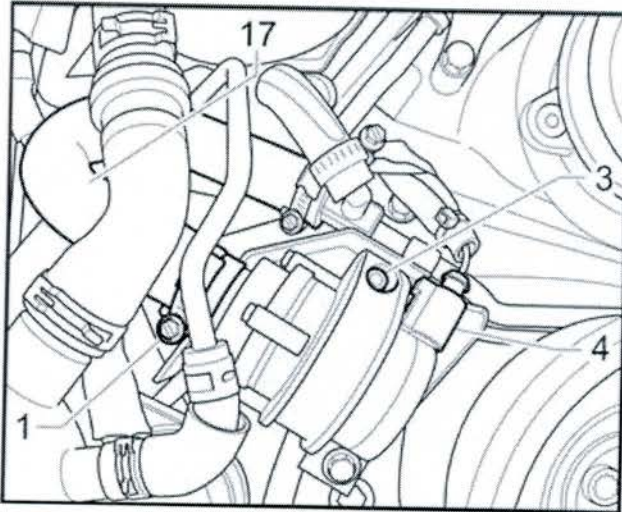
Figure 16

18. From underneath the car remove, discard and replace hose -19-
19. Disconnect oil cooler end of hose -18
20. From above remove and discard small link hose -16
21. Remove and discard hose -17- (see Figure 16)
22. Partially remove the after run electric water pump (V51)

- Remove the screw – 3- (T25), partially withdraw the pump (see Figure 16)

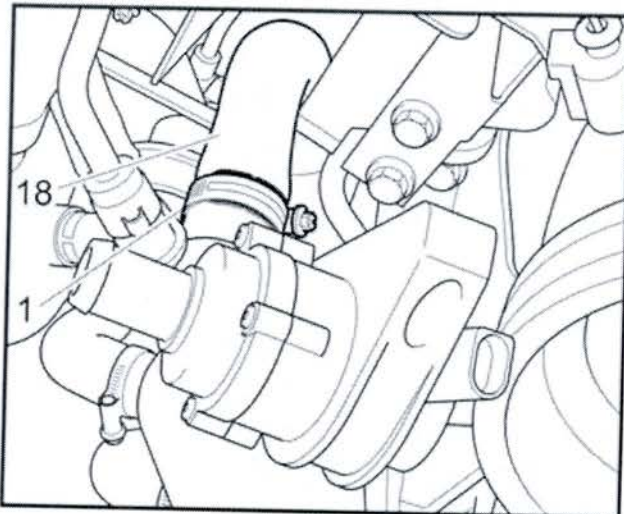
Figure 17

- With the pump partially withdrawn undo hose clip –1- and remove and discard hose –18-
 - Note: the pump can remain electrically connected whilst the hoses are replaced
23. From underneath feed up a new -18- hose
 24. Connect the new 18 hose to the electric water pump and tighten hose clip- 1- (see Figure 17)
 25. Refit electric water pump and tighten securing screw –3- (see Figure 16)
 26. Fit new -17- hose and secure hose clips (see Figure 16)
 27. Fit new -16- hose and secure hose clips
 28. Underneath connect oil cooler end of new 18 hose and secure hose clips
 29. Refit removed parts

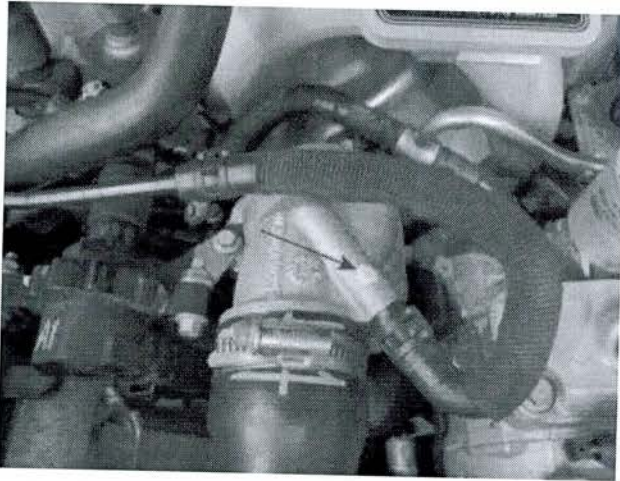
Figure 19

On completion apply a white campaign completion mark to the engine coolant thermostat housing (see Figure 19)

If the campaign identification mark is not evident (see Figure 18), or there is no evidence that the parts have not been fitted in a previous repair (check claim history in SAGA 2) then carry out the required work in accordance with these instructions
