S303-S518

V6 Coolant Pump Outlet Hose –
Replace With Correct Specification –
Service Action S518

MODEL 2004-05 MY
S-TYPE 3.0L

VIN N08089-N22276

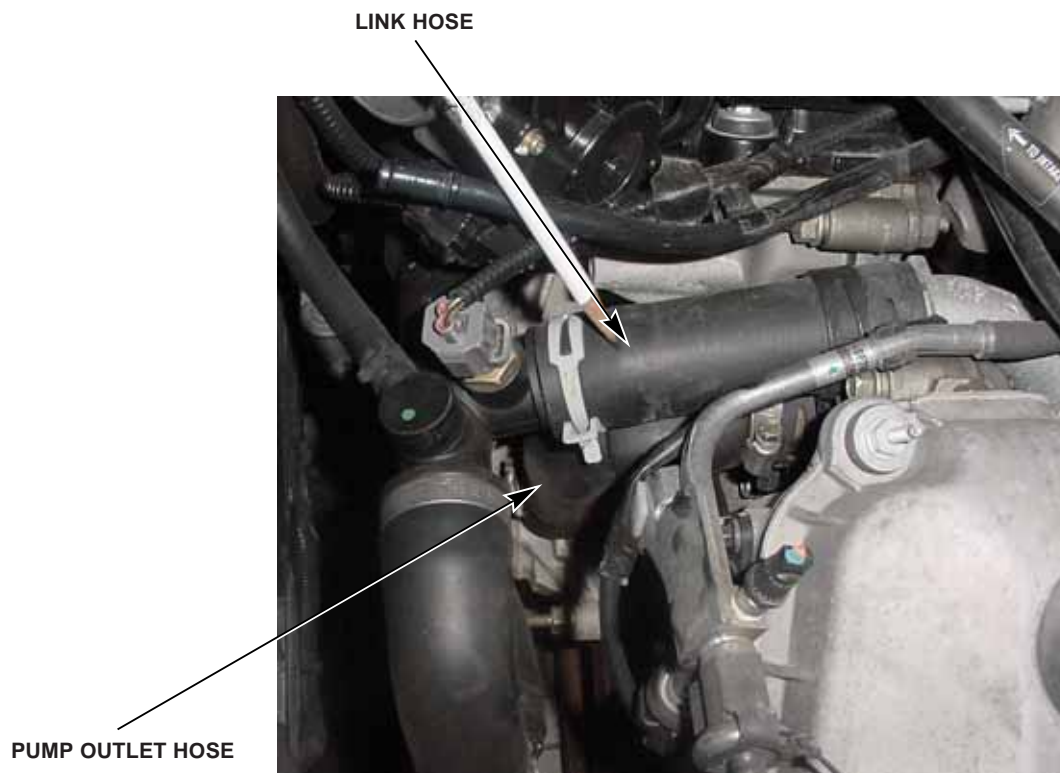
ILLUSTRATION 1

LOCATION OF LINK HOSE

1. Open door, hood, and luggage compartment and install exterior vehicle protection.
2. Disconnect the battery, refer to Global Technical Reference (GTR), Workshop Procedure, section 414-01.
3. Raise the vehicle.
4. **Drain the coolant and set aside for reuse.**
5. Remove engine cover.
6. Remove the air cleaner outlet tube.
7. Disconnect the top hose from the link hose (Illustration 1).
8. Remove the link hose from the engine (Illustration 1).

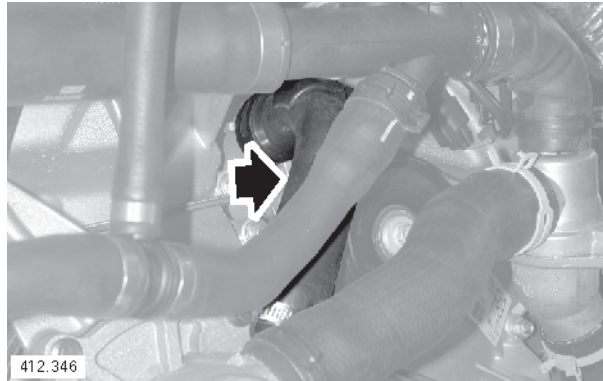
ILLUSTRATION 2

COOLANT PUMP OUTLET HOSE

9. Disconnect the coolant pump outlet hose (Illustration 2) from the coolant pump.
10. Remove the coolant pump outlet hose from the engine.
11. Remove and set aside the two securing clips from the coolant pump outlet to engine hose.
