**TECHNICAL BULLETIN**

Vibration When Braking –  
Brembo Brakes Disc Thickness Variation –  
Diagnosis/Repair

MODEL 2004-05 MY  
XJ supercharged  
VIN G00442-G45704

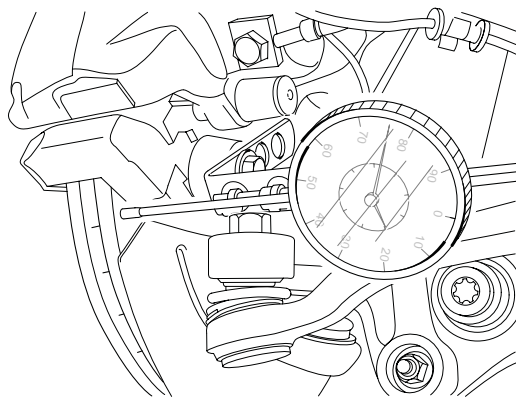
ILLUSTRATION 3

4. Install the new brake disc to the drive flange and secure with at least three wheel nuts, tightened to a maximum of 4 Nm.
5. Mount a dial test indicator (DTI) to the inboard side of the vertical link using the caliper assembly lower bolt hole (Illustration 3).

**DIAL TEST INDICATOR MOUNTED ON VERTICAL LINK**

6. Position the DTI probe 5 mm in from outer edge of disc.
7. Measure the disc run-out with one rotation of the disc.
  - If the measured run-out is less than 0.04 mm then go to step 20.
  - If the measured run-out is greater than 0.04 mm then go to step 8.
8. Remove the wheel nuts from the wheel studs.

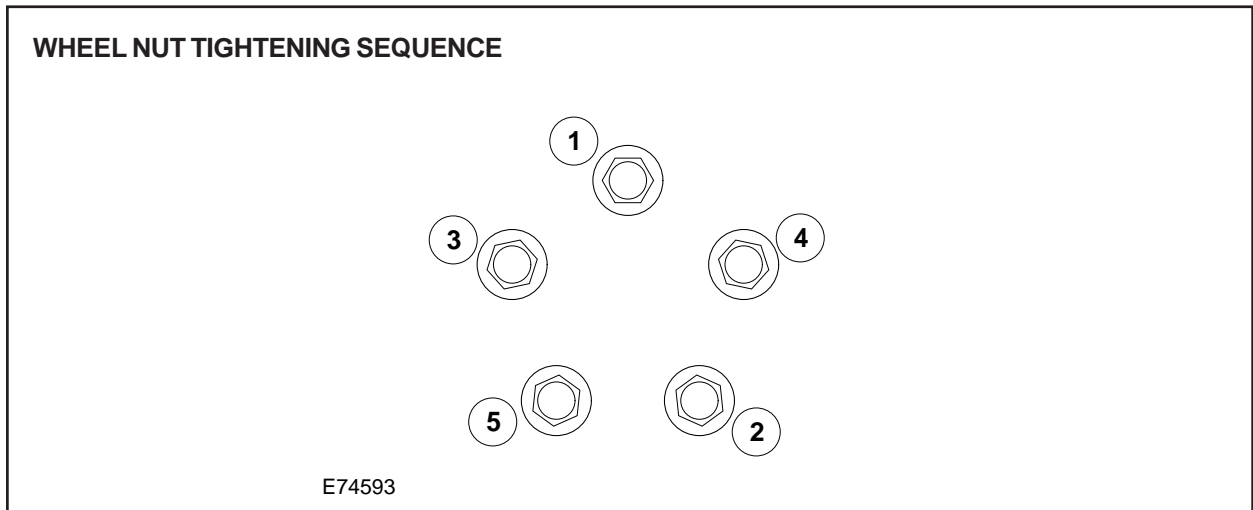
ILLUSTRATION 4

**Note:** Torque the wheels in the order illustrated.

24. Refit the road wheel and tighten nuts to 128 Nm (94 lb-ft) Illustration 4.
