<h1 style="text-align: center;">TSB-Local</h1>	Model	Rio [JB](2009MY), Rio [JB](2010MY), Rio [JB](2011MY)
	Group	Suspension System(21)
	TSB No.	KCE10-21-P120-JB;C21VA
Subject <h2 style="text-align: center;">Rio (JB) Front Strut Noise Repair</h2>	Published	12/6/2010
	TSB Type	Service Action
	Area & Distributor	U.K (C21VA)

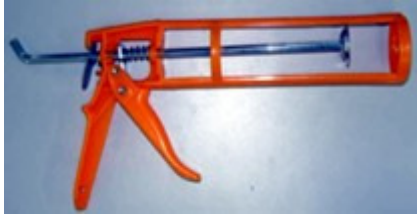
Sealant Gun

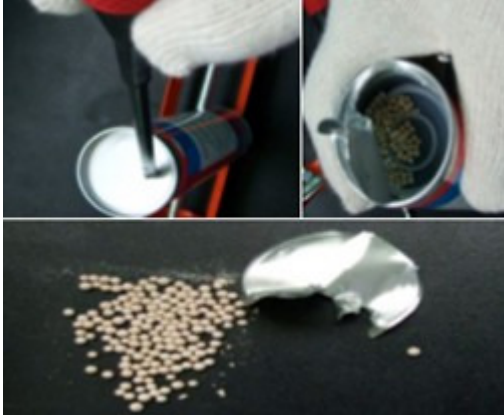
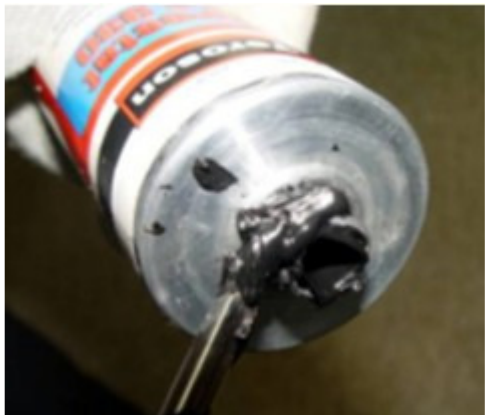
1) Using a screwdriver open the bottom cover of the urethane sealant and remove a desiccant.	2) Using a screwdriver open the inlet cover. Dip the screwdriver end in urethane sealant and apply sealant around the outside of the inlet.

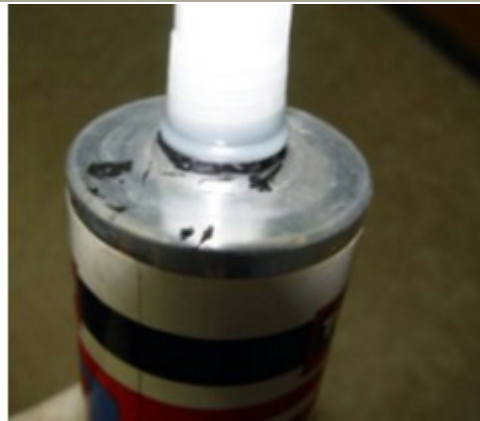
3) Cut the sealant nozzle end about 12mm with a cutter.	4) Install the nozzle to the inlet of the urethane sealant.

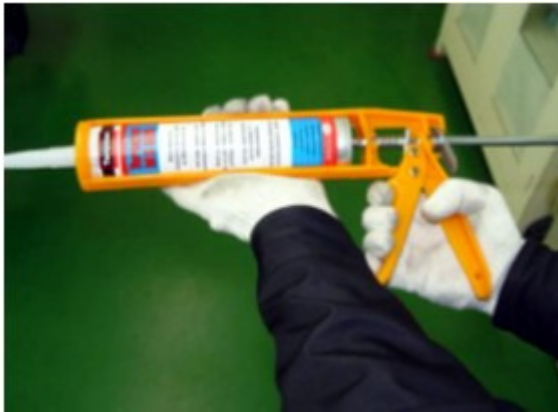
5) Set the urethane sealant to the sealant gun as shown on the photo.

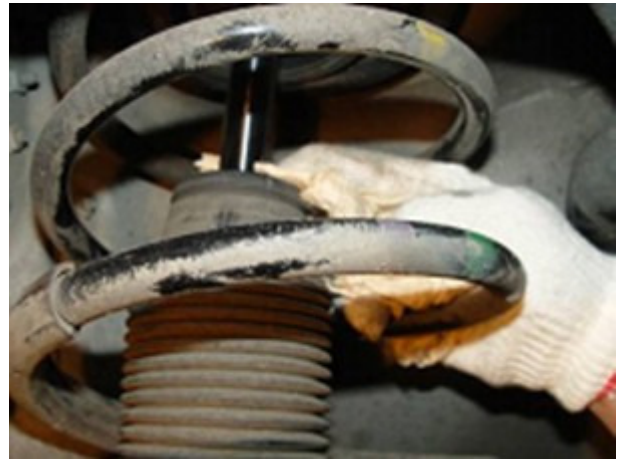
3. Clean the upper part of the strut dust cover with a shop towel.

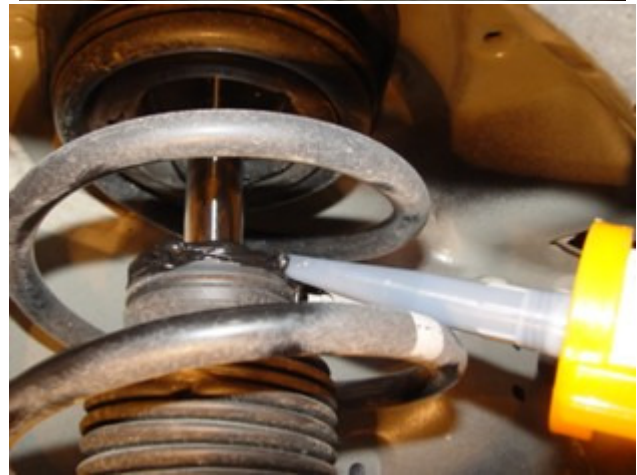
4-1. Apply urethane sealant on the outside of the upper part of the dust cover as shown on the illustration below.

Caution:
Be careful not to contaminate the piston rod with urethane sealant.

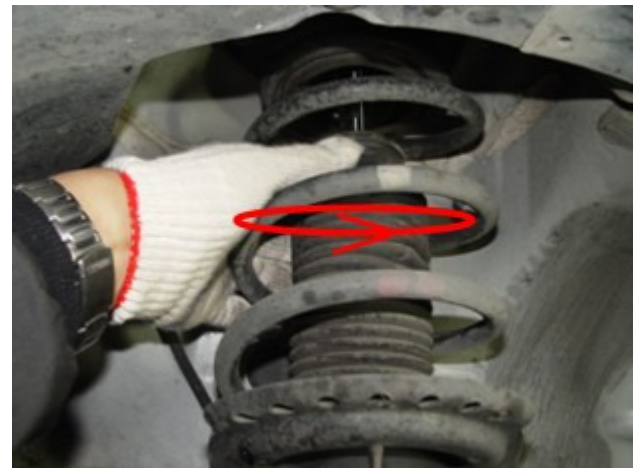
4-2. Turn the dust cover applying urethane sealant all round the dust cover.

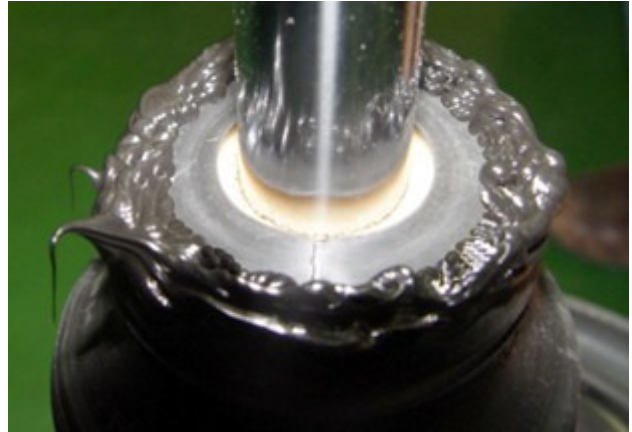
This photo shows normal application of urethane sealant.

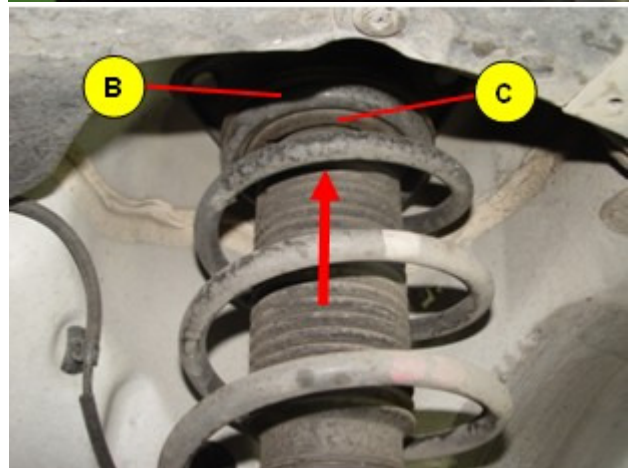
5. Push up the dust cover (B) to reach the insulator assembly (C).
