<h1>TSB-Local</h1>	Model	Rio [UB]()
		Group	Engine Mechanical System(12)
		TSB No.	KCE11-12-P330-UB;C21VA
Subject UB Kappa/Gamma Engine Drive Belt Tension Inspection/Adjustment	Published	1/9/2012	
	TSB Type	Service Action	
	Area & Distributor	U.K (C21VA)

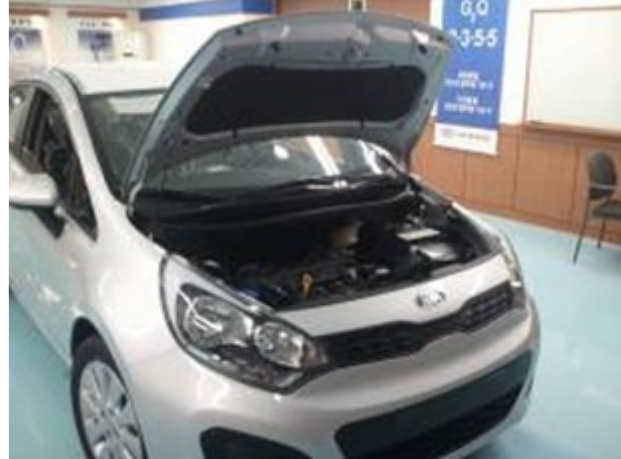
1. Open the hood.

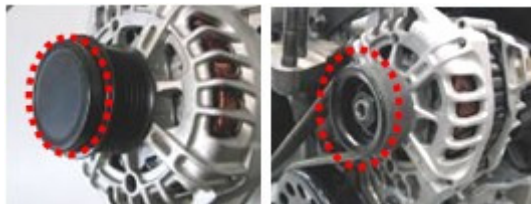
2. Confirm the alternator type installed on the vehicle by checking the pulley type as depicted below:

with OAD

without OAD

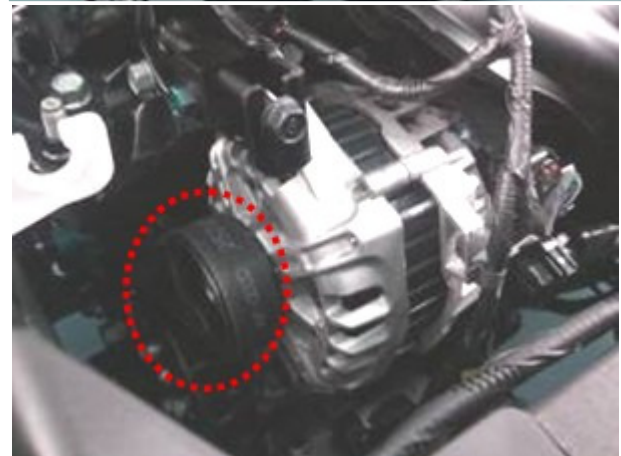
3. Using a ruler, measure the distance (A) between the drive belt tensioner adjust bolt end and the alternator upper mounting bolt bracket.

B : Alternator upper mounting bolt

C : Drive belt tensioner adjust bolt

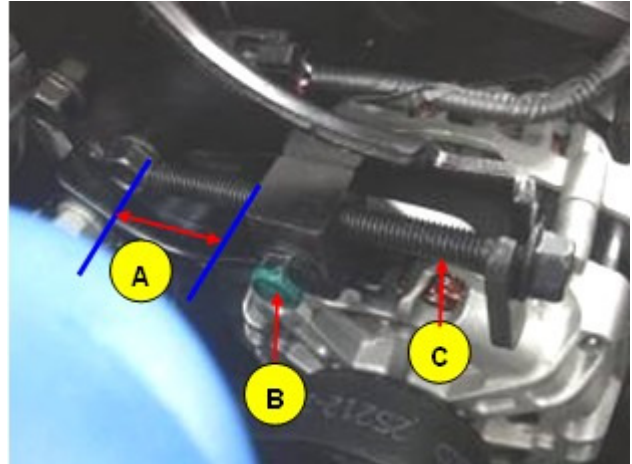
7. Retighten the alternator upper mounting bolt (B).

Tightening torque : 2.0~2.7 kgf.m
(19.7~ 26.4 N.m, 14.5~19.5
lbf.ft)

C : Drive belt tensioner adjust bolt
