<h1>TSB-Local</h1>	Model	Rio UB
		Group	Body Electrical System(92)
		TSB No.	KCE11-92-P370-UB;C21VA
Subject Power Window Regulator Replacement	Published	8/26/2011	
	TSB Type	Service Action	
	Area & Distributor	U.K (C21VA)

Some MY12 Rio (UB) vehicles may experience some abnormal noise from the front and/or rear power window regulators during operation of the mechanism.

Replace the power window regulators with modified parts according to the following the Service Procedure detailed below.

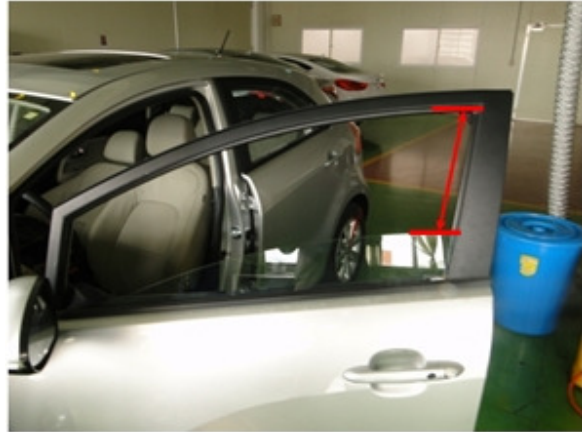
1. Open the front door.
2. Lower the window glass 27 cm in order to remove the 2 glass window mounting bolts easily in operation 9 below.

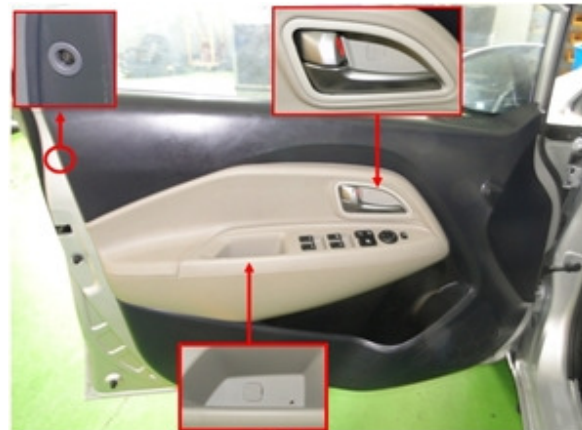
3. Remove the 3 door trim mounting screws.

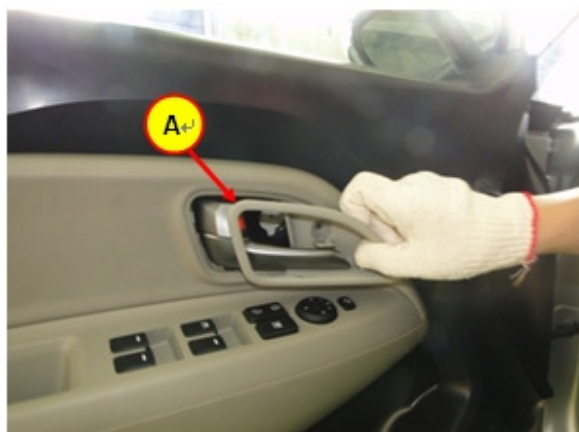
4. Remove the inside handle housing (A).

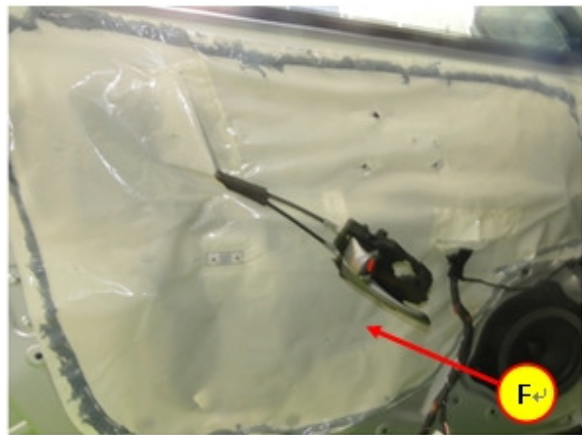
8. Remove the front door membrane (F) from the front door panel.

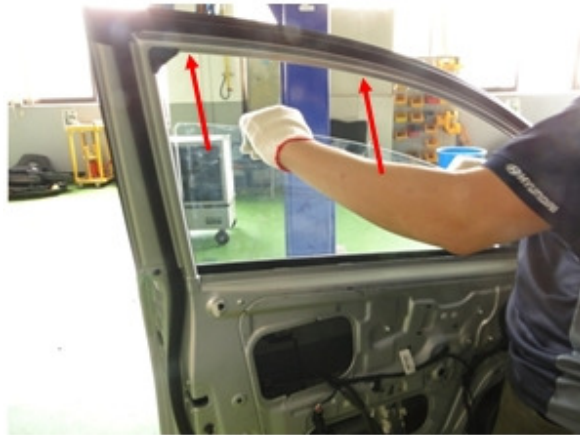
10. Raise the window glass all the way by hand.

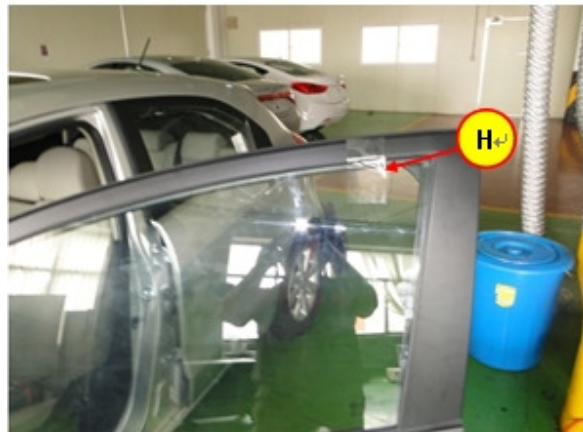
11. Fix the window glass with the tape (H) as shown in the image to prevent it from sliding down

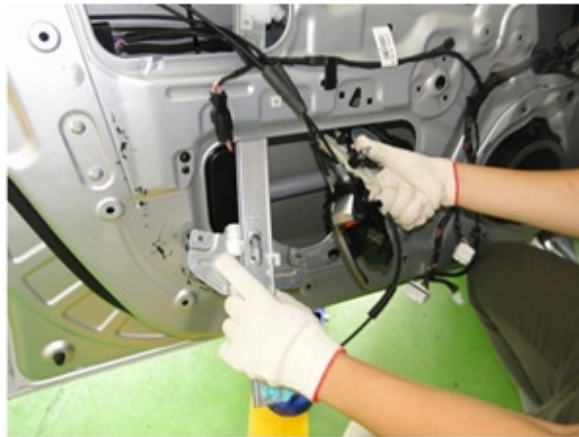
13. Remove the power window regulator assembly from the front door panel.

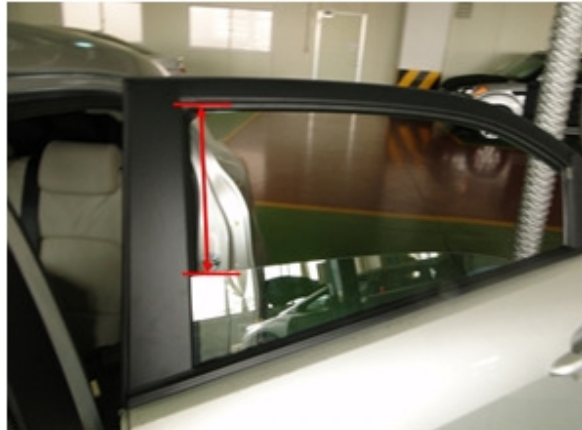
2. Lower the glass window 23 cm in order to remove the window glass mounting bolts more easily in step 9.

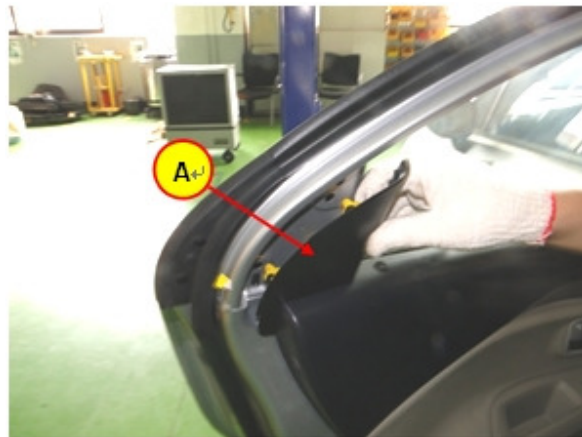
3. Remove the rear door inner cover (A).

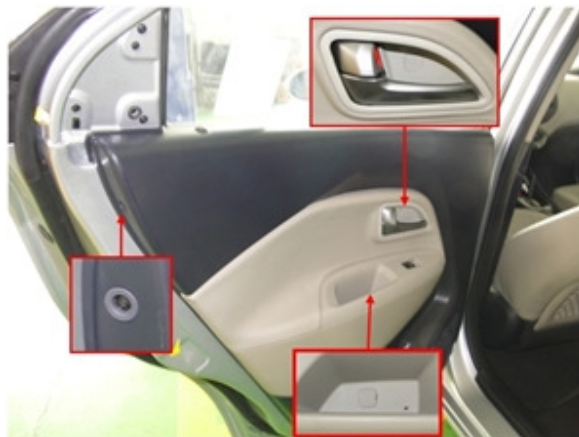
4. Remove the 3 door trim mounting screws.

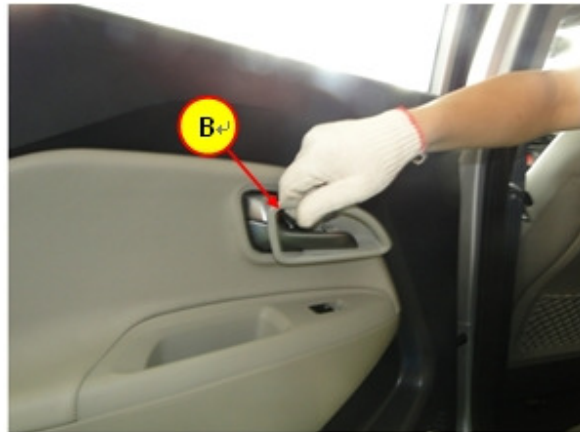
5. Remove the rear door inside handle housing (B).

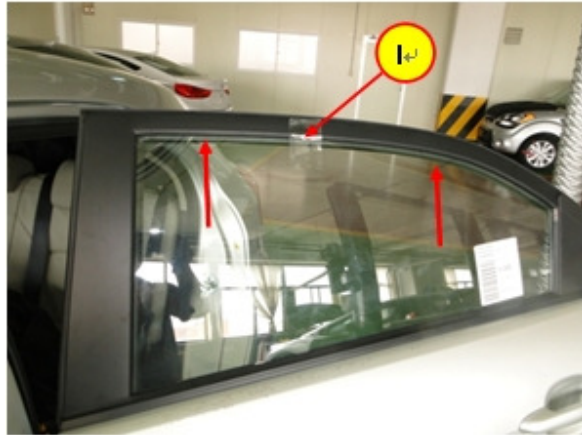
10. Raise the window glass all the way by hand.

11. Fix the window glass with the tape (I) as shown in the image to prevent it from sliding down.

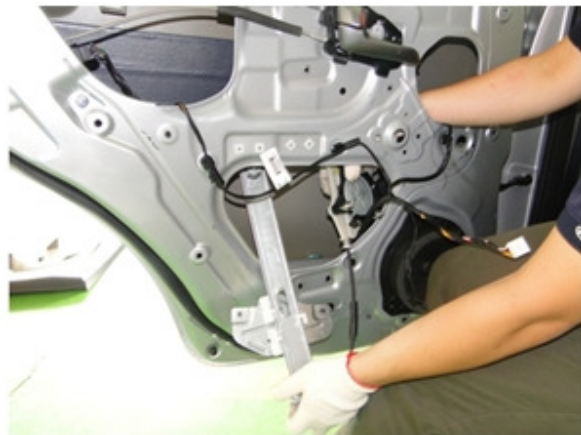
13. Remove the power window regulator assembly from the rear door panel.
