| | <h1>TSB-Local</h1> | Model | Rio [UB]() |
| | | TSB No. | KCE11-92-P490-UB;C21VA |
| Subject Rio (UB) Front wiper switch connector wire rework to prevent incorrect operation. | Published | 10/10/2011 | |

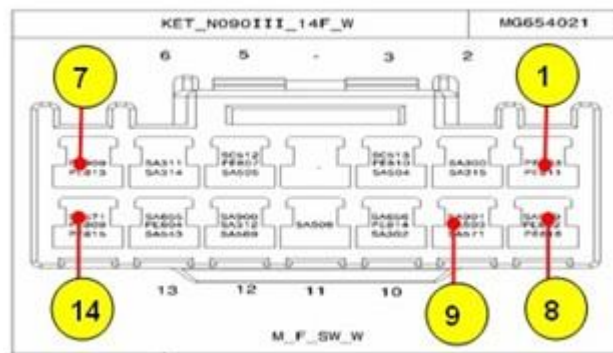
M_F_SW_F

9. Two brown wires are connected into pin 14. One is bridged to the pin 9 and the other is connected to the BCM (Body Control Module).

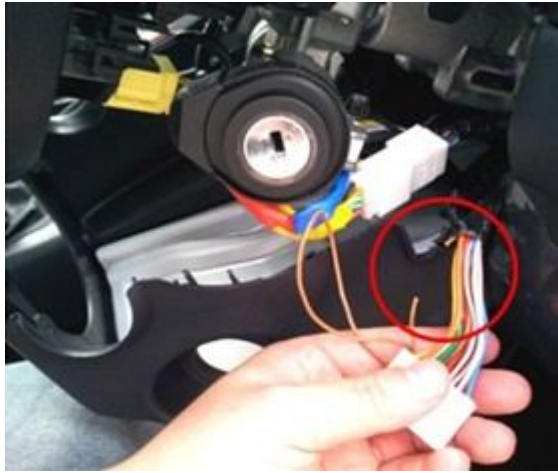
When operating the front windshield wiper in auto mode on some RIO (UB) RHD vehicles equipped with rain sensor only, the wiper might operate one time first then keep operating every 8 seconds regardless of the amount of rain.

10. Cut the brown wire going to BCM leaving the brown wire bridged still between pin 14 and pin 9
