<h1>TSB-Local</h1>	<b>Model</b>	Cerato/Spectra [TD](), Soul [AM](), Rio [UB]()
		<b>Group</b>	Manual Transaxle System(51)
		<b>TSB No.</b>	KCE12-51-P090-TDAMUB;C21VA
<b>Subject</b> <b>6 speed manual transmission (M6CF3-1) case inspection and replacement</b>	<b>Published</b>	10/8/2012	
	<b>TSB Type</b>	Customer Satisfaction(Complaint Base)	
	<b>Area &amp; Distributor</b>	U.K (C21VA)

## 1. Description

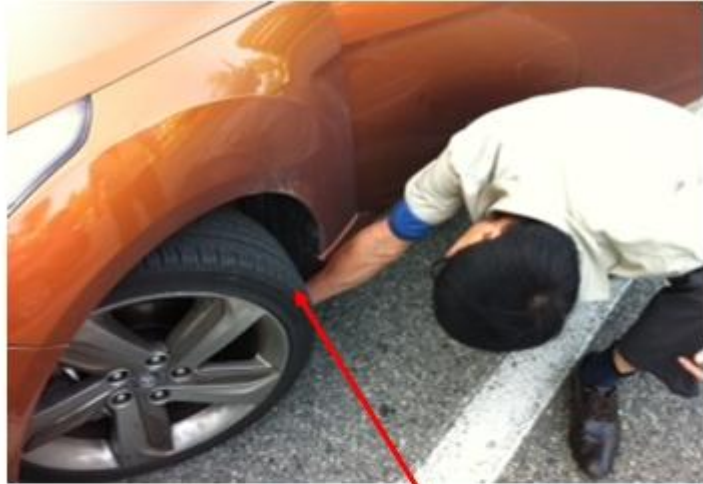
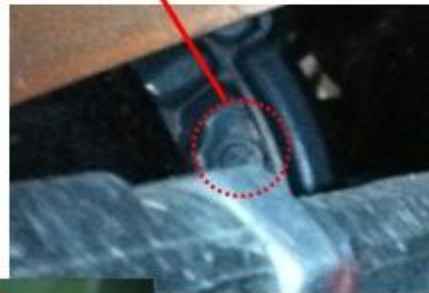
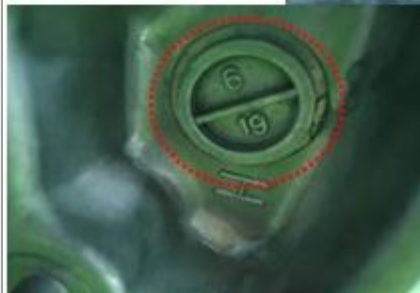
1. Fully turn the steering wheel to right direction.
2. Check the manual transmission LOT No. located on the rear side of the left front wheel by shining a flashlight.
3. If the LOT No. is affected one (6/18, 6/19, 6/20), note the VIN of the vehicle.

A : June (Month)  
B : 18, 19, 20 (Day)

If customer complaint occurs about shift lever vibration while driving (acceleration) in 6th gear, check whether the LOT No. of M6CF3-1 is affected Number (6/18, 6/19, 6/20), or not. If the LOT No. is affected one, replace the manual transmission assembly with a new one.

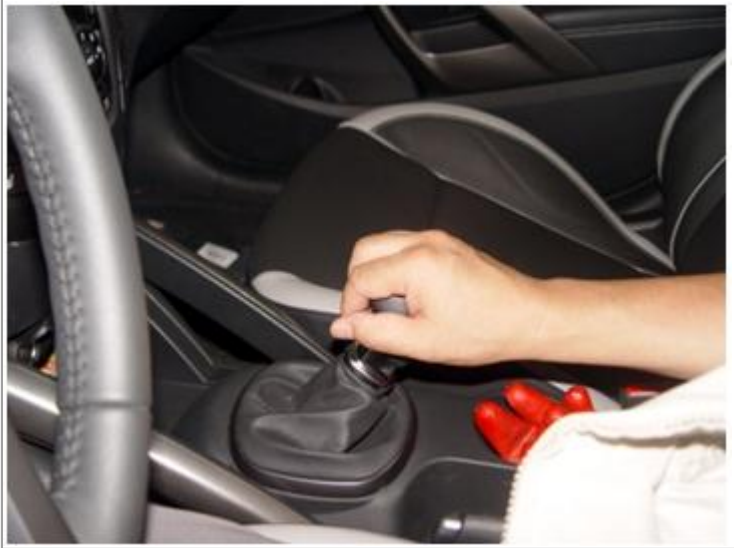
2. Gently hold the shift lever while driving on above conditions as shown in the photo.  
Check that there is vibration on the shift lever while driving for about 4 miles.  
If any, replace the M/T assembly with a new one according to the applicable workshop manual.  
If vibration cannot be confirmed no further procedure is required.

1. Test drive the vehicle to check vibration on the shift lever while driving for about 4 miles on below conditions.
  - Shift lever : 6-speed gear
  - Above 2,000 RPM
  - Above 50mph
  - Flat road without bumps
