<h1 style="text-align: center;">TSB-Local</h1>	Model	Soul [AM]()
	Group	Fuel System(14)
	TSB No.	KCE11-14-P060-AM;C21VA
Subject Soul Fuel Pump Assembly Replacement	Published	10/6/2011
	TSB Type	Service Action
	Area & Distributor	U.K (C21VA)

1. Description

On some Soul (AM) vehicles with diesel 1.6 engine excessive fuel suction noise might be heard from the fuel pump assembly.

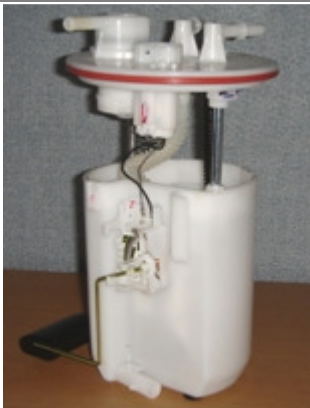
Part Name	Parts Number	Figure	Remark
Fuel Pump Assembly	311102K900QQK

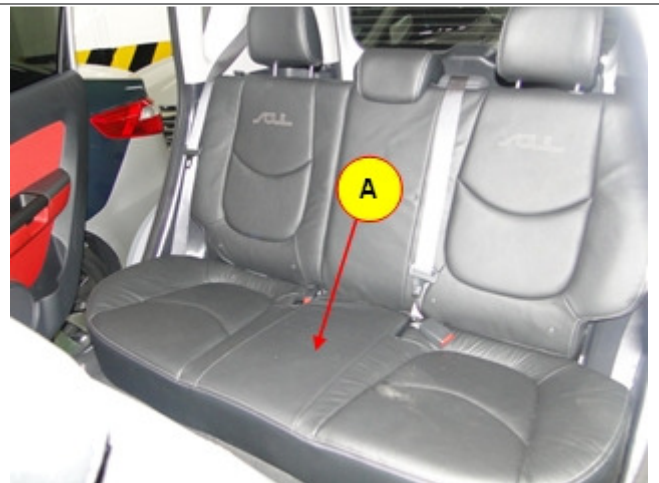
1. Place the ignition switch to the "OFF" position.
2. Remove the rear seat cushion (A).

1) Loosen the mounting bolt (B).

Tightening Torque

17 ~ 25 N.m (1.7 ~ 2.5 kgf.m, 13 ~ 18 lb-ft)

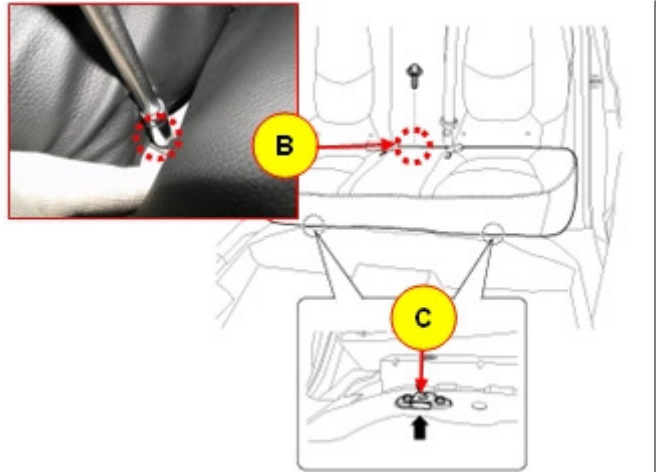
2) Remove the rear seat cushion by pushing the lock pins (C).

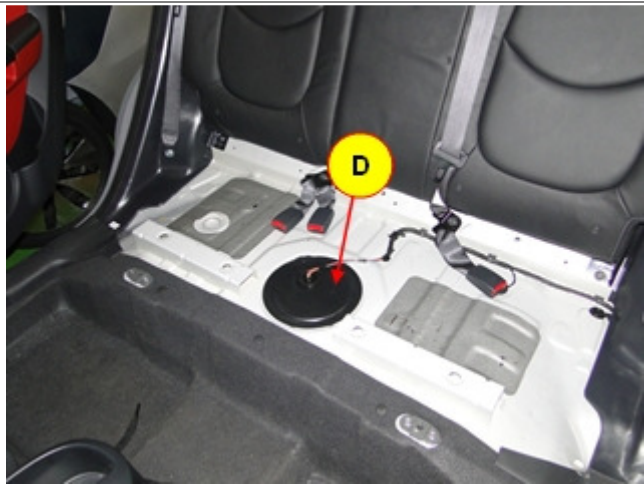
3. Remove the fuel pump service cover (D).

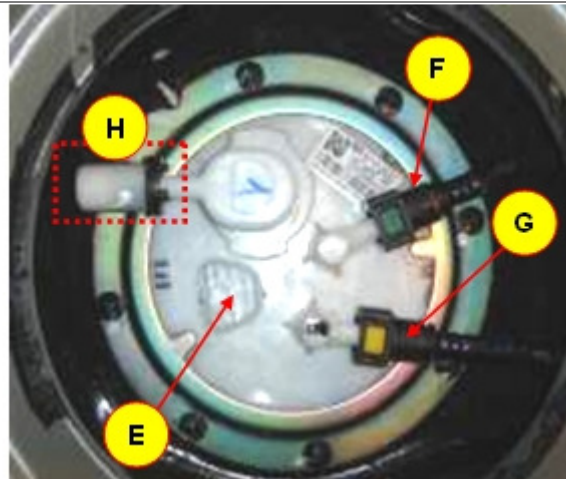
1) Disconnect the fuel pump connector (E)

2) Disconnect the fuel feed tube quick-connector (F) and the fuel return tube quick-connector (G).

3) Remove the air filter (H).

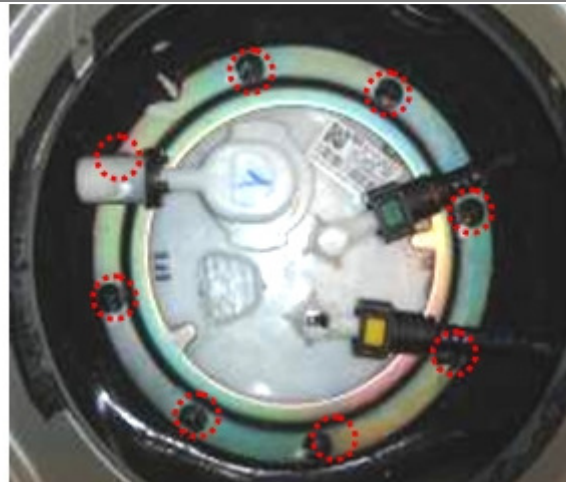
4) Loosen the fuel pump assembly mounting bolts (8EA), and then remove the fuel pump assembly.

5) Install the new fuel pump assembly.

Tightening Torque

2.0 ~ 2.9 N.m (0.2 ~ 0.3 kgf.m, 1.4 ~ 2.2 lb-ft)
