TECHNICAL BULLETIN

LTB00513

4.4 TDV8 Exhaust Smoke

Range Rover (LM)

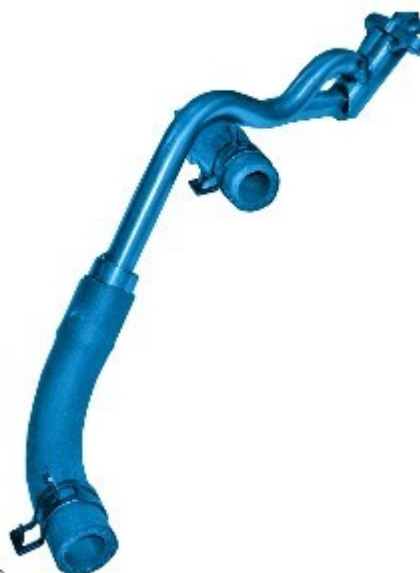
E151559

1. Identify the new design oil drain pipe supplied in the parts kit.

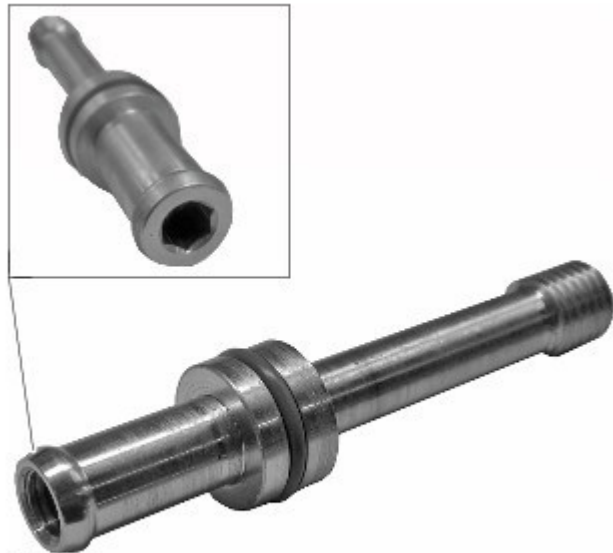
E149678

2. Identify the oil drain tube supplied in the parts kit.

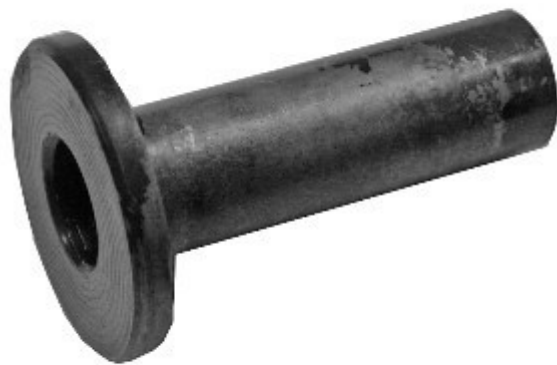
E149682

3. Identify the drill guide supplied in the parts kit.

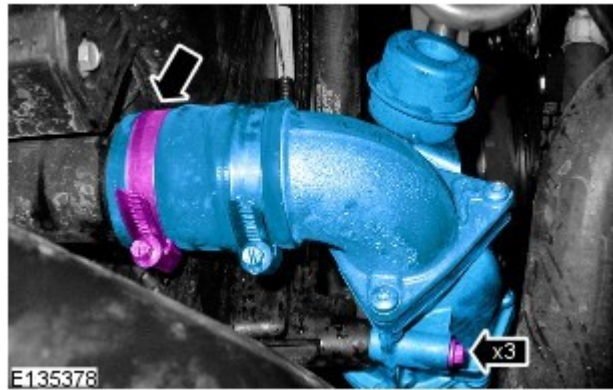
11. Release the hose from the charge air cooler and allow any fluid to drain.

- z Position a container to collect fluid loss.
- z Release the clip.

- z Remove the 3 bolts.

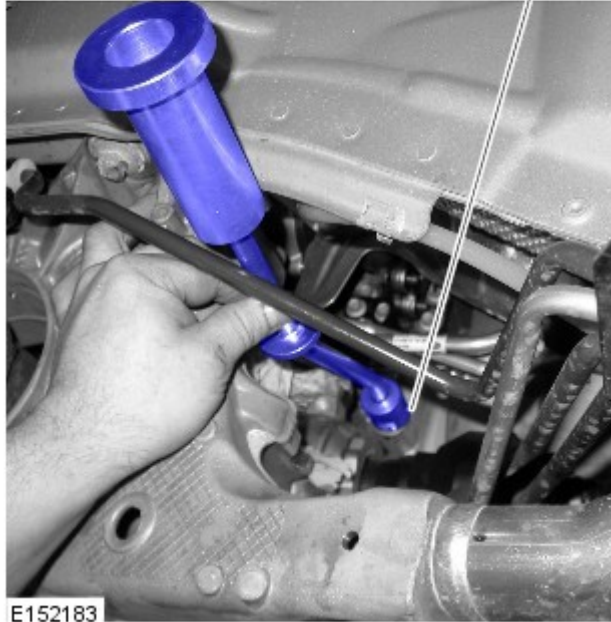
Using the special tool 310-197, remove and discard the core plug.

- z Repeat steps 19 and 20 to the lower core plug.

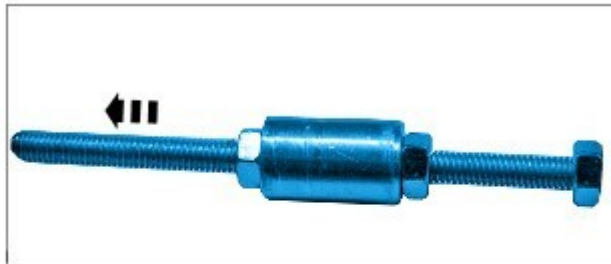
Install the drill guide and swarf tool in the positions shown.

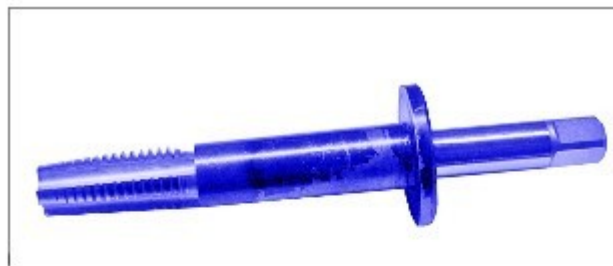
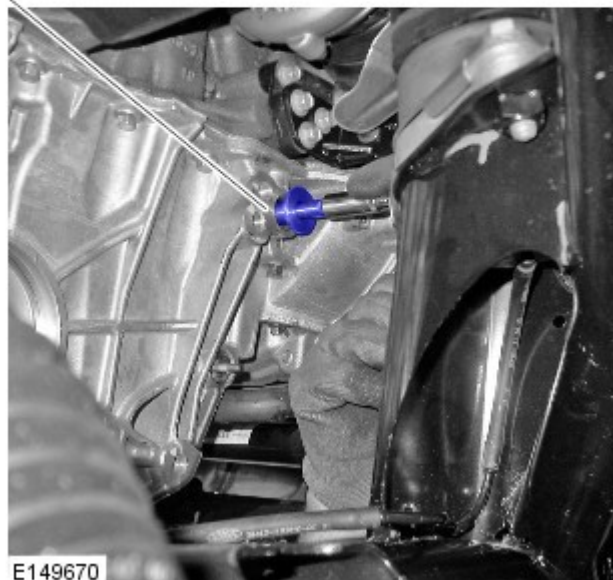
Using a suitable drill and a 12mm drill bit, drill through the centre of the drill guide in to the oil pan until the drill bit breaks through the inner wall of the oil pan, (resistance will no longer be felt on the drill once the inner wall has been broken through).

Tap a thread in the drilled hole.

- z Remove the drill guide.
- z Install the tap to the drill guide.
- z Apply a suitable grease to the tip of the tap.
- z Install the tap and drill guide assembly to the upper core plug hole.
- z Carefully tap the new thread.
- z Remove the tap and drill guide assembly.

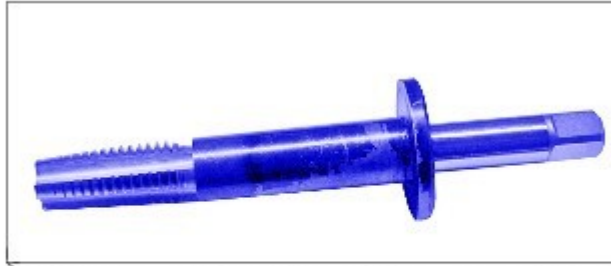
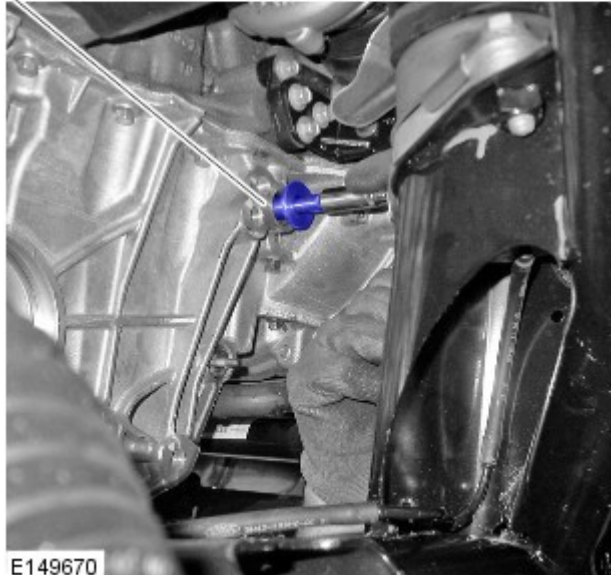
E149670

Using the tap and drill guide, make sure that the thread is free from swarf and debris.

- z Install the tap to the drill guide.
- z Apply a suitable grease to the tip of the tap.
- z Install the tap and drill guide assembly to the upper core plug hole.

- z Carefully run the tap through the new thread.
- z Remove the tap and drill guide assembly.

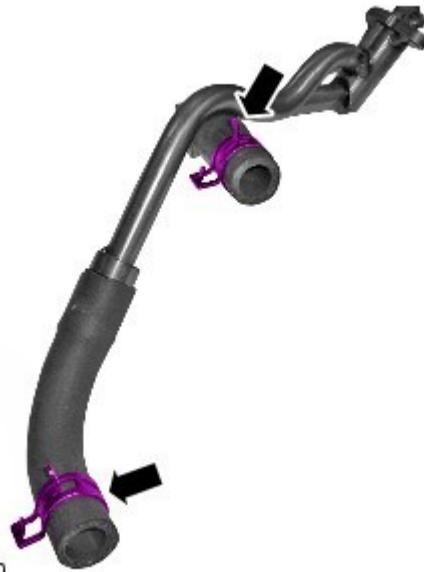
31. Make sure that the 2 clips are installed on to the new design oil drain pipe before installing the oil drain pipe.

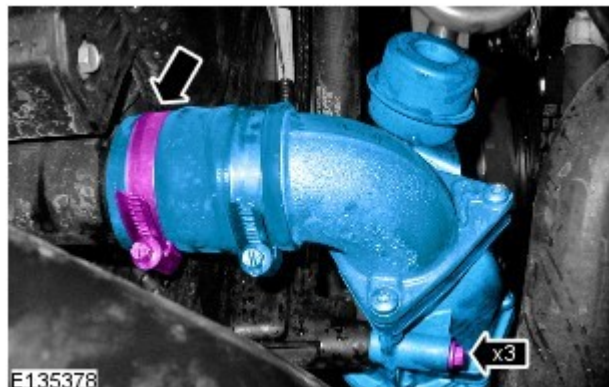
38. Secure the hose to the charge air cooler.

- z Using a suitable cloth, wipe away any remaining fluid.
- z Secure the clip.
- z Tighten the 3 bolts to 10 Nm.
