# Trunk Hard to Close

**Service Category** Vehicle Exterior

**Section** Door/Hatch

YEAR(S)	MODEL(S)	ADDITIONAL INFORMATION
2013	GS350	VDS(s): BE1BL, CE1BL

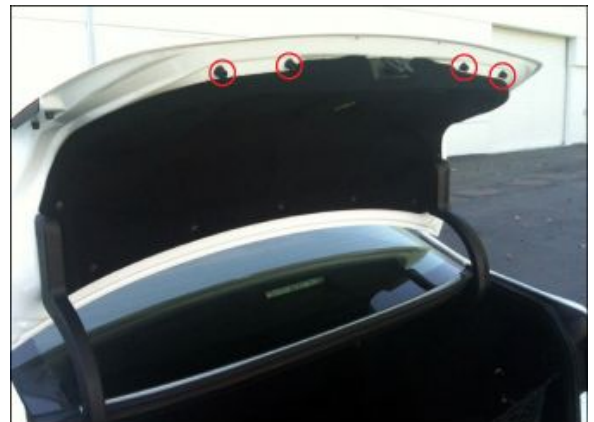
Figure 1.

Some 2013 GS 350 vehicles may exhibit a condition where the trunk is hard to close. On rear spoiler equipped models, this may also be perceived as an unusual amount of force required to pull down the trunk lid. Follow the procedure in this bulletin to address the condition.

1. Remove the 4 rubber cushions located in the lower portion of the luggage door.
2. Insert the 4 new rubber cushions.

3. Confirm successful repair.
