**Technical Service
Information Bulletin**

OUTER REAR VIEW MIRROR OPERATION

'04 – '05 RX 330

ELECTRICAL
EL004-07

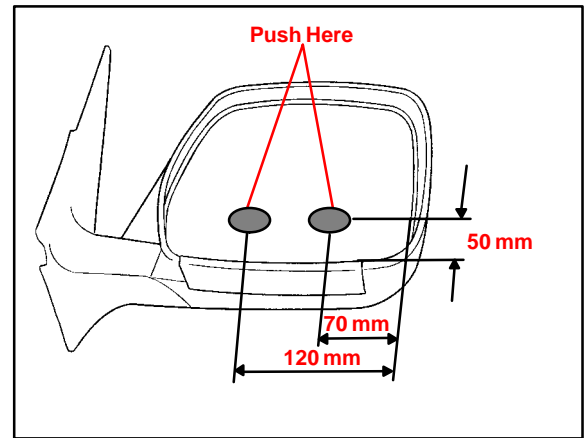
- E. Reconnect the mirror holder — Apply pressure to the indicated areas until you hear the holder clips snap into place.

If pressure is applied in areas other than the ones indicated, the mirror glass may break.
