TECHNICAL BULLETIN

MG TF

No: TB0085 Issue 1**Date:** 04.12.2002**Section:** BODY**Title:**

HEADER SEAL MODIFICATION – A POST FIXING

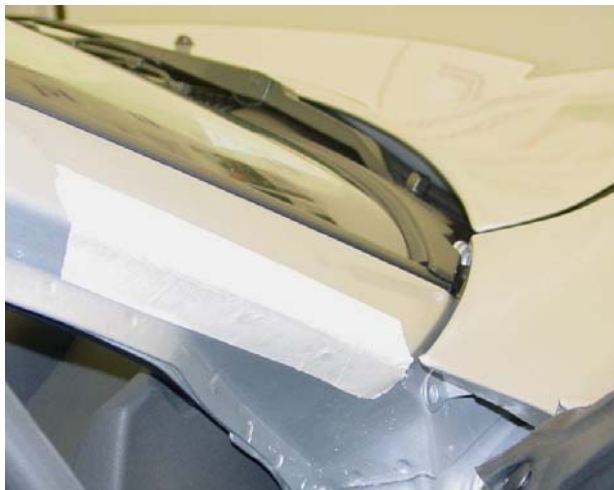
1

1. Referring to workshop repair [76.31.85](#) remove old seal.
2. Remove any traces of adhesive or road debris from the A post area.
3. Apply a 50mm wide X 200mm long strip of masking tape to the lower A post as shown in illustration 1. Close door.
