Service Campaign Bulletin

Campaign No. 2013010001, February 2013

SUBJECT: **Model 207, 212, 218, 221, 231 with Engine M278, Model Year 2013
Remove Check Valve for Left and Right Secondary Chain Tensioners**

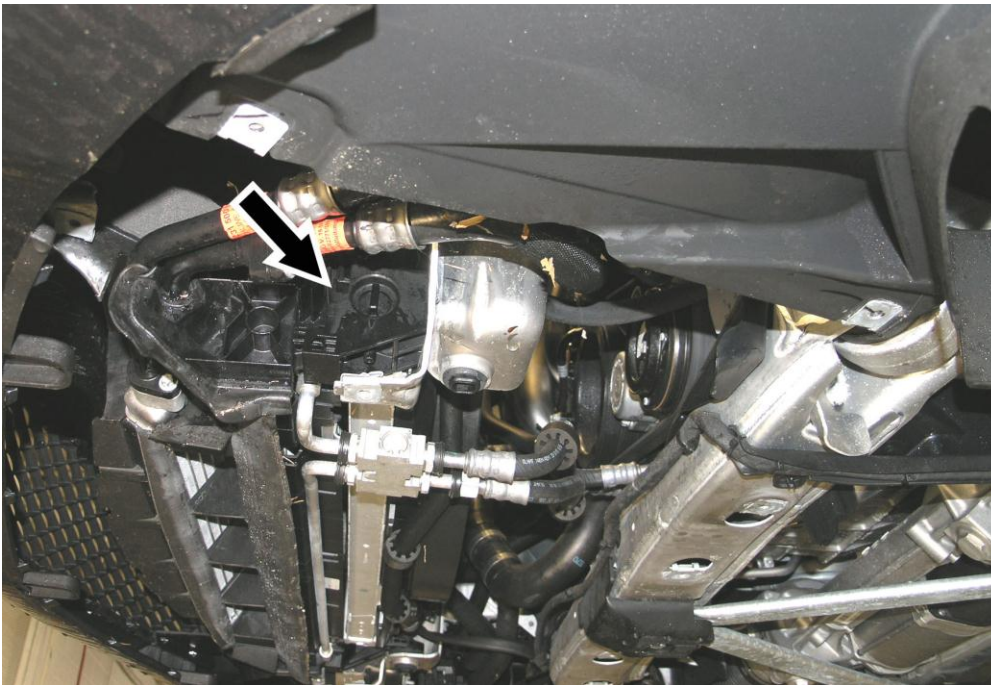
Figure 1 (model 231)

- Remove/install charge air ducts (refer to attached WIS document on page 6).
- Remove lower engine compartment panels, refer to WIS: AR61.020-P-1105RK.
- Drain coolant from radiator (arrow, Figure 1).

- Refill cooling system and bleed (after performing subject B), refer WIS: AR20.00-P-1142-04A
- Check cooling system for leaks (after performing subject B), refer to WIS document on page 9.

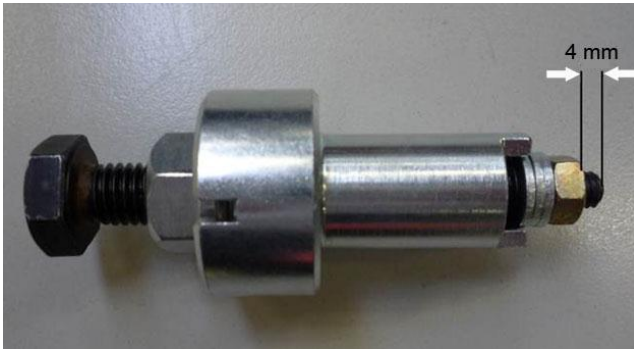
**Figure 2**

1. Set puller W 605 589 00 33 00 with washers and an M6 nut to a remaining length of approx. 4 mm (Figure 2).

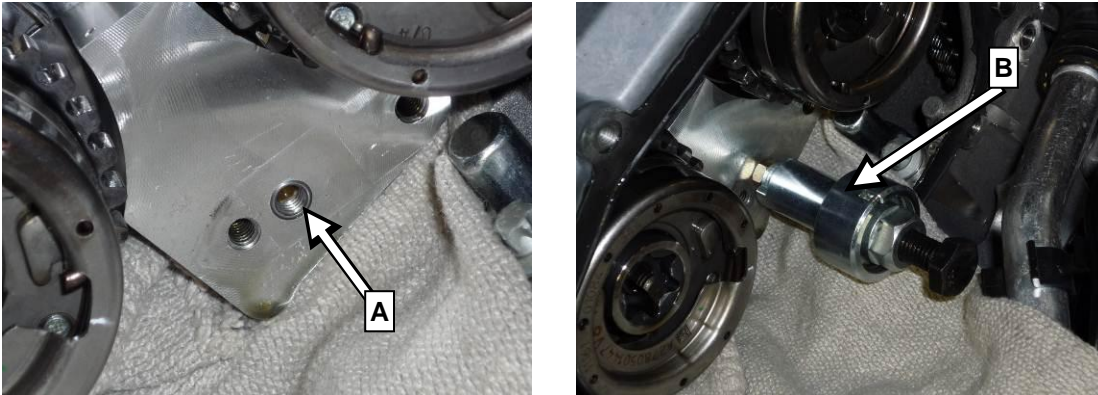
**Figure 3** (Shown on right side)**Note:**

2. Remove check valve (A, Figure 3) with set puller (B) W 605 589 00 33 00 from cylinder head.

Cover chain case opening with rag so no parts can fall in.

4. Assemble in the reverse order.

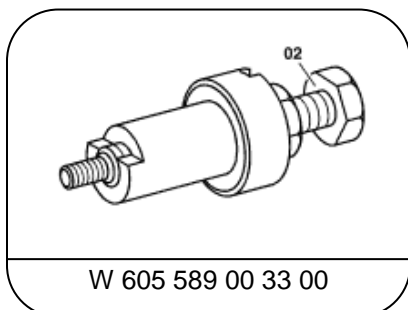
W 605 589 00 33 00

Puller

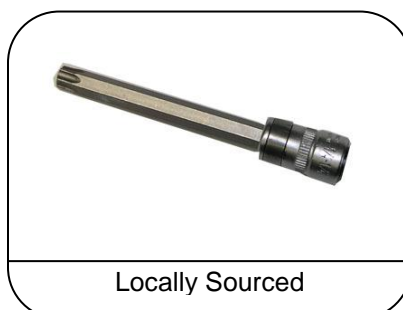
Locally Sourced

Torx 40 bit x 70 mm*

* Please be advised that the Torx 40 bit x 70mm (2.75") length is available through your Local Tool dealers (e.g. Snap-on, Matco, Mac) or online via these websites:

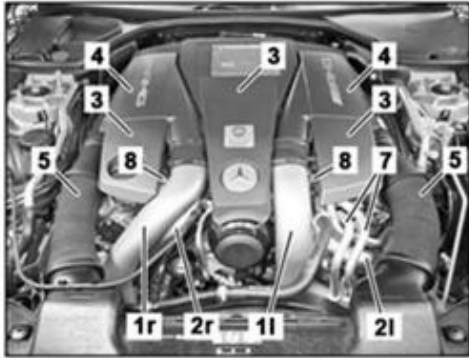
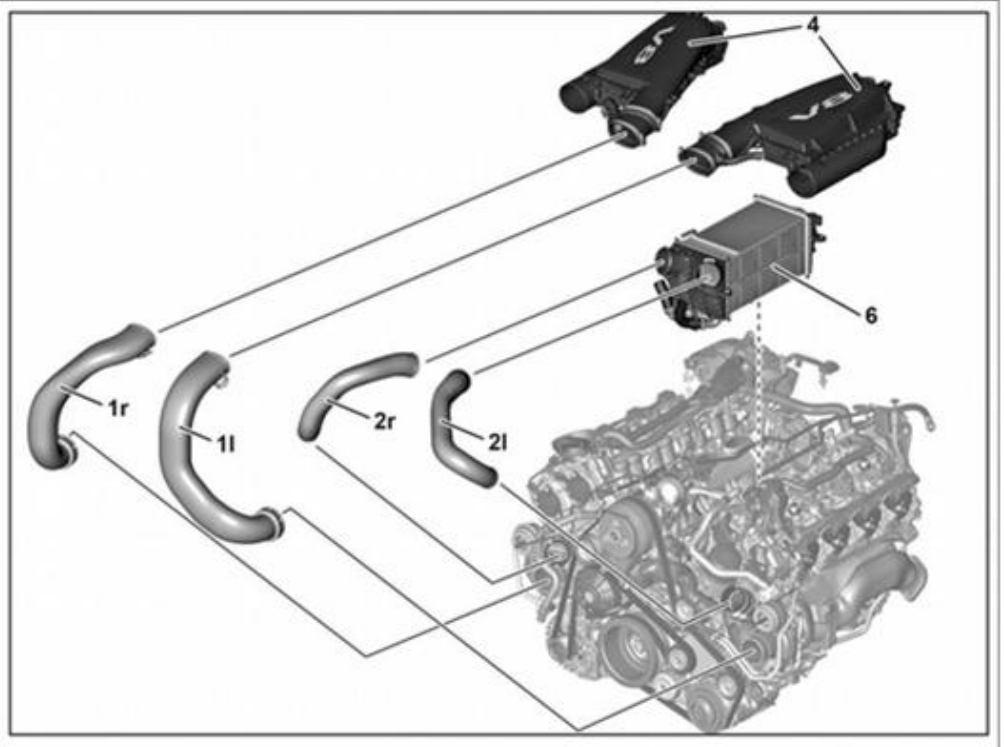
AR09.41-P-8620RKB Remove/install charge air ducts

1l Upper charge air duct on the left
 1r Upper charge air duct on the right
 2l Lower charge air duct on the left
 2r Lower charge air duct on the right
 3 Engine cover

4 Air cleaner housing
 5 Engine suction air duct
 6 Charge air cooler
 7 Oil line
 8 Screw/bolt

Remove/install		
1	Remove engine covers (3)		
2	Remove right and left engine suction air duct (5)		
3.	Remove oil lines (7) for engine oil cooling from oil filter housing and lay to the side outside of the working area	ENGINE 157 in MODEL 231

4	Release clamp for upper charge air duct on the left (1l) or for upper charge air duct on the right (1r) on boot air filter housing (4)

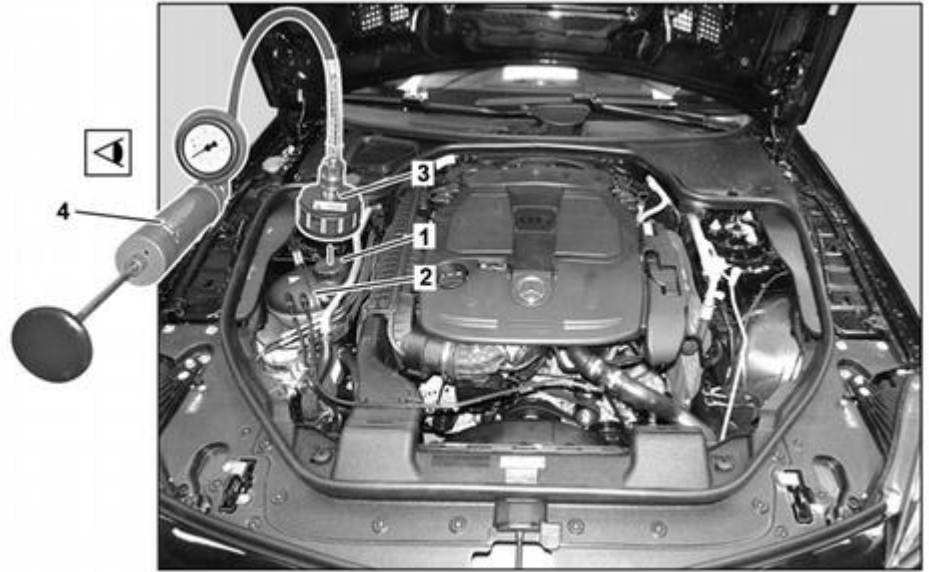
P20.00-2455-05

Shown on engine 276

- 1 Cap
- 2 Coolant expansion reservoir
- 3 Tester cap
- 4 Pressure pump
