SB-10055923-4231

SERVICE CAMPAIGN BULLETIN

NTB14-030c

**VOLUNTARY SERVICE CAMPAIGN
2011 - 2013 JUKE TIMING CHAIN**

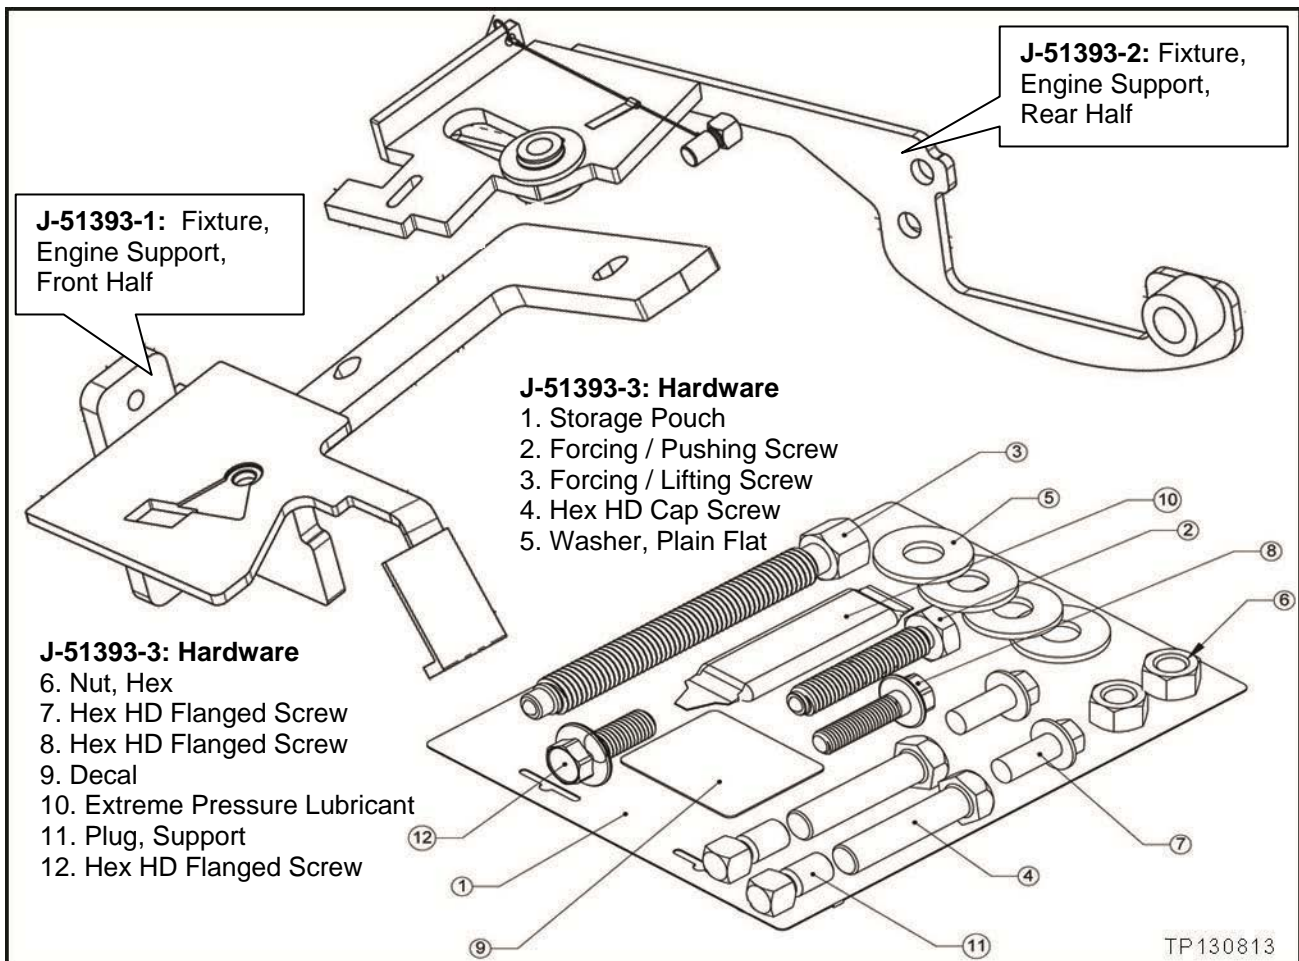
Special Tool - J-51393 - Engine Support Fixture

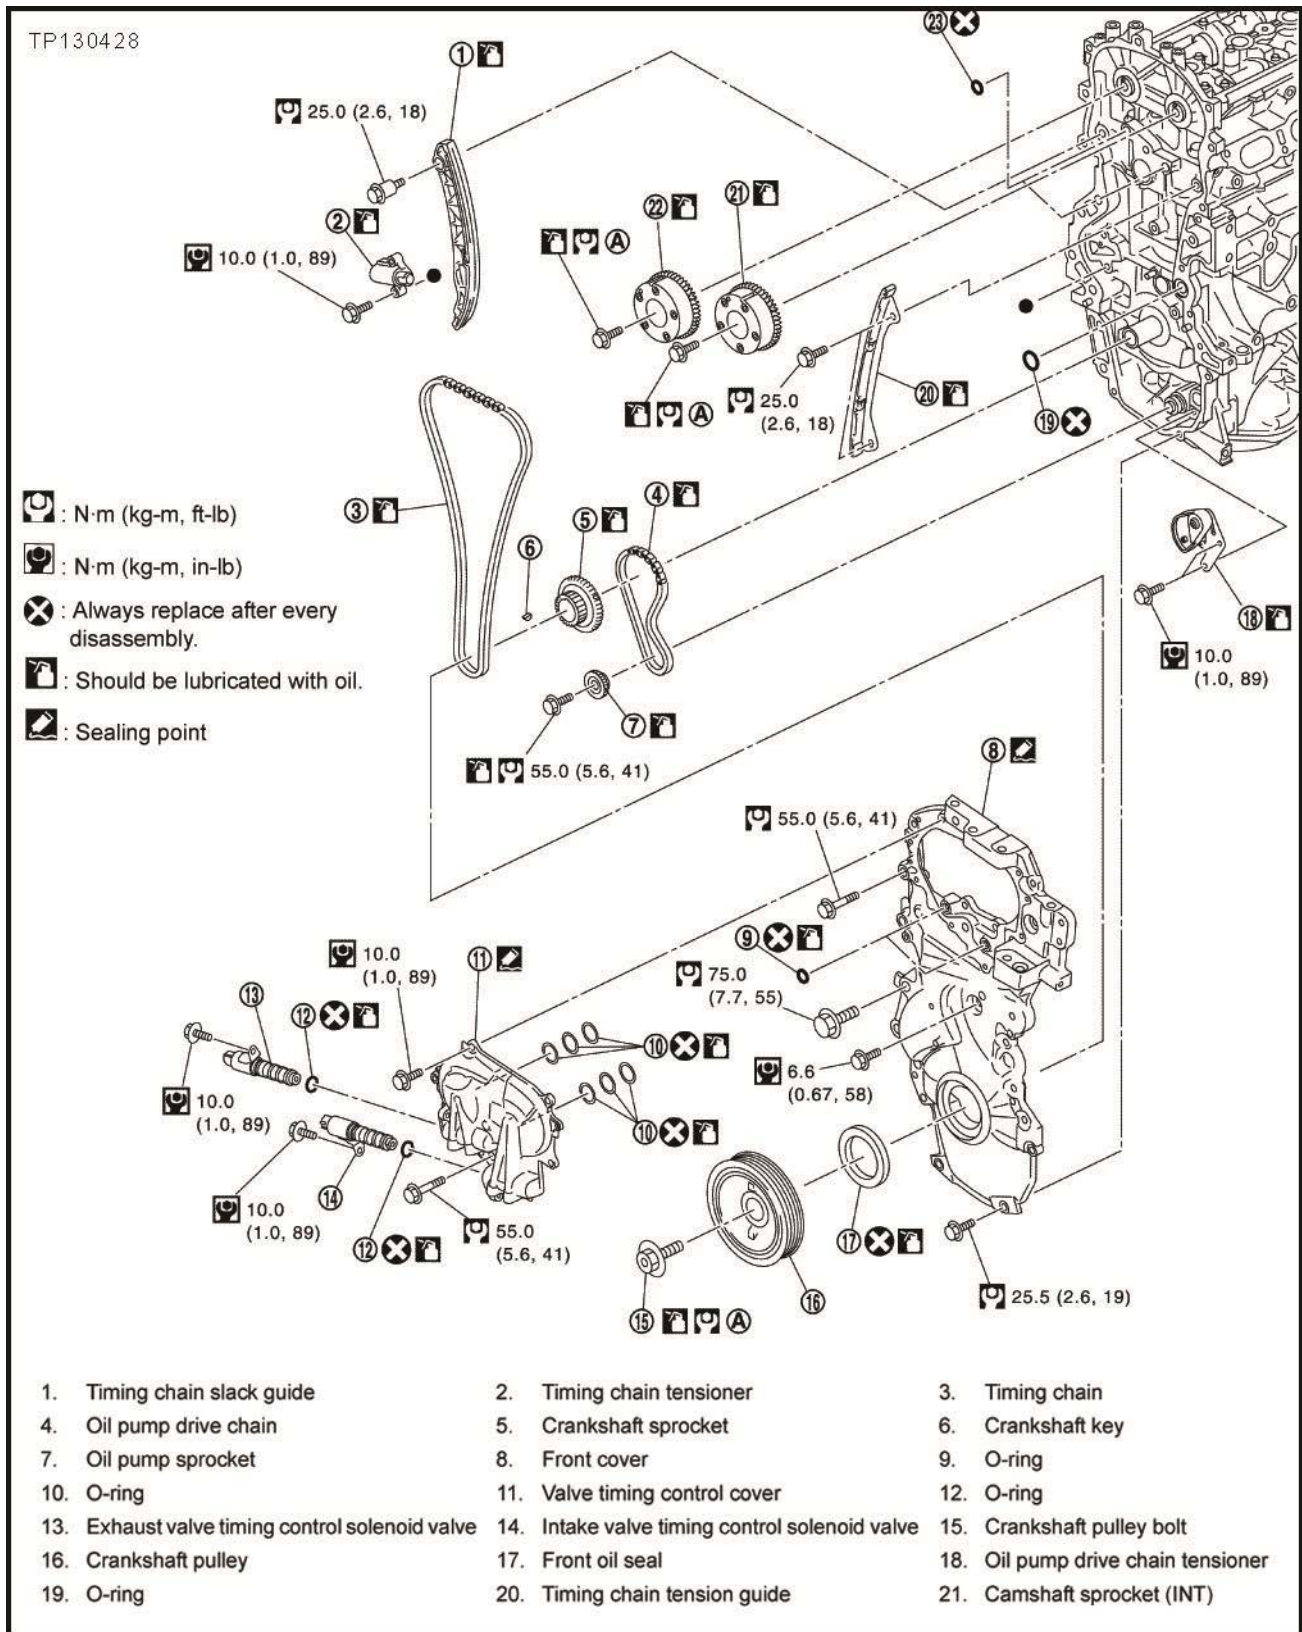
Figure A

Timing Chain Exploded View

- This exploded view of the timing chain is provided for convenience. Reference it as needed while performing the service procedure in this bulletin.

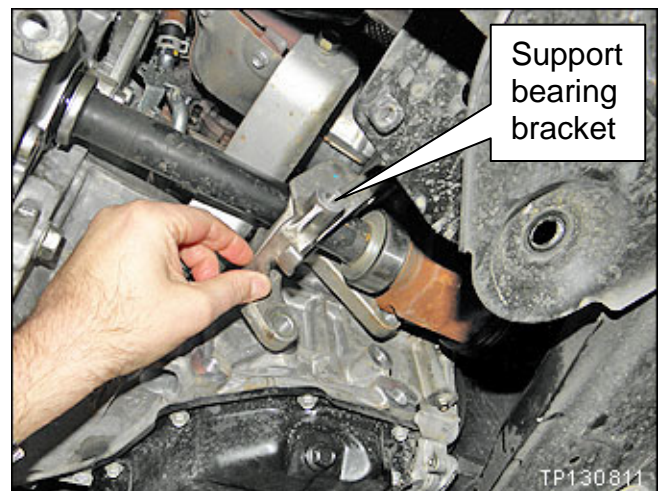
Figure A4

- The support bearing bracket will not be completely removed. It will stay loose on the axle during the procedure, as shown in Figure A4.
- Be careful not to pull the axle out of the transmission or oil will leak out.

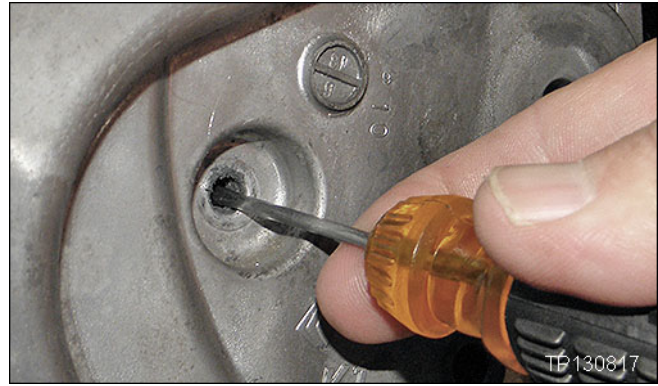
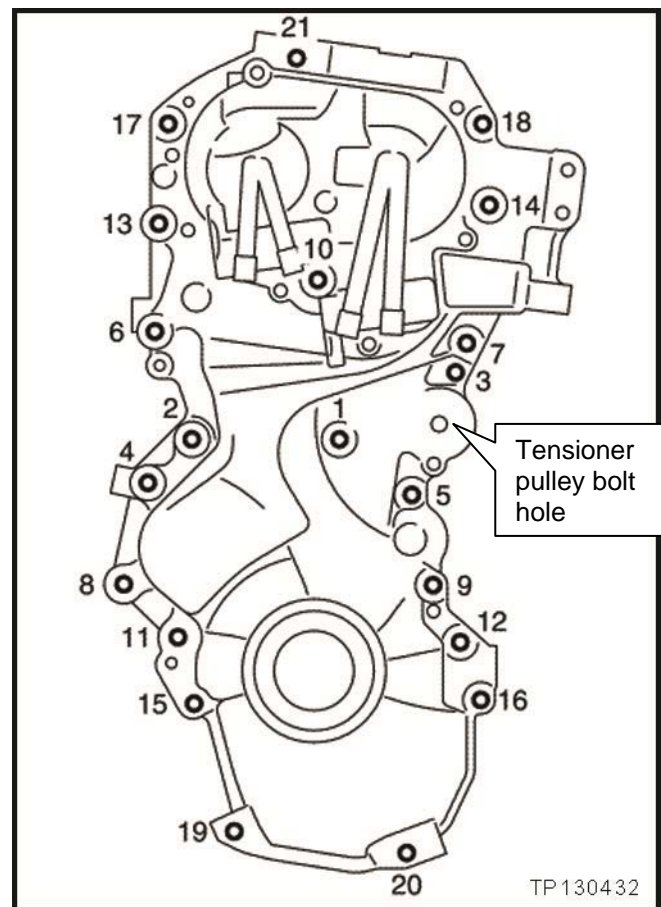
Figure 45a

- Clean excess silicone out of bolt holes 1, 3, 5, 7, 10, 15, 19, 20 (see Figure 45a).
- Also clean excess silicone out of the hole for the belt tensioner pulley bolt hole (see Figure 45a).
- Use a small flat blade screwdriver or other suitable tool to clean excess silicone from the bolt holes.

59. Install the front cover bolts shown in Figure 45a.

- Tighten the bolts in the order shown.
- Refer to the table below for torque specifications.

Bolt Number	Head/Hex Size	Torque
1	8 mm	6.6 N•m (0.67 kg-m, 58 in-lb)
6, 7, 10, 13, 31	13 mm	55 N•m (5.6 kg-m, 41 ft-lb)
2, 4, 8, 11	16 mm	75 N•m (7.7 kg-m, 55 ft-lb)
Other bolts not listed above	10 mm	25.5 N•m (2.6 kg-m, 19 ft-lb)
