Subject: CHECK ENGINE LIGHT AND AUTOMATIC TRANSAXLE WARNING LIGHT ON WITH DTC P0842, P0847, P0872 AND/OR P0877 STORED IN TCM MEMORY	Bulletin No: 05-005/14
	Last Issued: 04/29/2014

2012-2014 Mazda3 (with SKYACTIV 6AT)

2013-2015 CX-5 (with SKYACTIV 6AT)

2014-2015 Mazda6 (with SKYACTIV 6AT)

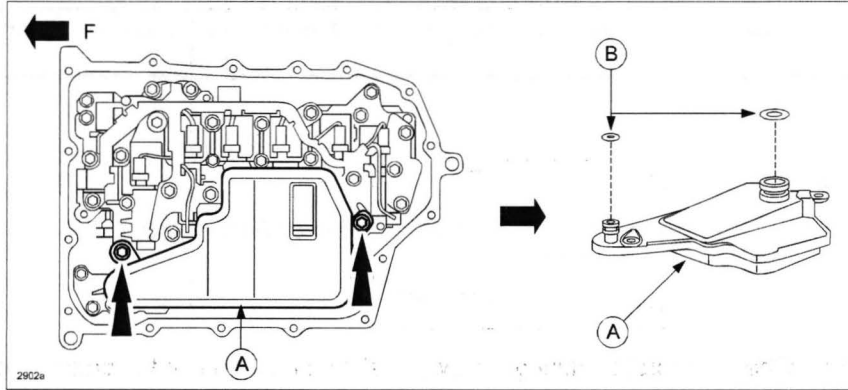
4. Remove the oil strainer (A) and the oil strainer O-rings (B) from the transaxle.
F=Front of vehicle

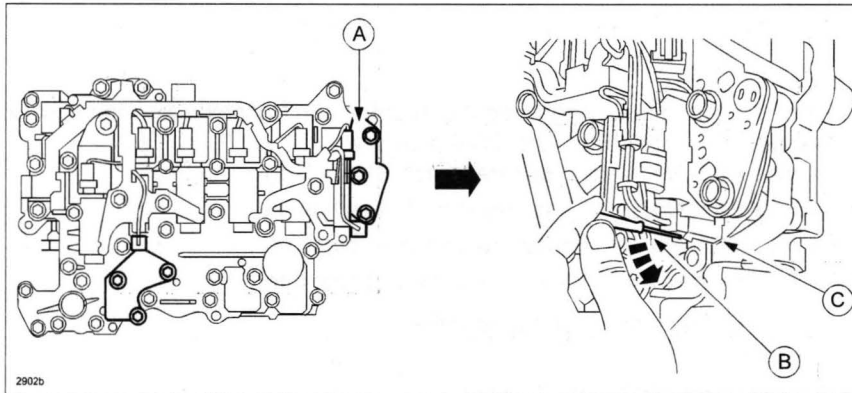
5. Remove oil pressure switch A.
a. At oil pressure switch A, insert a precision flathead screwdriver (B) and move it in the direction of the arrow in the figure to disconnect the oil pressure switch A connector (C).

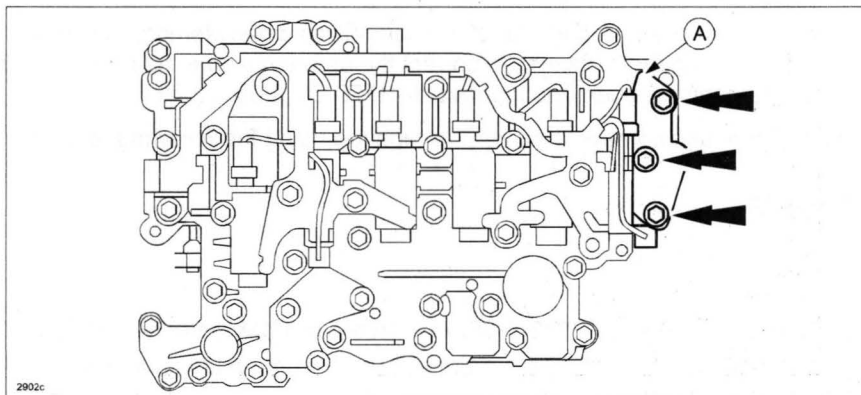
- b. Remove the bolts for oil pressure switch A.

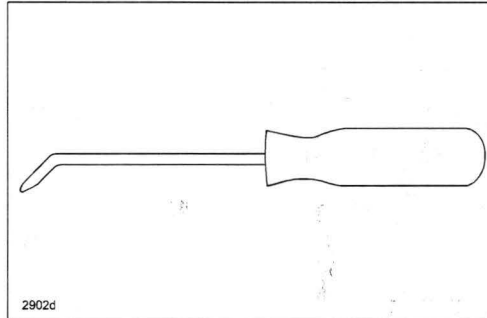
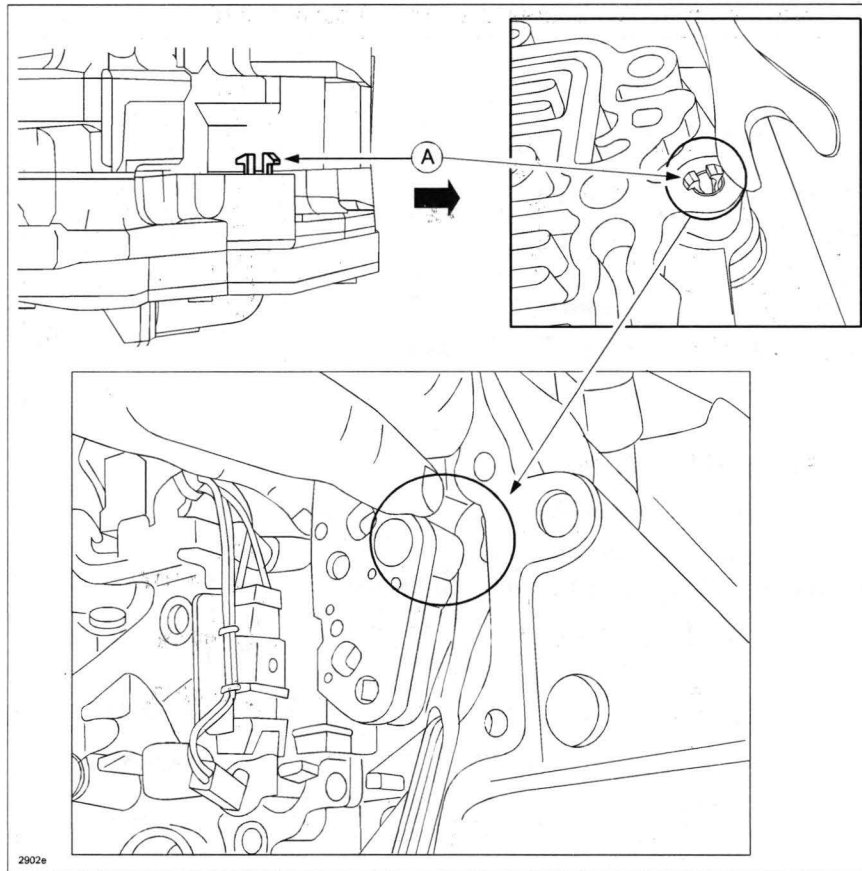
- c. Detach the tab shown and remove oil pressure switch A from the control valve body.
1. Using an appropriate tool (such as a fastener remover), push the tab (A) of oil pressure switch A.

CAUTION: If the tab is broken during removal, make sure to remove the broken pieces.

2. Pull out oil pressure switch A by shaking it.

CAUTION: When removing oil pressure switch A, be careful not to damage the transaxle fluid temperature (TFT) sensor harness nearby.

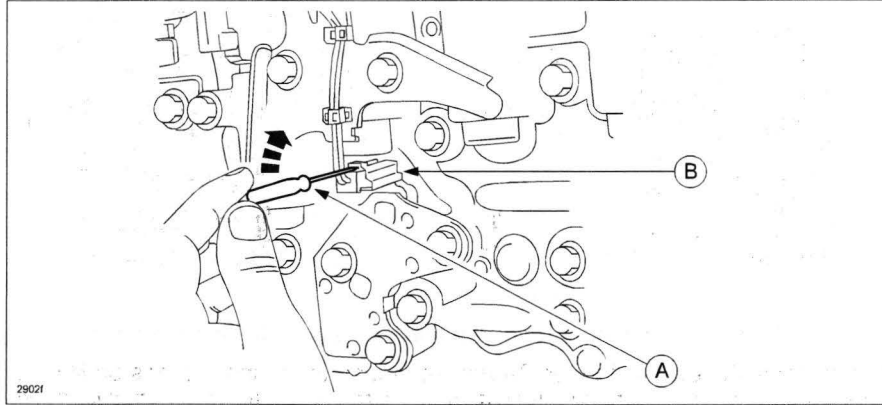
6. Remove oil pressure switch B.
 - a. Insert a precision flathead screwdriver (A) and move it in the direction of the arrow as shown to disconnect the oil pressure switch B connector.

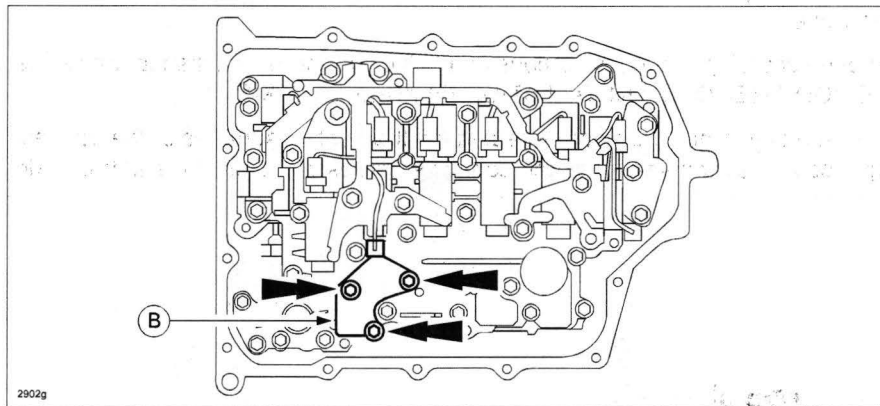
- b. Remove oil pressure switch B.

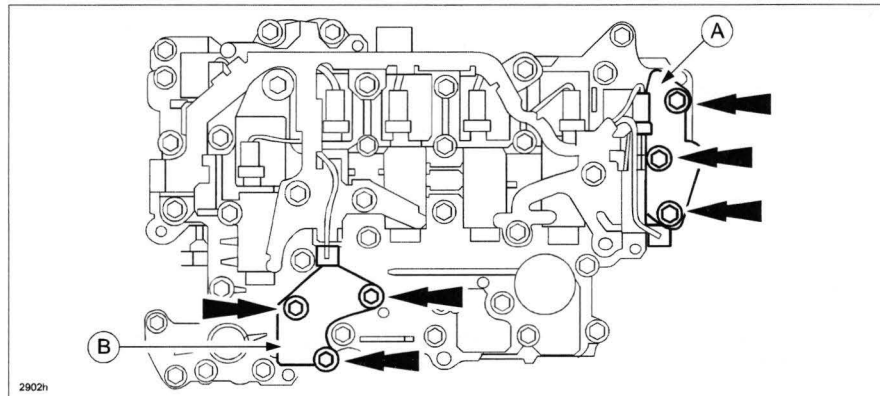
7. Install new oil pressure switches A and B.
8. Verify that the tab of each oil pressure switch A and B is attached correctly.
9. Install the bolts for oil pressure switches A and B.
Tightening torque: 9-10 N•m {92-101 khf•cm, 80-88 in•lbf}

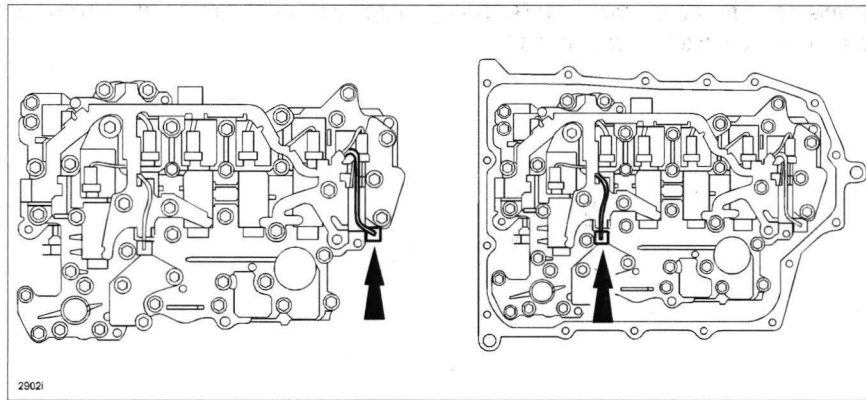
10. Connect the oil pressure switches A and B connectors.

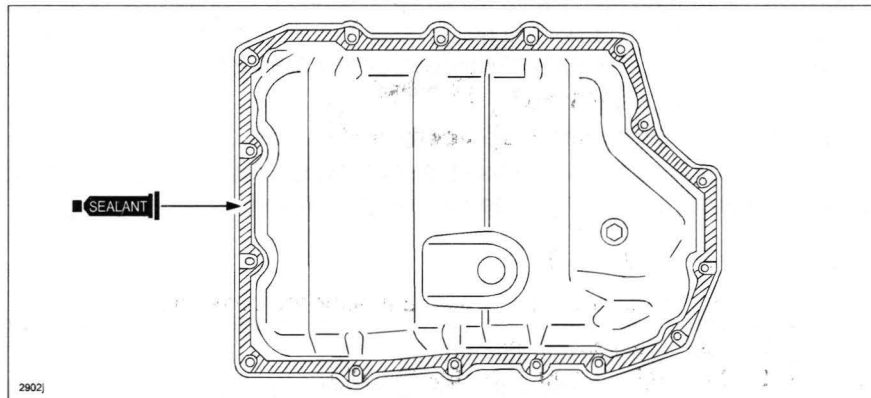
CAUTION: Clean any remaining silicone sealant off the contact surfaces of the transaxle case and oil pan.
a. Apply a light coat of silicon sealant to the contact surfaces of the oil pan and transaxle case.

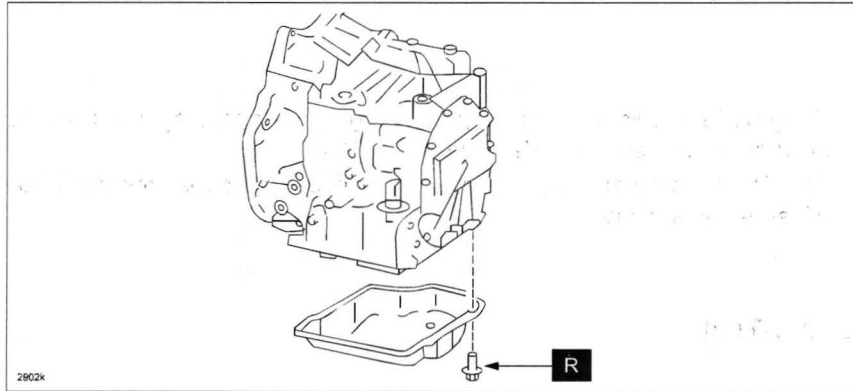
- b. Install the oil pan with new bolts before the applied sealant starts to harden.

Tightening torque: 8-10 N•m {82-101 khf•cm, 71-88 in•lbf}
