Rear Differential Coupling Growl Noise

YEAR(S)	MODEL(S)	ADDITIONAL INFORMATION
2006 – 2012	RAV4	Drive Type(s): 4WD Transmission(s): 5AT, 4AT

Some 2006 – 2012 model year 4WD RAV4 vehicles may exhibit a growl type noise from the rear differential coupling when driving as a result of contamination to the front bearing. Follow the procedure in this bulletin to address this condition.

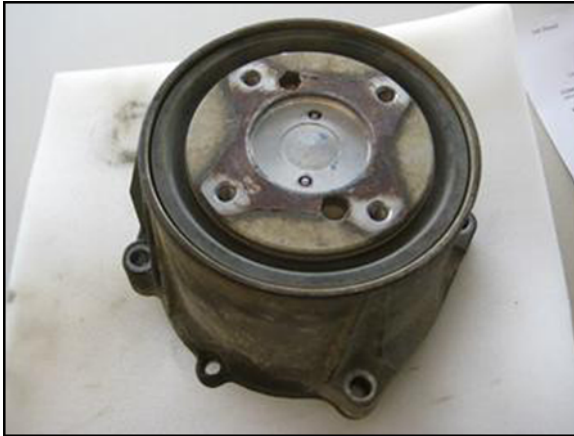
Figure 1. For This Deflector Type, Use P/N 41252-42020

- When ordering Deflector be sure to order the correct part number based on original deflector shape as shown below.
- The Linear Solenoid Yoke of Coupling Sub-Assy PN 41303-42023 has 2 mounting holes while original has 3. This is by design.

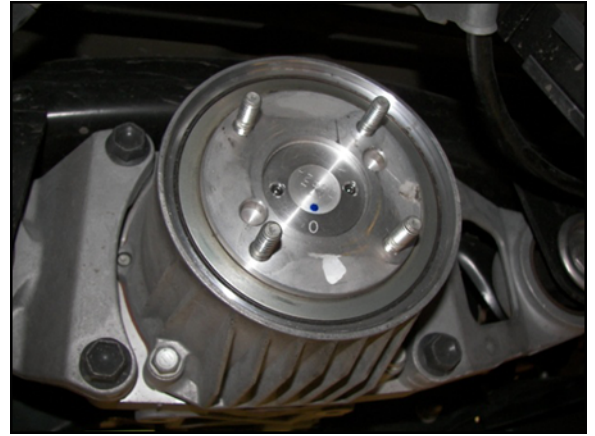
Figure 2. For This Deflector Type, Use P/N 41252-42013

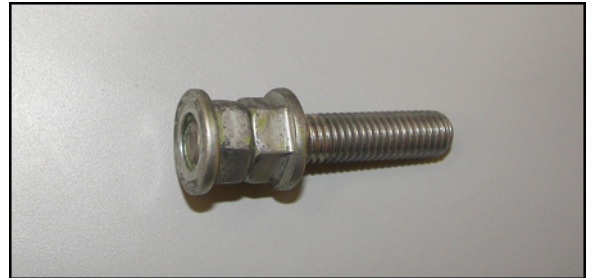
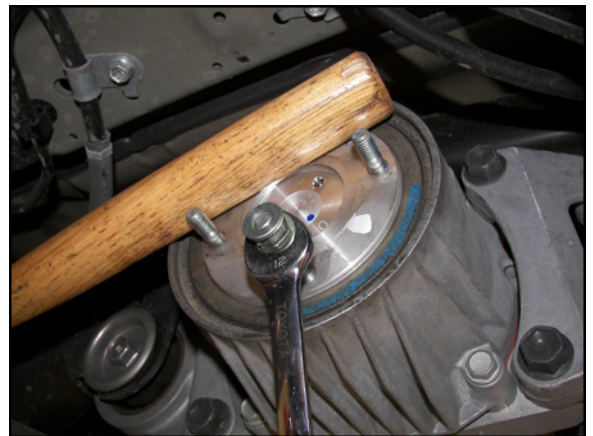
- C. Remove the 4 stud bolts.

Using a double nut configuration, with new nuts, remove the 4 studs from the rear differential coupling.

Use a wooden or plastic hammer/mallet handle to protect the stud threads and hold the coupling when loosening the stud bolts. Once the stud bolt is removed, loosely thread the stud bolt back into the coupling to allow for removal of the other stud bolts.

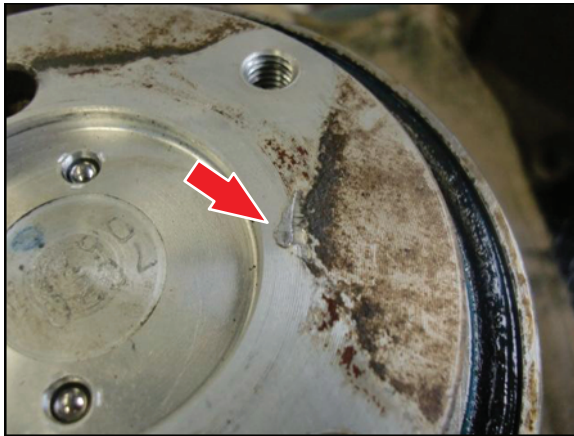
Figure 6. Damage Where Propeller Shaft Contacts Coupling Body

If the rear differential coupling body assembly shows any of the issues noted below, the rear differential coupling assembly **CANNOT** be rebuilt and must be replaced as an assembly.

- **YES** — Continue to step 6. Remove the rear differential coupling cover assembly.
- **NO** — Continue to step 5. Replace the rear differential coupling assembly.

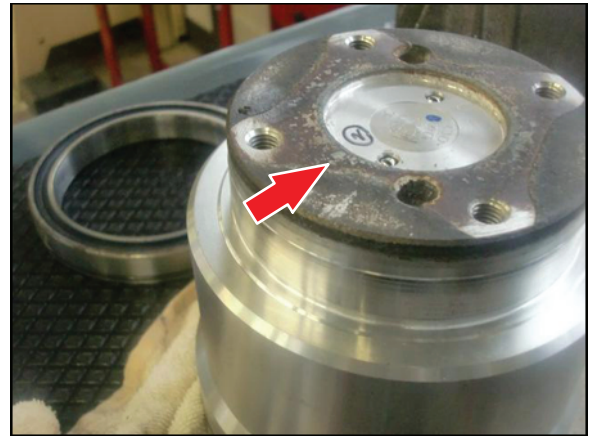
Figure 7. Excessive Rust/Corrosion Buildup on Top of Coupling Body

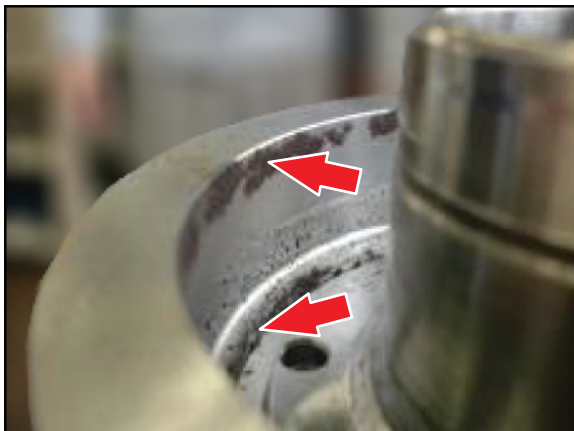
Figure 8. Rust/Corrosion on Inside of Coupling Body

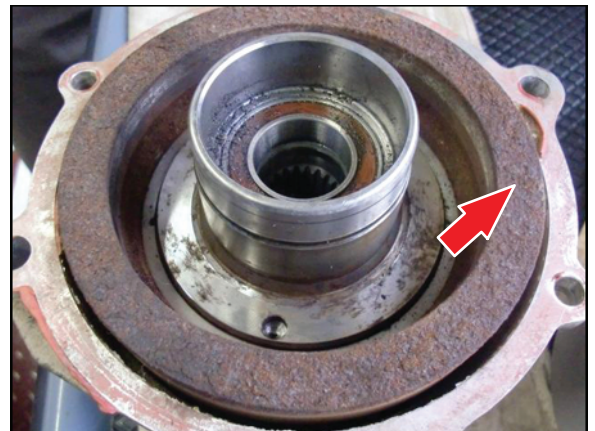
Figure 9. Excessive Rust/Corrosion Buildup on Edge of Coupling Body

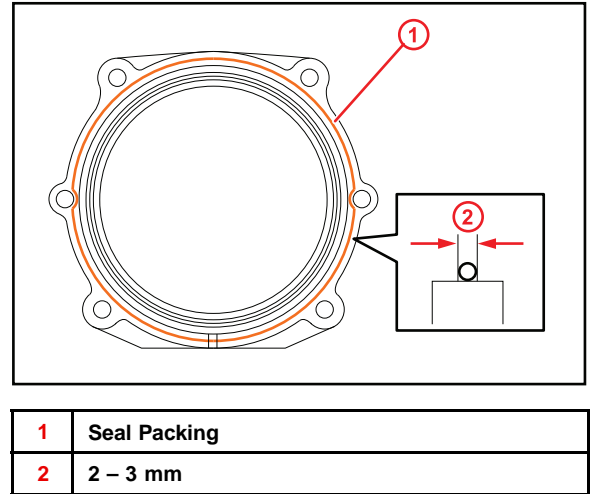
Figure 12.

- C. Clean the rear differential coupling and rear differential seal surfaces, then apply seal packing in a continuous line, 2 – 3 mm (0.08 – 0.12 in.) in diameter, to the rear differential coupling.

FIPG Sealant: Three Bond 1281, or equivalent

Install the rear differential coupling within 3 minutes of applying seal packing.

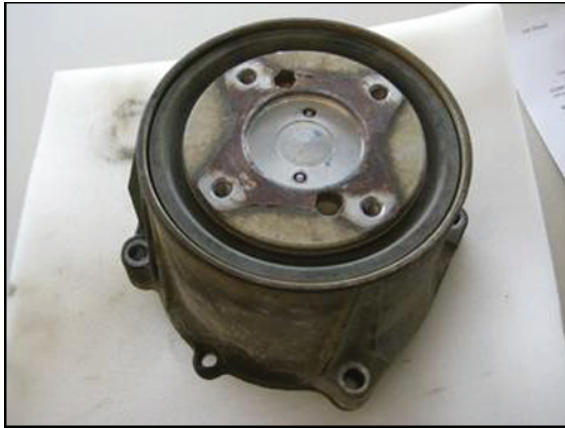
Figure 28. Use P/N 41252-42020

Confirm the correct deflector is installed based on original deflector shape.
