This Service Information bulletin supersedes SI B11 04 04 dated October 2004.

Service Action: E46 M3 S54 Connecting Rod Bearings Replacement

E46 M3 coupe/convertible with S54B32 engine produced from 02/12/2001 up to 05/22/2003

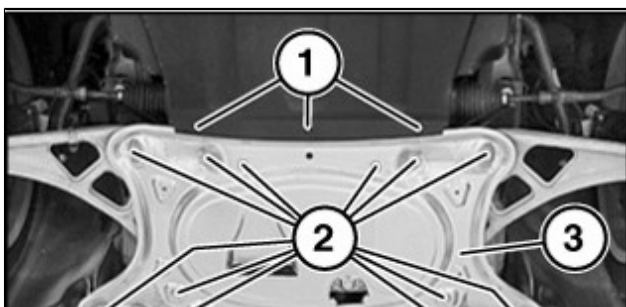
5. Remove engine splashguard. Remove thrust (3) plate on front axle support. For removal instructions refer to RA 51 71 374.

**Important:** When reinstalling thrust plate, use a set of new M10 x 30 x 1.5 screws provided in the parts kit. Then, the

reinforcement plate screws must be tightened in two stages:  
 - first, torque with 59 Nm  
 - then, angle torque to 90°  
 Using Torque Angle Measuring Tool (p/n 90 88 6 009 120 available through the Automatic Tools Shipment Program)

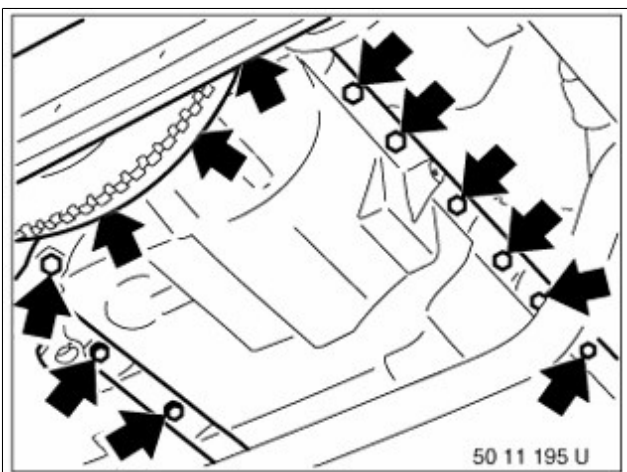
21. Unfasten oil sump screws and carefully remove oil pan.

**Important:** Three screws on the left side of the oil pan (near the oil condensate return hose) are 5 mm longer than the rest of them. On SMG transmission equipped vehicles, if necessary, disconnect bracket for engine oil lines to ensure sufficient clearance for oil sump movement. When reinstalling, use new Oil Pan Gasket (p/n 11 13 1 437 237 ordered separately). Also, apply a small amount (bead approximately 3 mm wide and 2 mm high) of HYLOMAR Sealing Compound (p/n 81 22 9 400 339) in areas around timing cover/engine block/bell housing joints. Detailed procedure can be found in the instructional CD. Then, torque down oil pan screws (M6) to 10 Nm when reinstalling.

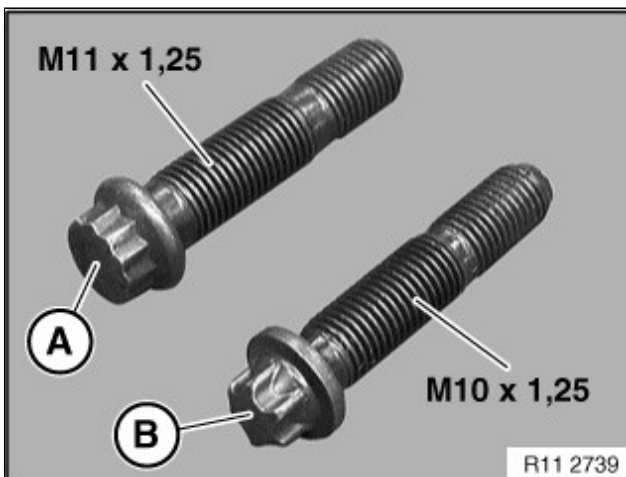
28. Remove connecting rod bolts (use M12 mm, 12-point socket on vehicles with M11 x 1.25 bolts; or Torx E12 on vehicles equipped with M10 x 1.25).

**Important:** On vehicles produced up to 12/13/2002, the M11 x 1.25 connecting rod bolts (A) will be reused with the new bearings. It is essential to mark them and then reinstall them in the same order (e.g. bolt from the exhaust side must be reinstalled again on the exhaust side, etc). On vehicles produced from 12/13/2002, the new design M10 x 1.25 connecting rod bolts (B) have to be replaced with the new connecting rod bearings. The M10 x 1.25 bolts have to be ordered separately (p/n 11 24 7 834 310 – 12 bolts per vehicle).

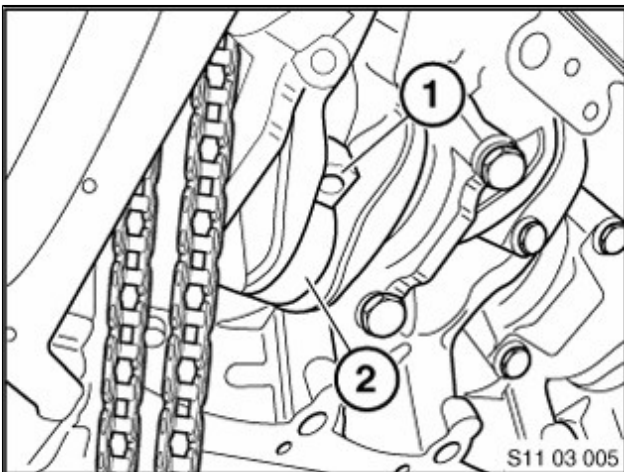
31. Clean connecting rod bearing surface with fiber-free cloth, then install "blue" bearing shell and moisten it with clean 10W-60 engine oil.

32. Then, carefully push the connecting rod (1) upwards and over the crankshaft journal (2), making sure that crankshaft surface is not scratched in the process.

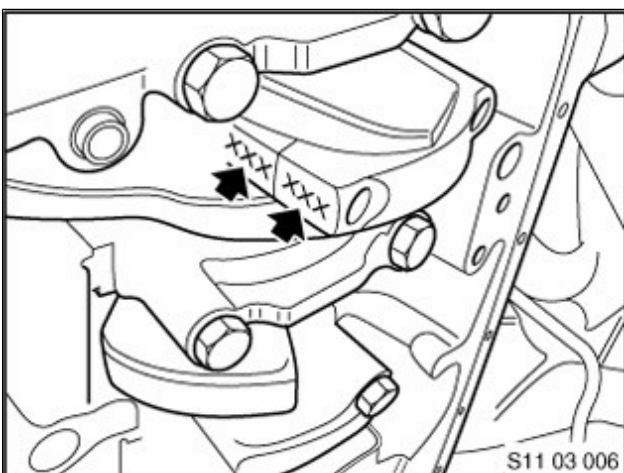
33. Install "red" bearing shell in the corresponding connecting rod cap and moisten it with clean 10W-60 engine oil.

34. Install connecting rod cap in the proper position, with matching serial numbers stamped on cap and rod as shown on the illustration.

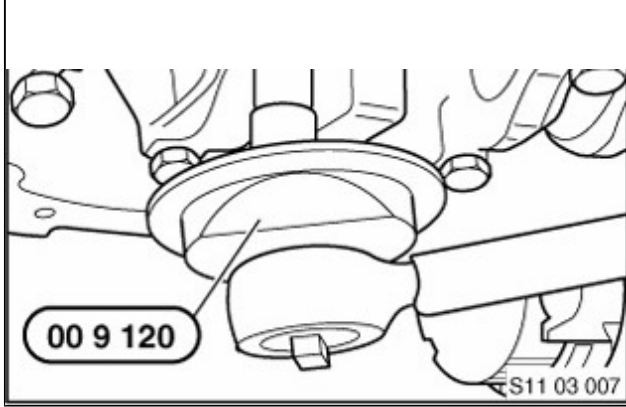
35. On vehicles produced up to 12/13/2002, install the original M11 x 1.25 connecting rod bolts in the same positions as when removed. On vehicles produced from 12/13/2002, install new set of M10 x 1.25 Connecting

Rod Bolts (p/n 11 24 7 834 310).

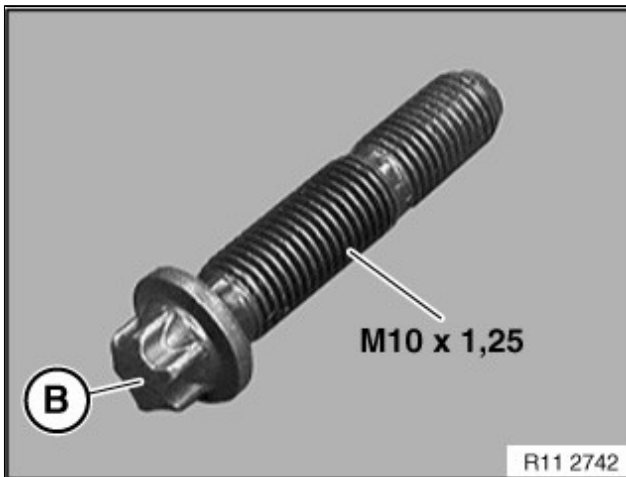
37. On vehicles from 12/12/2002 production, the M10 x 1.25 con rod bolts must be tighten at least **three** times in order to reach its maximum tensile strength.

**Important:** Not adhering to the tightening specifications detailed below, will result in serious engine damage.

- settling torque: 5 Nm
- initial torque: 30 Nm
- angle torque to 105°, in one single stroke.

Use the Torque Angle Tool (p/n 90 88 6 00 9 120 available through the Automatic Parts Shipment Program). Then, release the torque by backing off conrod bolts by approximately one turn and then retighten them again.
