# TECHNICAL BULLETIN

## Poor Idle Quality – Normally Aspirated AJ16 Engine – Valve Timing Modification

12-57

MODEL 4.0L Normally Aspirated 1995 MY DATE 8/95

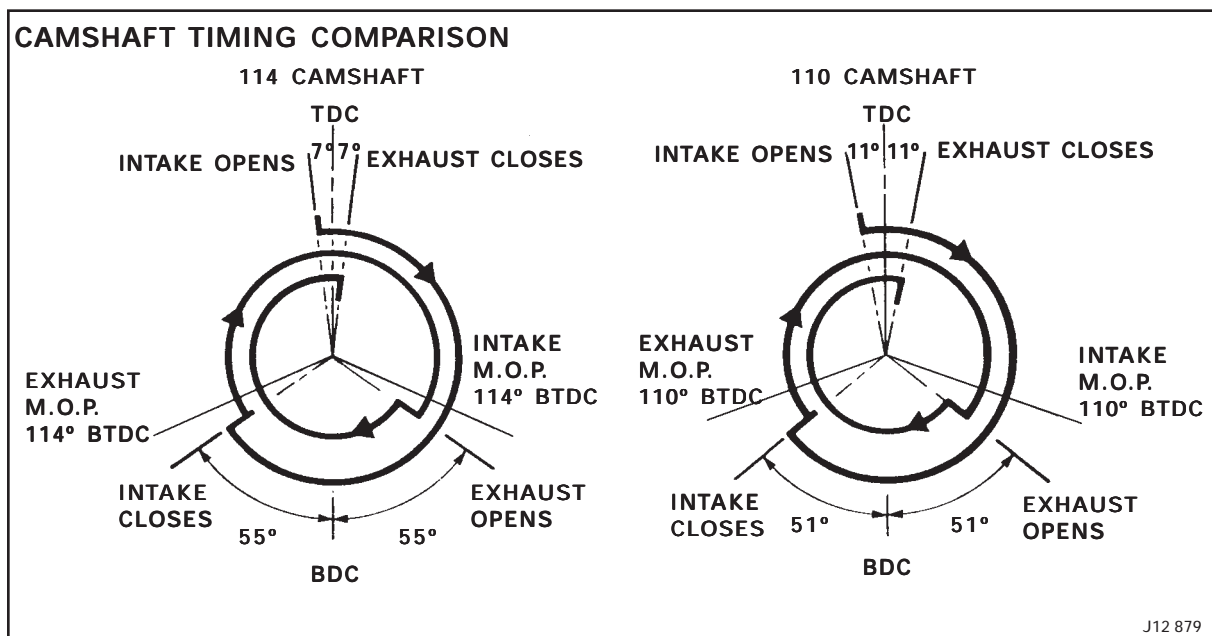
ILLUSTRATION 1

The original camshafts, with a maximum opening position of 110 degrees have been superseded by camshafts with a maximum opening position of 114 degrees. This change is accomplished by machining the camshaft slot in a different

position. The valve timing overlap is reduced from 22 degrees on the 110 camshafts to 14 degrees on the 114 camshafts, Illustration 1.

Normally aspirated engines with the 110 camshafts, that exhibit poor idle quality, can be modified to achieve the same reduction in valve timing overlap as with the 114 camshafts.
