KIA MOTORS

NUMBER
044 [Revised]

TECHNICAL SERVICE BULLETIN

ECM UPGRADE WITH TP SENSOR REPLACEMENT – MIL ON WITH DTC P2135 / P0638

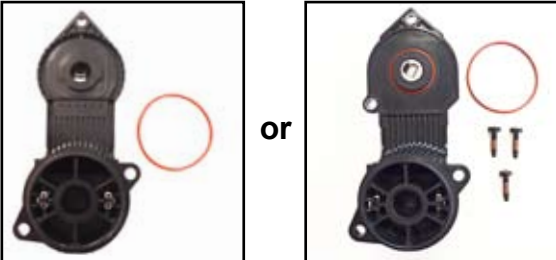
Part Name	Part Number		Part Kit
Throttle Position Sensor (TPS)	Optima/Rondo with 2.7L	35107 3E000FFF or 35107 3E100FFF

Sedona, Sorento and Amanti with 3.3L or 3.8L	35107 3C000FFF or 35107 3C100FFF
