| | GROUP Service Campaign | MODEL 2011MY Sportage (SL) |
| | NUMBER SC086 | DATE November 2010 |
| SUBJECT: 2011MY SPORTAGE LX DRIVER'S SIDE POWER WINDOW SWITCH ASSEMBLY VOLUNTARY SERVICE CAMPAIGN | | |

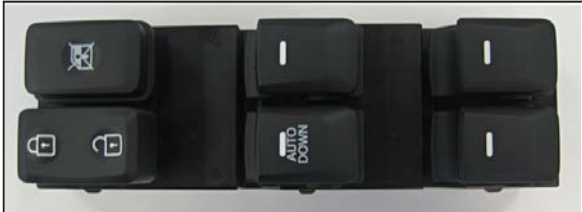
This bulletin provides information relating to some LX Sportage vehicles equipped with "Auto Down" function and produced from the start of production through October 27, 2010. In affected vehicles, the window may not raise or lower even though the power window switch is actuated. To correct this condition and improve customer satisfaction Kia is launching this Service Campaign and replacing the power window switch module assembly on all affected 2011 Sportage vehicles that fall within the vehicle production range. Kia is requesting the completion of this Service Campaign on all affected 2011MY Sportage vehicles in dealer stock prior to retail sales.

5. Replace the power window switch module assembly (C) with an new improved assembly into switch case (D)
