SERVICE BULLETIN

APPLICABILITY: 2013MY Legacy and Outback 2.5L Models
 2012-13MY Impreza 2.0L Models
 2013MY XV Crosstrek
 2011-2014MY Forester
 2013MY BRZ

NUMBER: 11-130-13R
DATE: 04/05/13
REVISED: 06/19/13

SUBJECT: Difficulty Starting, Rough Idle, Cam Position or Misfire DTCs
 P0340, P0341, P0345, P0346, P0365, P0366, P0390, P0391,
 P0301, P0302, P0303 or P0304

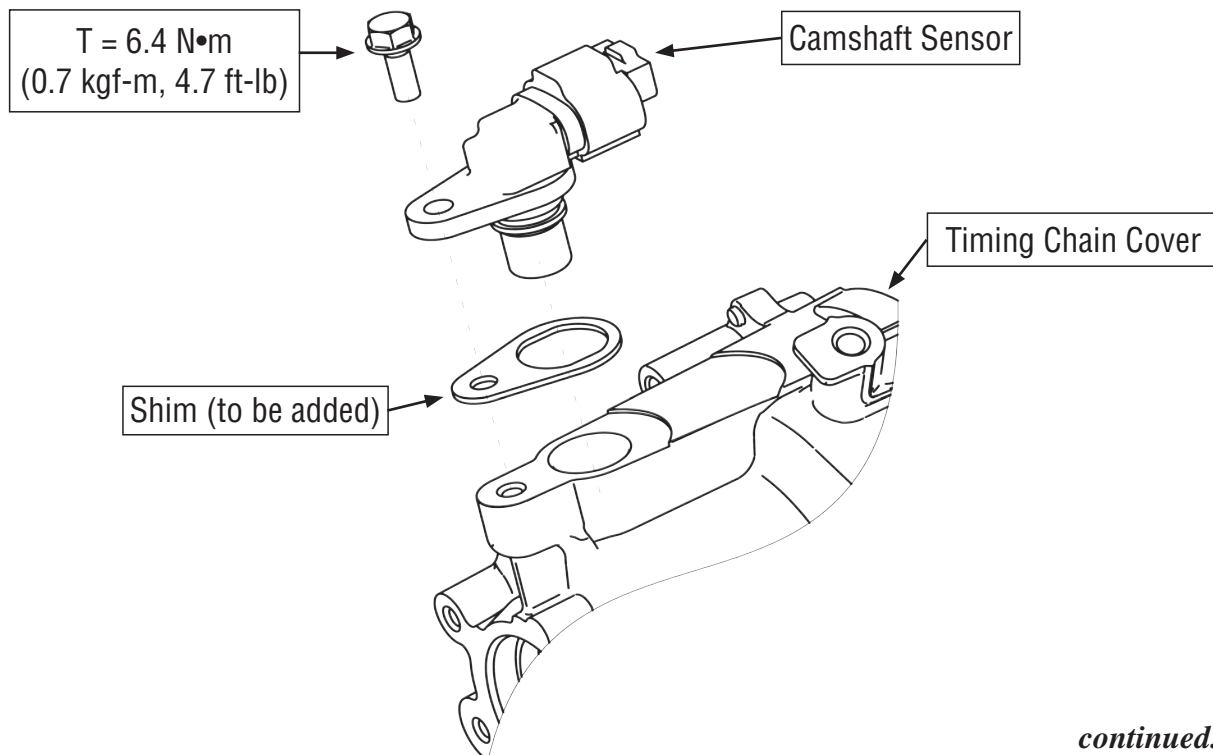
1. Record the customer's radio station presets (and navigation system favorites if applicable).
2. Disconnect the negative battery cable.
3. Remove the camshaft position sensor from the timing chain cover using the procedure in the applicable Service Manual.

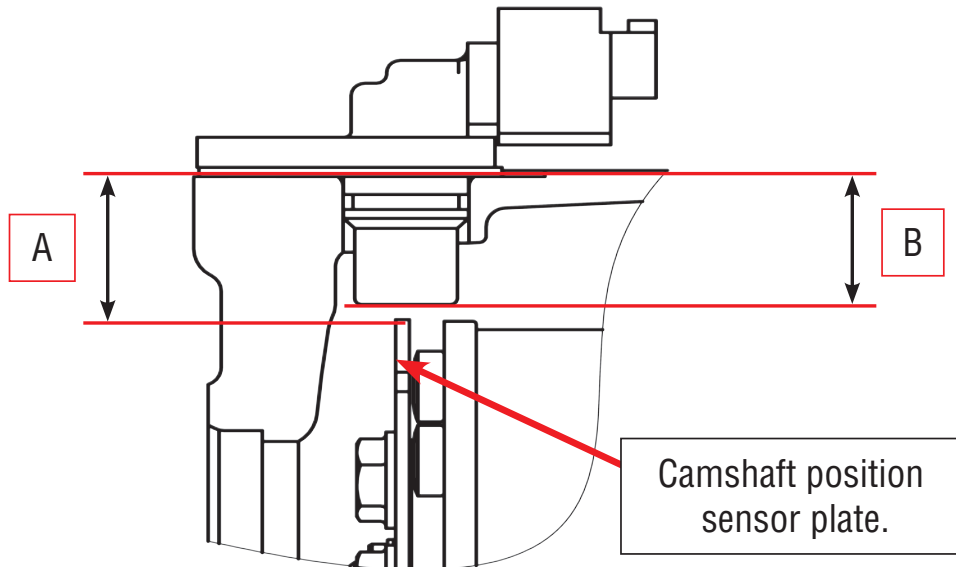
A = Top of timing chain cover to camshaft position sensor plate

B = Camshaft position sensor mating surface to the bottom of the sensor

NOTE: When measuring “A”, make sure you are measuring to the outside diameter or “top” of the sensor plate and not to the bottom of a notch as shown below. Be sure to record all measurements.
