Technical Bulletin

Section Title: Restraints
 TSB No. TS 06 05212R1

SUBJECT: SPECIAL COVERAGE EXTENSION “ZA”; SPECIFIC “AIRBAG”
 WARNING LIGHT ILLUMINATION (DTC B1312 ONLY).
MODEL(S): GRAND VITARA (JB424, JB627, JB632)
YEAR: 2006~2011

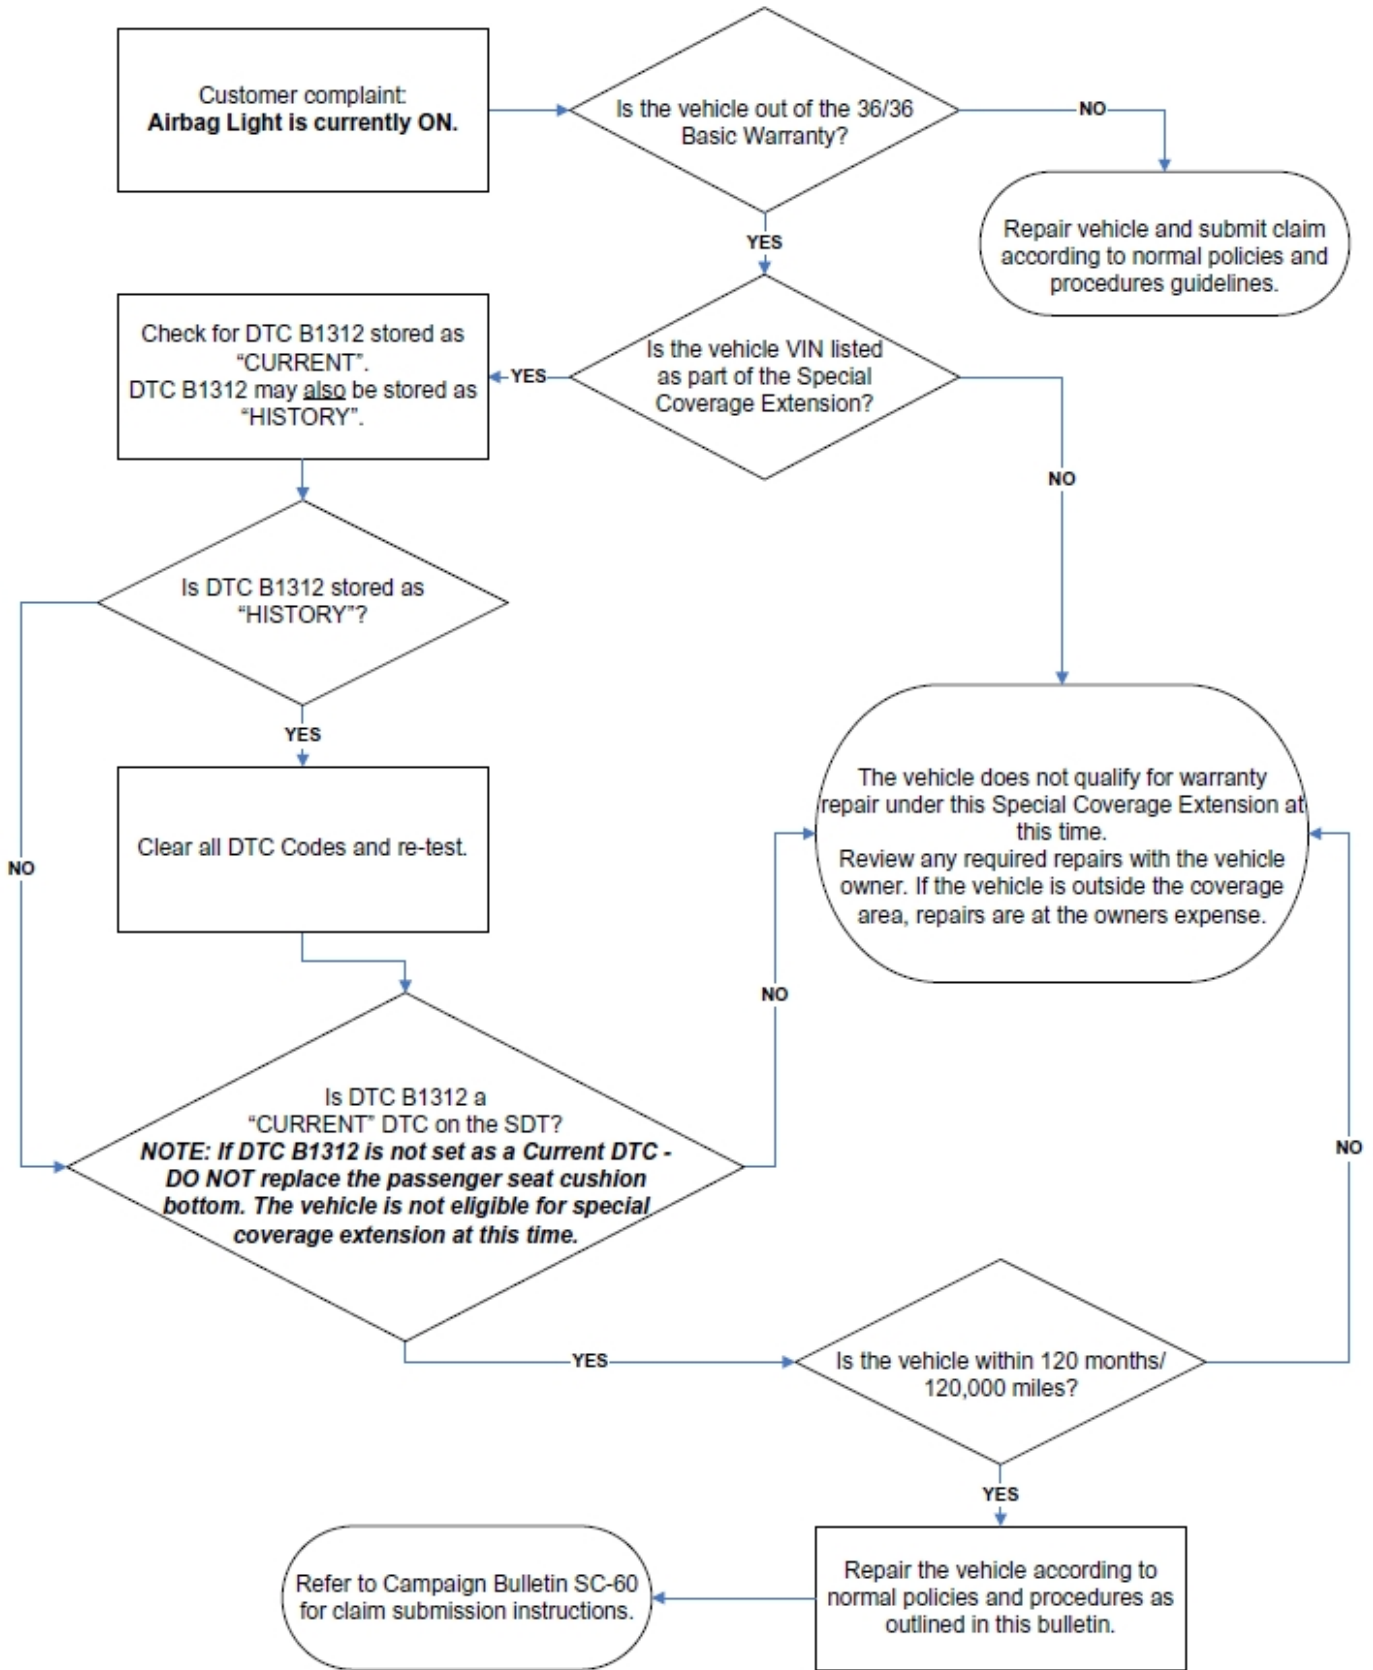
WORKFLOW

CONDITION: The “Airbag” light is illuminated in the instrument cluster and DTC (Diagnostic Trouble Code) B1312 is identified as a Current DTC using the SDT. No other DTC or condition qualifies for this coverage extension.

CAUSE: Suzuki Motor Corporation has determined that certain 2006~2011 Suzuki Grand Vitara vehicles may develop, due to repeated flexing, an electric disconnection (open) in the Front Passenger Sensing System circuit within the sensor-mat located in the passenger seat bottom cushion assembly.

CORRECTION: In vehicles that are found to have the “Airbag” warning light ON, DTC B1312 identified as a Current DTC, and are beyond the basic warranty limits, a special coverage extension will apply, allowing repairs to be made for customers at no charge for parts or labor up to 10 years or 120,000 miles from the date of first use, at authorized Suzuki Service Points.
