Technical Journal

Oil leakage from plug in Variable Valve Timing pulley

REF NO: TJ 29131.5.0	ISSUING DEPARTMENT: Technical Service	CAR MARKET: United States and Canada	
PARTNER: 3 US 7510 Volvo Car USA		ISSUE DATE: 2016-10-17	STATUS DATE: 2016-10-20
FUNC GROUP: 2150	FUNC DESC: Transmission	Page 1 of 9

TJ Instruction VCC-475358-1

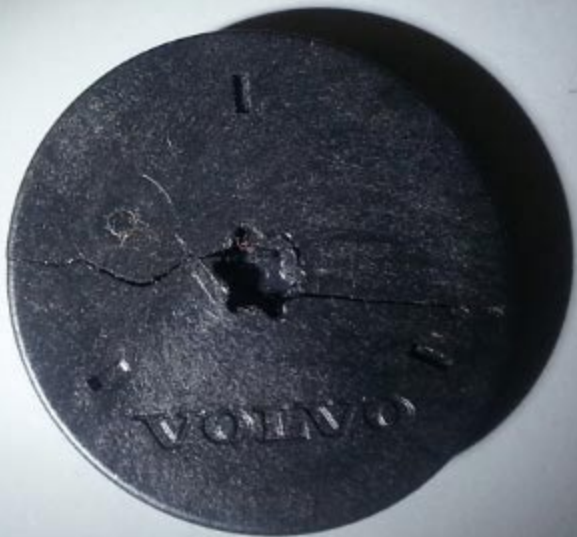
The oil may leak due to a crack in the plug from the VVT pulley (see attached photo).

Replace both plugs in both VVT-pulleys according to the attached instruction. Plug PN: 31375877

If the timing belt is effected with oil , replace the timing belt according to Vehicle Information Diagnostic for Aftersales (VIDA) instructions.
