WE02 - Re-programming Instrument Cluster (Workshop Campaign)

Model Line: **Boxster (981)
Cayman (981)
911 (991)**

Concerns: **Instrument cluster**

Action Required: Re-program the instrument cluster.

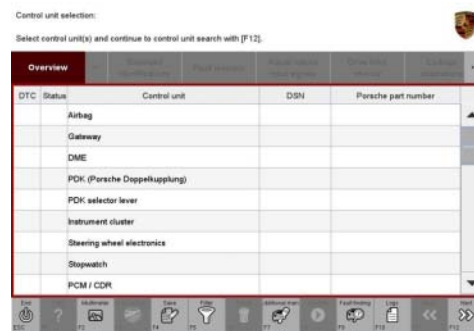
Control unit selection

- 5 Once you have erased the fault memories, select the ⇒ **'Overview'** menu and press •<<" to return to the control unit selection screen ⇒ *Control unit selection*.

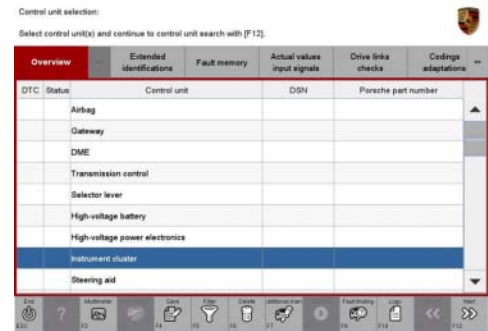
Control unit selection – Instrument cluster

- 1 Select ⇒ **'Instrument cluster'** in the control unit selection screen (⇒ **'Overview'** menu) and press **•>>“** to confirm your selection ⇒ *Control unit selection – Instrument cluster*.
- 2 Once the instrument cluster has been found and is displayed in the overview, select the ⇒ **'Codings/adaptations'** menu.
- 3 Select ⇒ **'Restore factory settings/codes'** and press **•>>“** to start the process ⇒ *Resetting instrument cluster to factory settings*.
- 4 Once the settings have been reset successfully, press **•>>“** to continue.
- 5 Select the ⇒ **'Overview'** menu and press **•<<“** to return to the control unit selection screen.
