**SERVICE BULLETIN RELEASE - 11/26/2014**

**05-008/14 - MULTI-MODEL (6 SPEED SKYACTIV M/T) - HARD  
TO SHIFT INTO 3RD, 4TH, 5TH AND/OR 6TH GEAR**

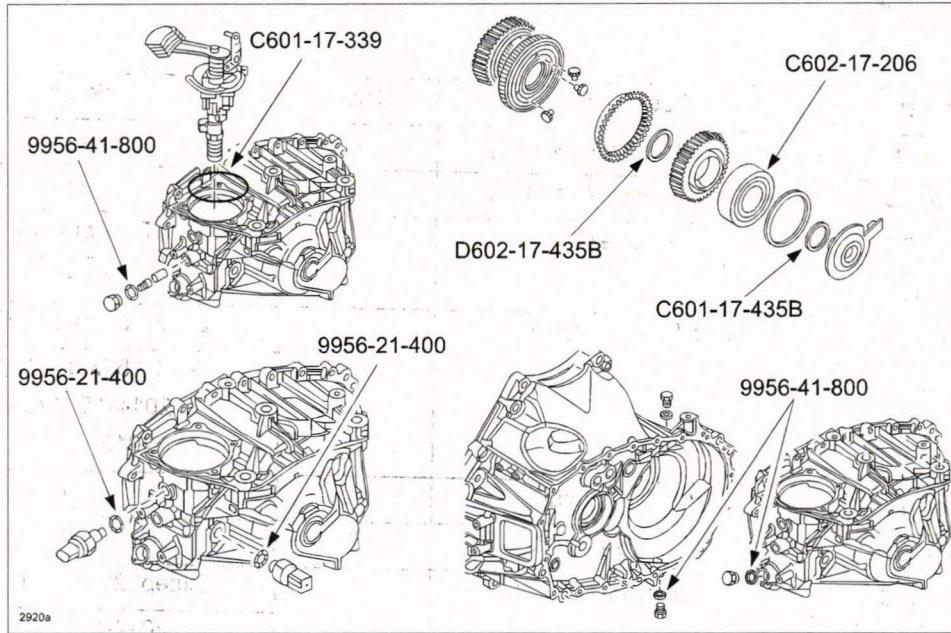
\* Replacement parts

\*\* Replace 3rd gear only if necessary (if 3rd gear jumps out).

1. Verify customer concern.
2. Remove the transaxle. Refer to MS3 online instructions or the Workshop Manual section 05-15.
3. Replace the 3-4 and 5-6 clutch hub with a modified one and the 3rd gear with a new one (listed in the Parts Information). Refer to the C66M-R 6-speed SKYACTIV Manual Transaxle Workshop Manual.
