**Service Action: Seal the Engine Compartment Center Bulkhead Partition**

E70 (X5 xDrive 35i) and E71 (X6 xDrive 35i) with the N55 engine produced from SOP to 10/30/2010

#### **51 71...Sealing the units compartment partition wall, top center**

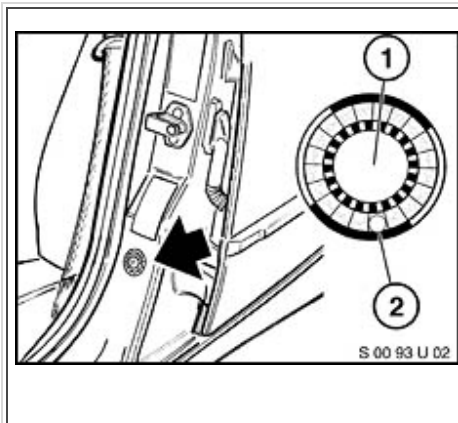
This Service Action has been assigned code number **603**. After the vehicle has been checked and/or corrected, obtain a label (SD 92-403) and:

- A. Emboss your BMW center warranty number in the middle of the label (1);
- B. Punch out code number **603** (2), printed on the label; and
- C. Affix the label to the B-pillar as shown.
