<h1>TSB- Local</h1>	Model	Carens/Rondo [UN](2010MY)
		Group	Body Electrical System(92)
		TSB No.	UN001 / AS188;C21VA
Subject BCM Upgrade - Functional Improvement of the RKE	Published	3/11/2010	
	TSB Type	Service Action	
	Area & Distributor	U.K (C21VA)

1. Description

RKE malfunction affecting some 10MY Carens (UN) vehicles.

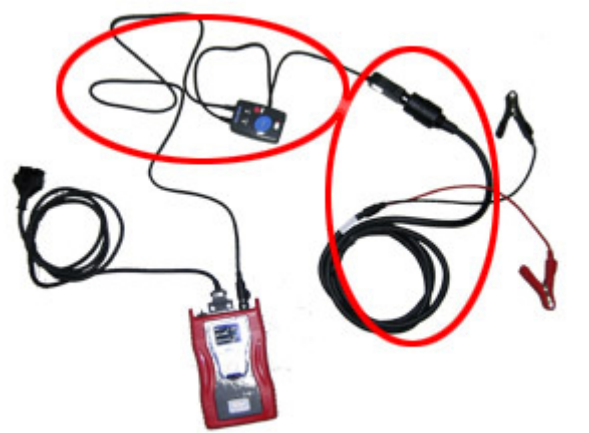
4) Connect the 16-pin DLC cable from the VCI into the OBD-II connector, located under the driver's side of the instrument panel.

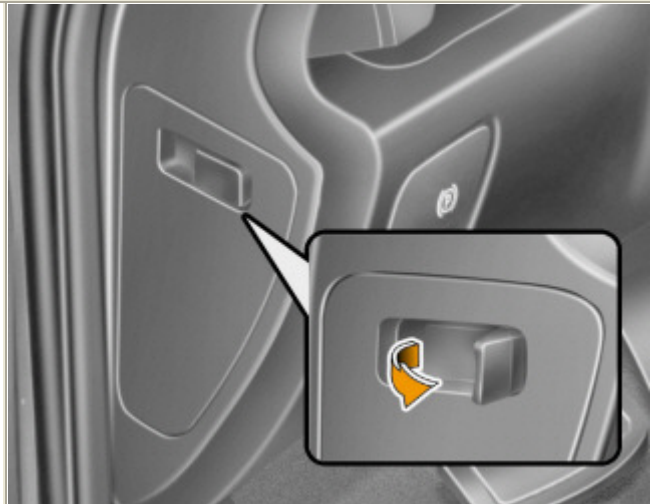
[Figure 1] : Inner panel fuse replacement

8) Open the driver's side panel.

9) Pull out the memory fuse from inner panel fuse replacement and then put it into place again in about 10 seconds.

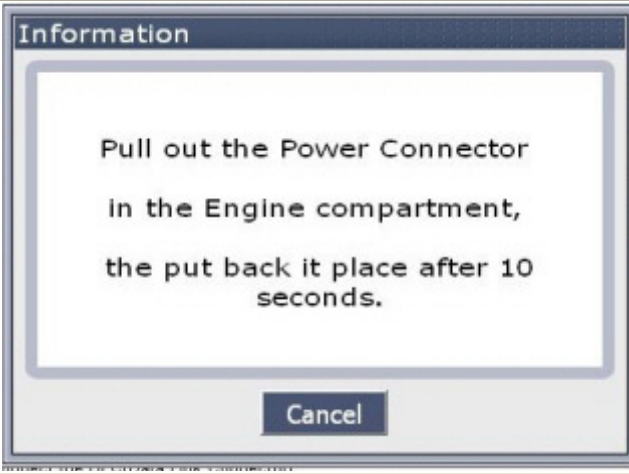
<p>Information</p> <p>Pull out the Power Connector in the Engine compartment, the put back it place after 10 seconds.</p> <p>Cancel</p>
<p>11) Update will occur until 100% is reached on the bar graph. pull out the memory fuse from inner panel fuse replacement and then put it into place again in about 10 seconds and then click OK to continue according to Information displayed on the screen.</p>

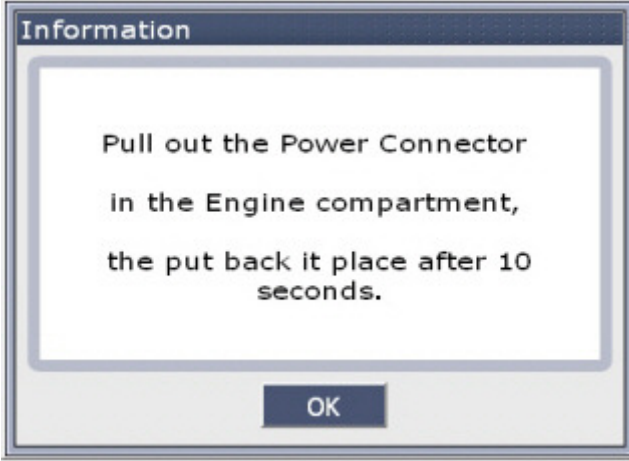
<p>Information</p> <p>Pull out the Power Connector in the Engine compartment, the put back it place after 10 seconds.</p> <p>OK</p>
