KIA MOTORS

MODEL
2011MY Forte (TD)
w/ 2.0L engine + A/T

TECHNICAL SERVICE BULLETIN

SUBJECT: SERVICE ACTION: ECM UPGRADE –
MIL ON WITH DTC P0564 (SA072)

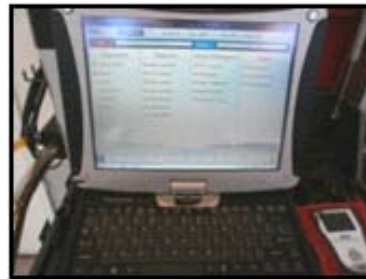
*Global
Diagnostic
System
(GDS)*

To correct this condition, the ECM should be reprogrammed using the GDS or G-Scan download as described in this bulletin.

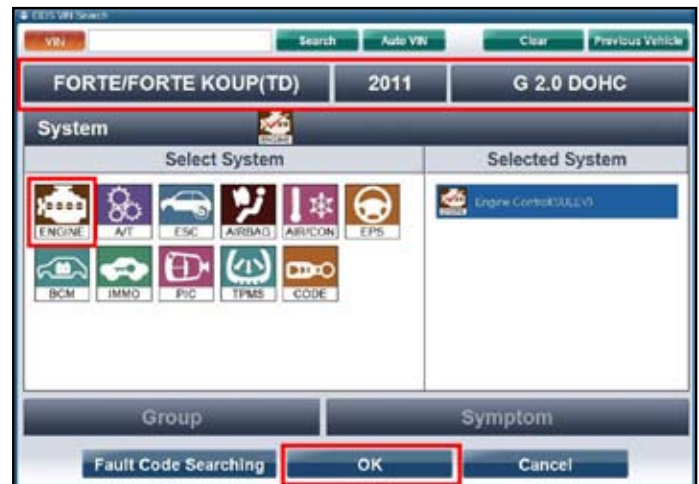
5. With the ignition key ON, turn ON the VCI and GDS tool. Access the GDS vehicle identification number (VIN) screen and configure the vehicle using the VIN AUTO DETECT Function.

6. Once back at the GDS Main Screen, select ECU Upgrade from the bottom right-hand corner. Next select Auto Mode, and then Engine. Perform the ECM upgrade in accordance with normal GDS tool ECM upgrade procedures.
