KIA MOTORS

MODEL
2008 Rio / Rio5 (JB)

NUMBER
066

SUBJECT: COMBINED TSB/SERVICE ACTION: ECM UPGRADE FOR MULTIPLE DTC'S LISTED P0300, P0128, P0140, P0442, P0451, P0461(SA 036)

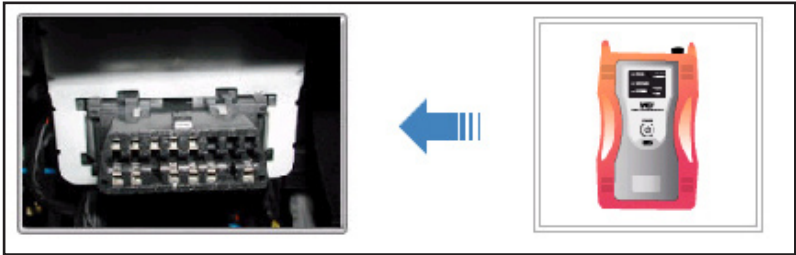
3. Connect the Main 16-pin DLC cable (GHDM – 241000) to the VCI.

4. Connect the Main 16-pin DLC cable (GHDM – 241000) to the OBD-II connector, located under the driver's side of the instrument panel.

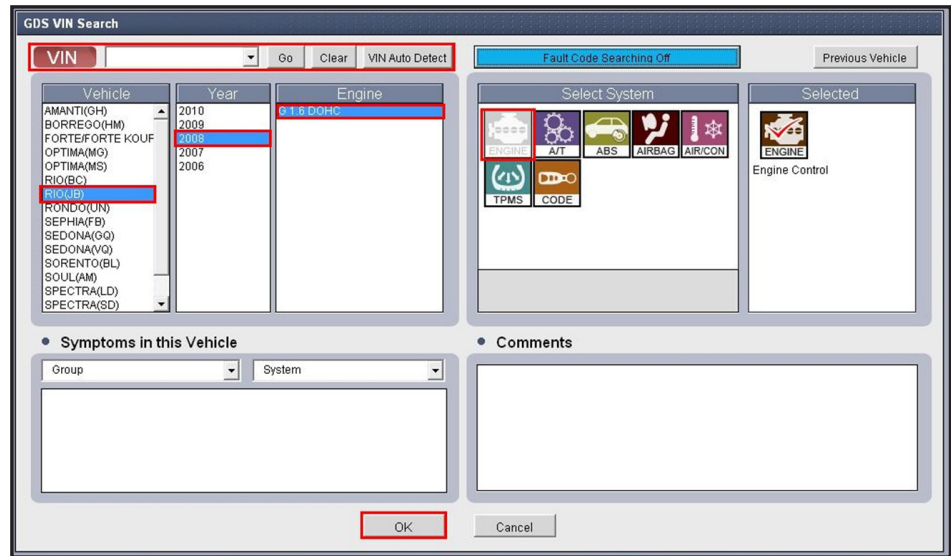
- With the ignition key ON, turn ON the VCI and GDS tool. Access the GDS vehicle identification number (VIN) screen and configure the vehicle using the VIN AUTO DETECT Function.

Global Diagnostic System (GDS) users should access the "Notice" function from the GDS Main Screen for instructions regarding ECM upgrade events.
