<h1 style="text-align: center;">TSB-Local</h1>	<b>Model</b>	RIO(UB) (2014, 2015)
	<b>Group</b>	Automatic Transaxle System (52)
	<b>TSB No.</b>	KCE14-52-E070-UB
<b>Subject</b> <b>TCM Upgrade : 2014,2015MY UB 1.4 TCM Logic Improvement</b>	<b>TSB Type</b>	Service Action
	<b>Published</b>	2015-03-07

This bulletin provides information related to the TCM (Transaxle Control Modules) software upgrade of some 2014, 2015MY RIO(UB) 1.4 A/T vehicles to improve Shift control logic.

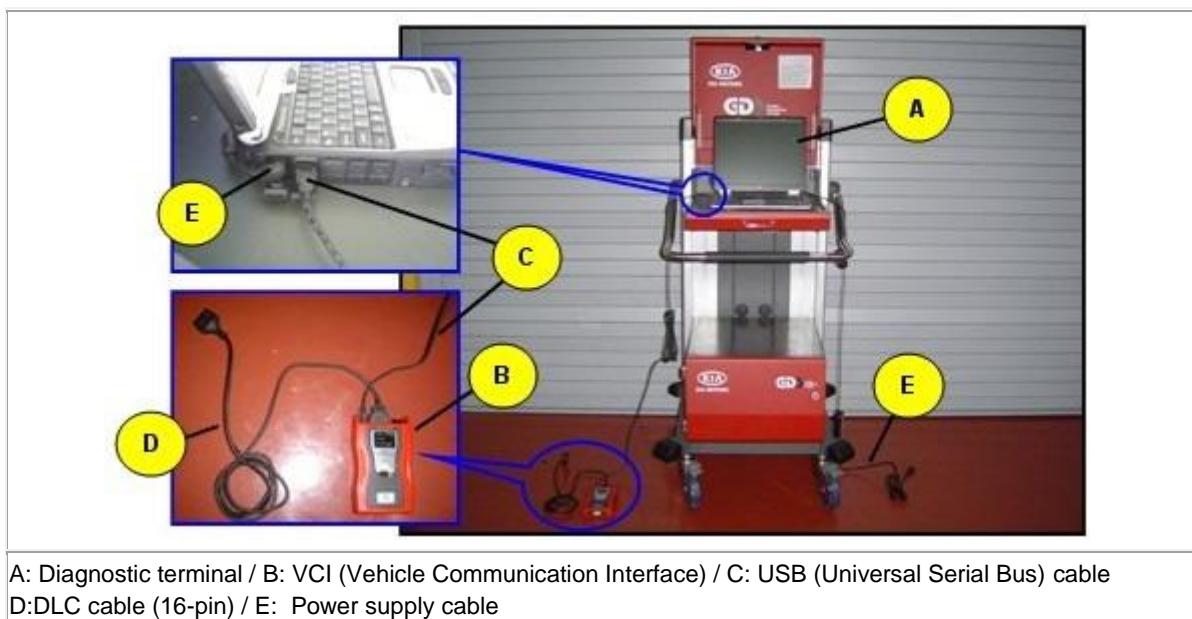
### 1. GDS (Global Diagnostic System) INSTALLATION PROCEDURE

1) Connect the power supply connector to the diagnostic terminal.

2) Connect the USB cable between the VCI and the diagnostic terminal.

3) Connect the 16-pin DLC cable from the VCI into the vehicle's DLC connector under the driver side instrument panel.

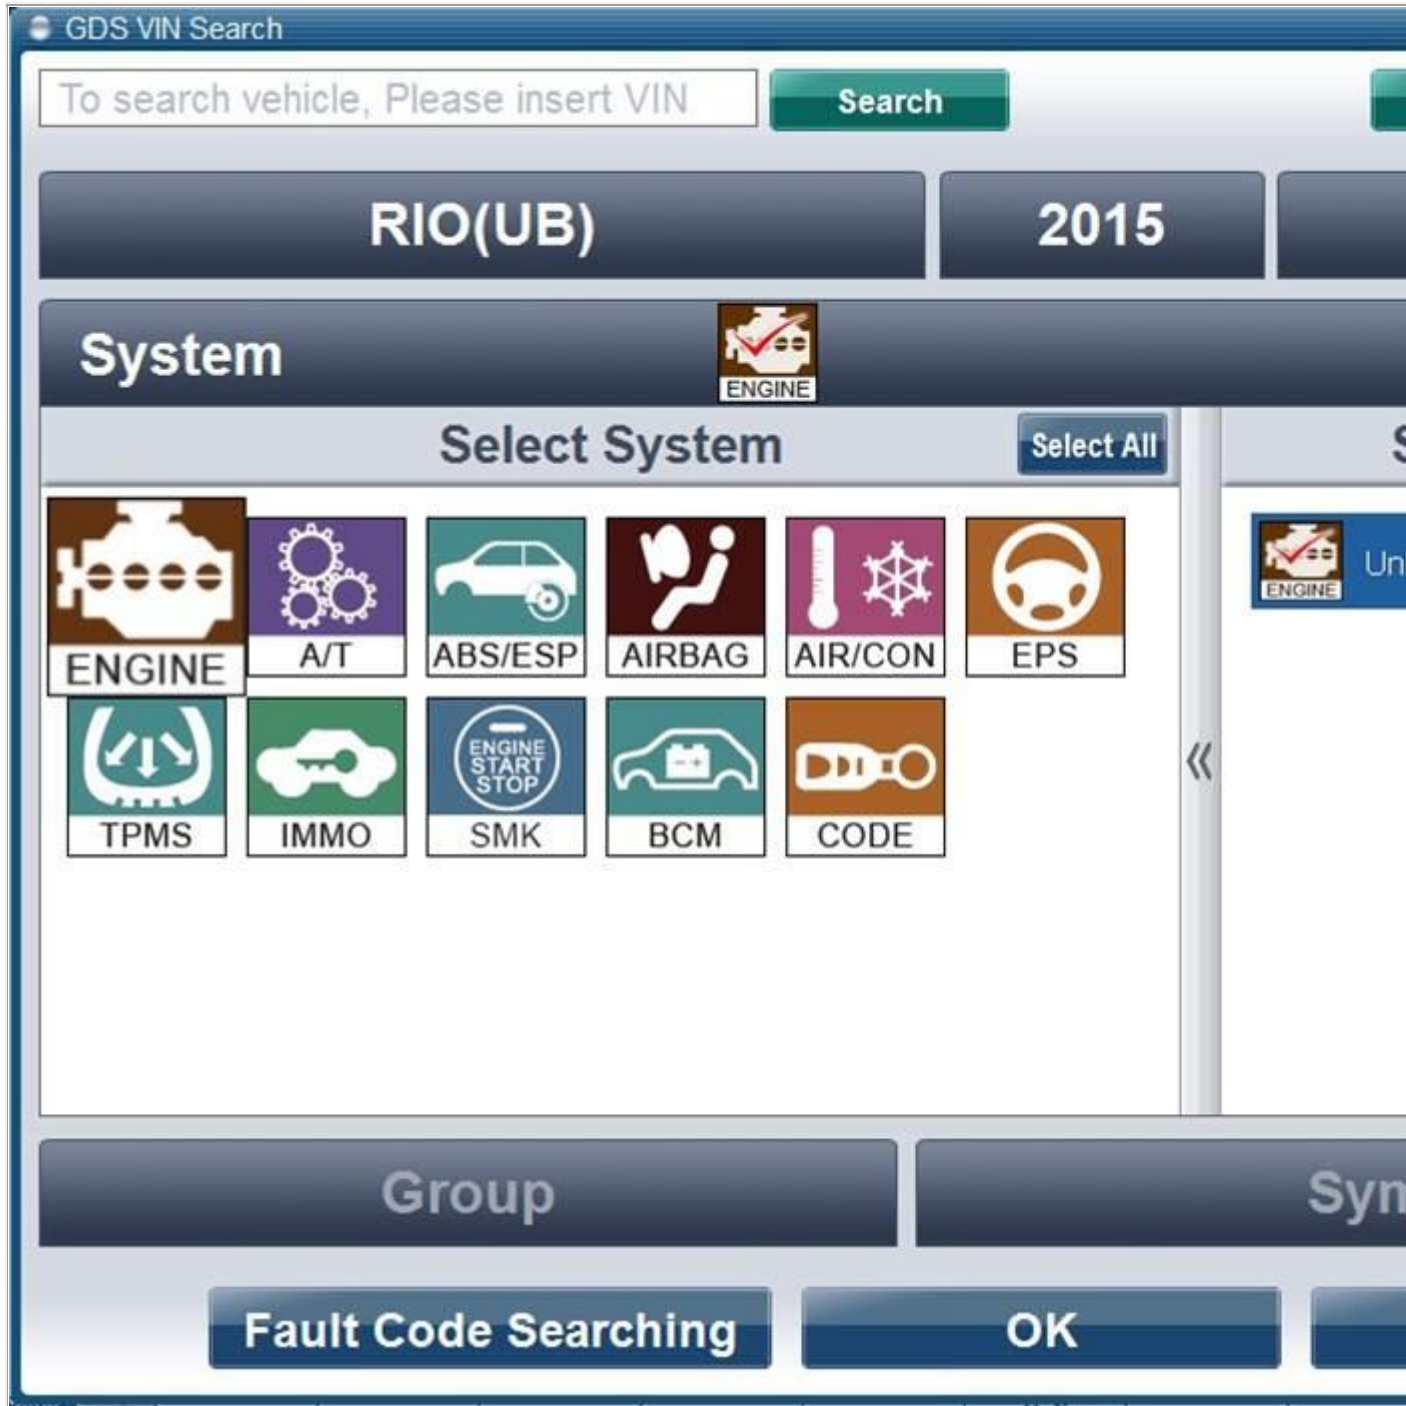
- 1) Choose **VIN** or **ECU Upgrade** on the initial screen.
- 2) Enter the vehicle information by entering the vehicle's VIN or selecting the vehicle model, model year, engine/fuel type and **A/T** as the system and then click **OK**.

- 3) Select **ECU Upgrade** on the initial screen after entering the vehicle information.
- 4) Select **Auto Mode** then **A/T** in the left **ECU Upgrade** column.
- 5) Read **Preparation** and click **OK**.
- 6) The GDS will read the vehicle's ROM ID.
- 7) After the **Current ROM ID** is displayed, select the **Upgrade Event**, "361.UB 1.4MPI TCM LOGIC IMPROVEMENT "
- 8) After clicking the **Upgrade** button, read **Information** then click **OK**.
