KIA MOTORS

MODEL
2007-2009MY
Sorento (BL)

TECHNICAL SERVICE BULLETIN

SUBJECT: SORENTO (BL) WITH 3.3/3.8 IDLE RPM IMPROVEMENT

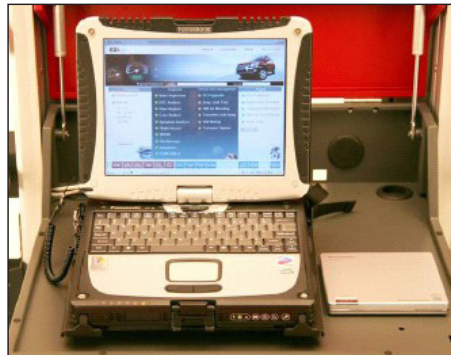
*Global
Diagnostic
System
(GDS)*

To correct this condition, the ECM should be reprogrammed using the GDS download as described in this bulletin.

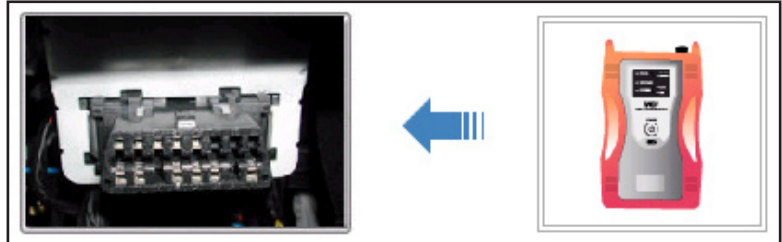
- Connect the USB cable between the VCI and the GDS tool.

- Connect the Main 16-pin DLC cable (GHDM – 241000) to the OBD-II connector, located under the driver's side of the instrument panel.

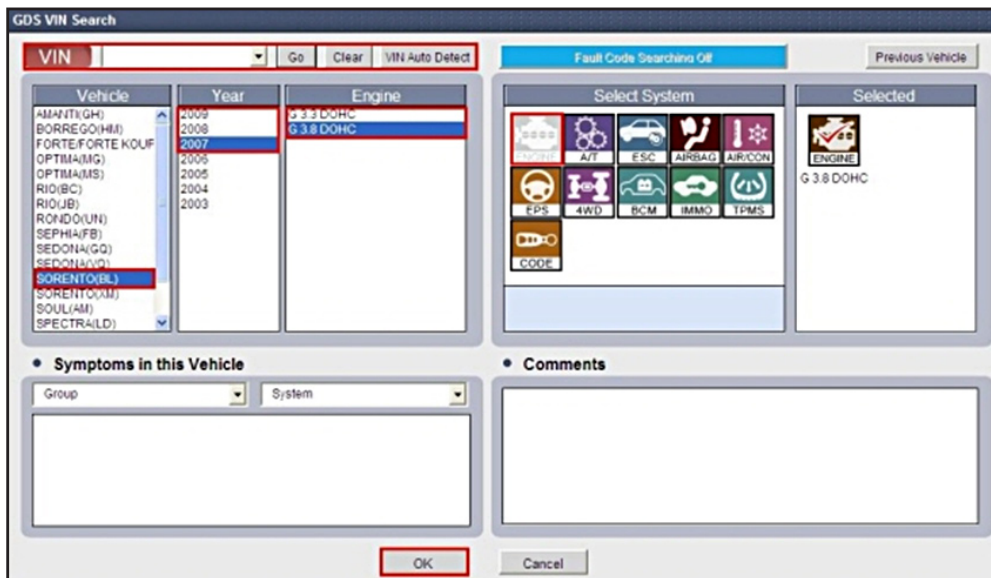
- Choose **VIN** or **ECU Upgrade** on the initial screen.

Enter the vehicle information by pressing the **VIN Auto Detect** button, entering the vehicle's VIN or selecting the vehicle model, model year, engine/fuel type and **ENGINE** as the system; then click **OK**.

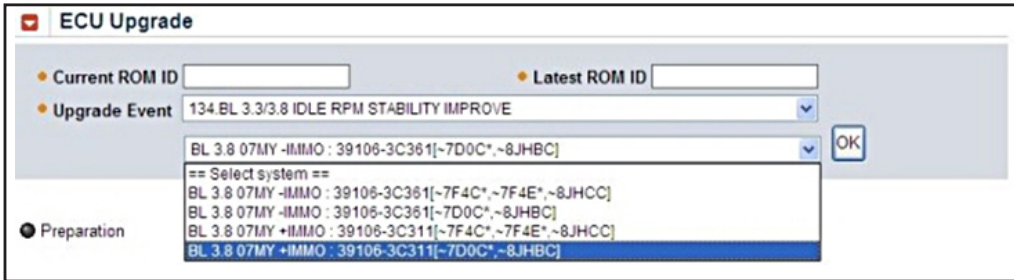
- Within the **ECU Upgrade** screen, select **Manual Mode** in the left column, then select the appropriate **#134 UPDATE**. Select the appropriate control unit part number with reference to the ROM ID Information Table and click **OK**.
