# HYUNDAI Technical Service Bulletin

Group	AUTOMATIC TRANSMISSION
Number	10-AT-007-1
Date	MAY, 2010
Model	2009~10 SONATA (NF) 2.4L

Subject	<b>AUTOMATIC TRANSAXLE ECM &amp; TCM UPDATE</b>
---------	---

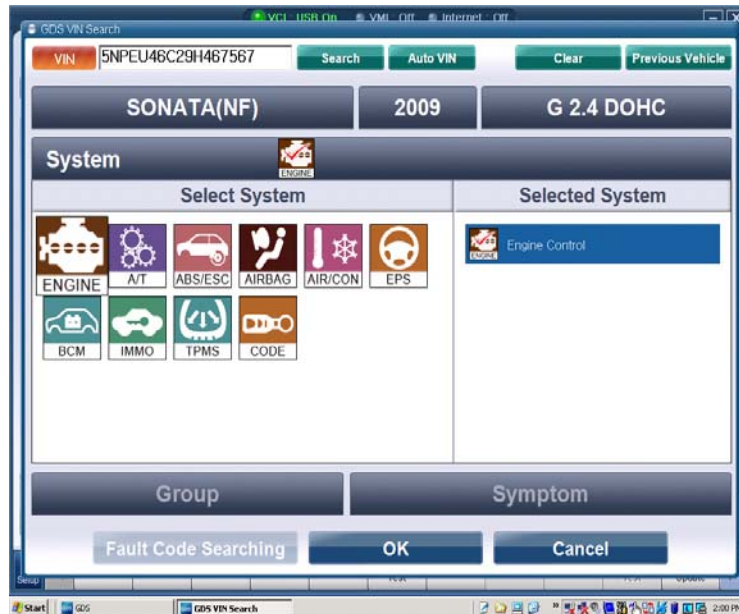
1. Turn the ignition key to the ON position
2. At the GDS home page screen, select **ECU Upgrade**. The GDS will display the VIN. If not, select **Clear** and input the vehicle and engine manually.
3. Select **ENGINE** and select **OK**.

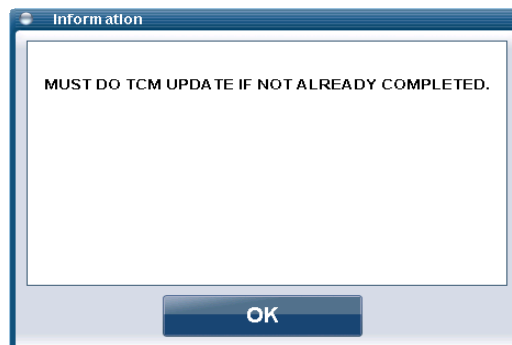
8. Updating will occur until 100% is reached on the bar graph. Turn the ignition key OFF for 10 seconds, then turn it ON and then select **OK**.
9. The GDS will confirm that ECU reprogramming is successfully finished. Select **OK** and Go to **2.1. GDS AUTO MODE TCM UPDATE PROCEDURE**”.

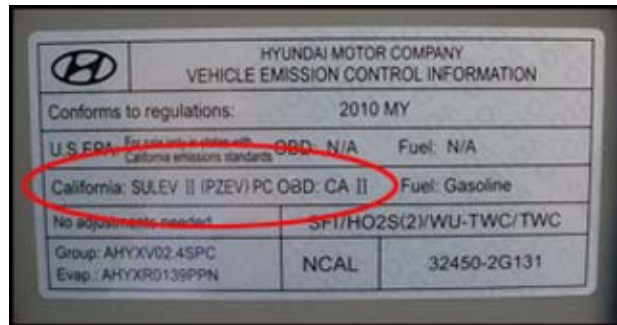
1. Refer to the Emissions Label on the underside of the hood to determine if the engine is ULEV or SULEV.

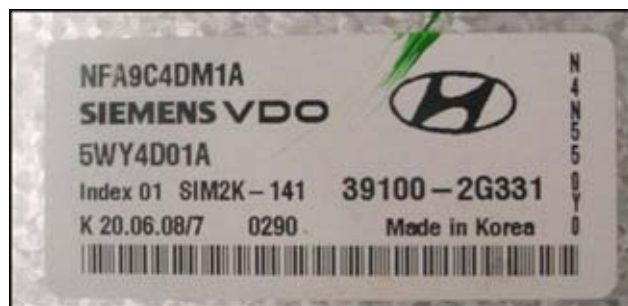
2. Locate the PCM in the engine compartment on the driver's side. Read the PCM part number on the PCM label.

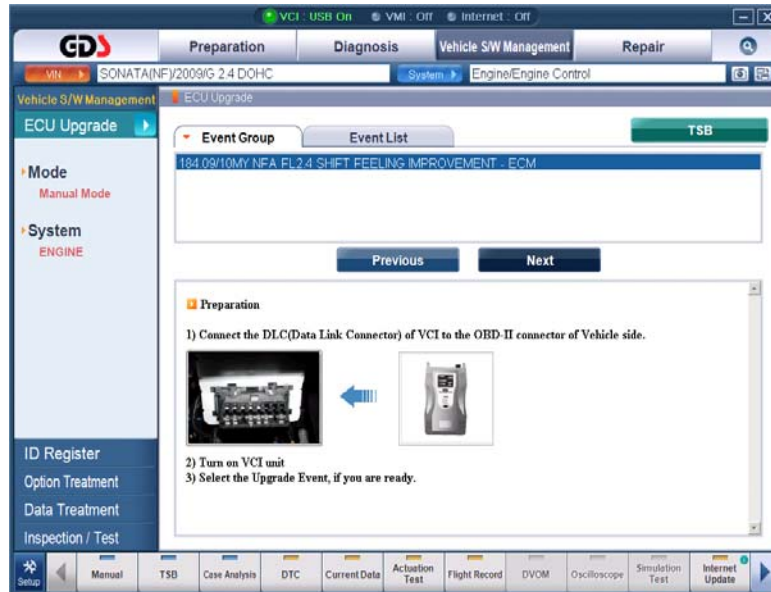
6. Upgrade Event **184 09/10MY NFA FL2.4 Shift Feeling Improvement - ECM** will display. Select **Next**.
