MODEL
Multiple Models

NUMBER
074 (Rev 1, 9/13/2016)

TECHNICAL SERVICE BULLETIN

SUBJECT: MDPS FLEXIBLE COUPLING REPLACEMENT

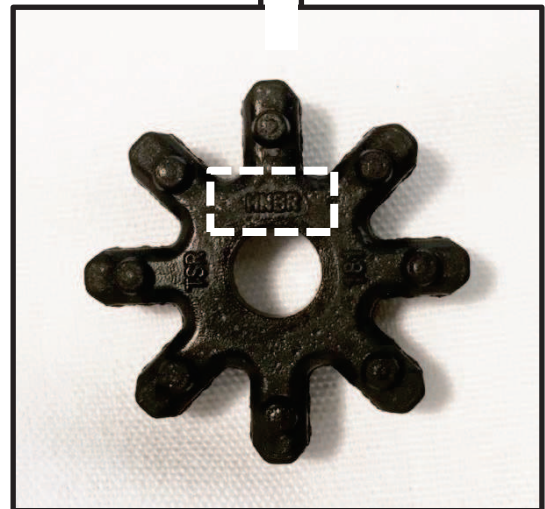
13. Install the new improved flexible coupling onto the steering column.

Before installing the new part, make sure it has “HNBR” embossed on the surface.

The position of the flexible coupling is not specific and can be installed facing upward or downward.

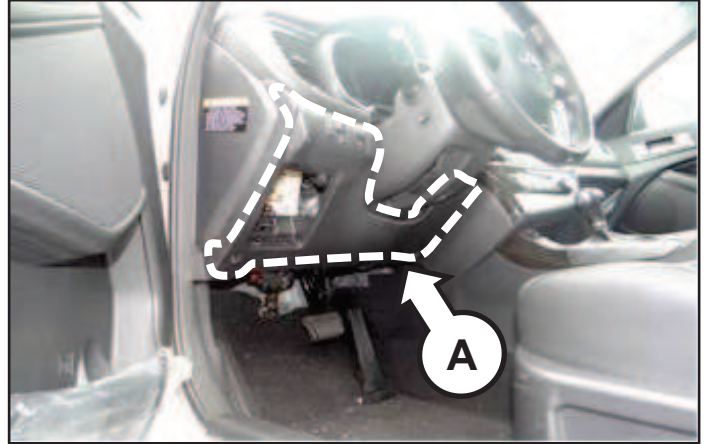
1. Remove the crash pad lower panel (A) by referring to "Body (Interior and Exterior) → Interior → Crash Pad → Repair procedures" on KGIS.

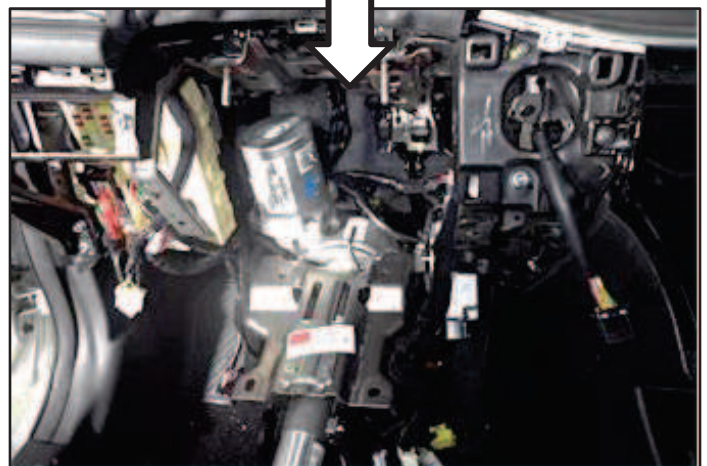
5. Loosen both steering column retaining bolts (D) and rear bolt (E) and lower the steering column assembly.

Tightening torque:
9.4~13.0 lb-ft (12.7~17.7 Nm)

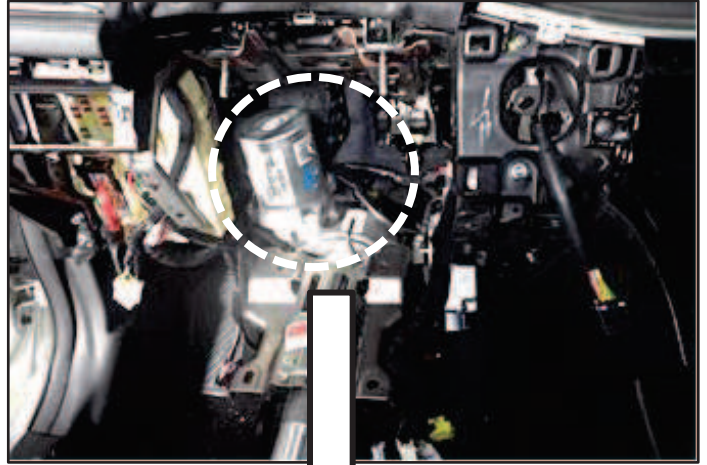
- Loosen the three MDPS motor retaining bolts (F) and lift the MDPS motor and set it to the side.

Tightening torque:

5.8~8.7 lb-ft (7.8~11.8 N-m)

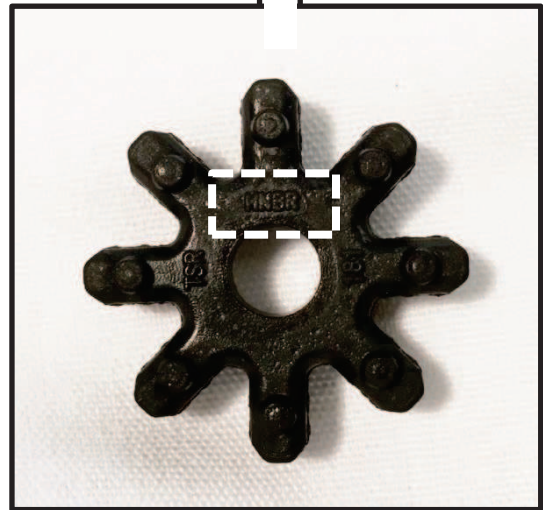
8. Install the new improved flexible coupling onto the steering column.

Before installing the new part, make sure it has “HNBR” embossed on the surface.

The position of the flexible coupling is not specific and can be installed facing upward or downward.

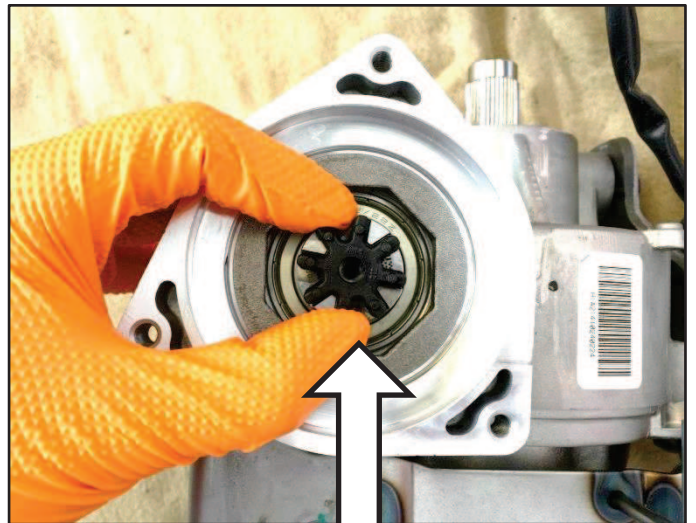
5. Install the new improved flexible coupling onto the steering column.

Before installing the new part, make sure it has “HNBR” embossed on the surface.

The position of the flexible coupling is not specific and can be installed facing upward or downward.

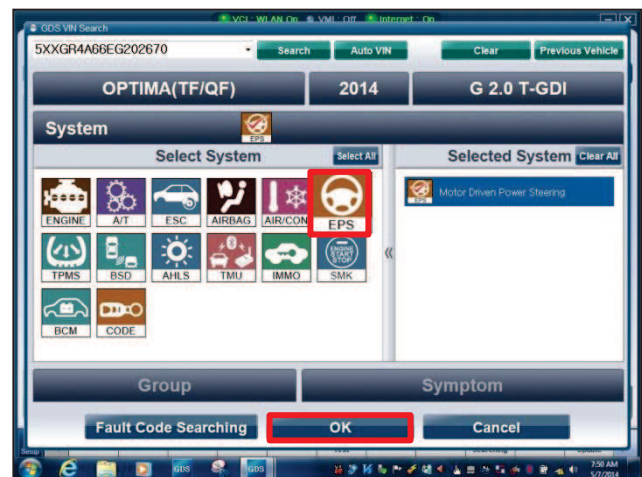
- Select **EPS** and click on **OK**.

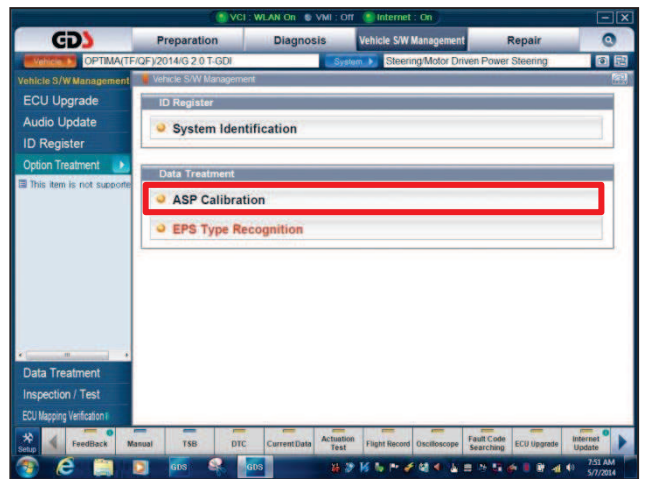
7. Select **ASP Calibration**.

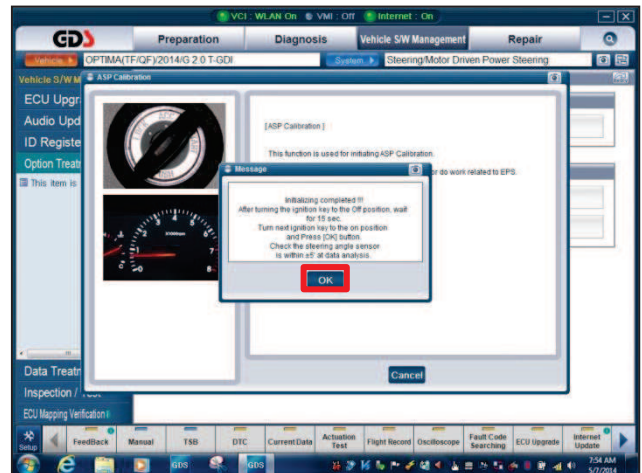
10. Turn the ignition **OFF** and wait 15 seconds. Then, turn the ignition **ON** and click **OK**.
