Inner Rear View Mirror Poor Appearance

Service Category Vehicle Interior

Section Mirror (int)

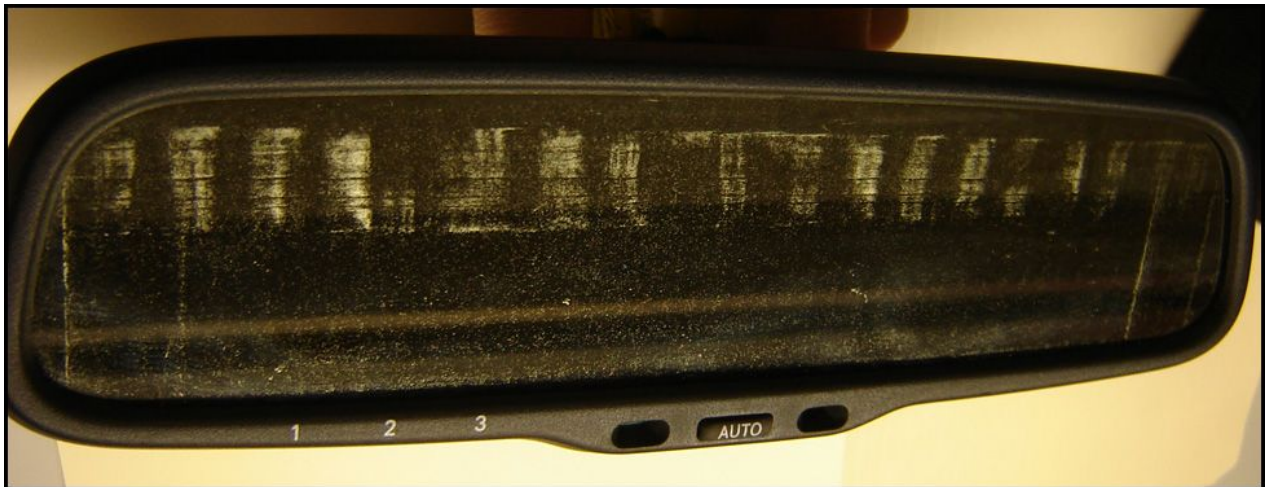
Some 2007 – 2009 GS 350/430/450h/460, 2006 – 2009 model year IS 250/350, 2008 – 2009 model year IS-F, 2007 – 2009 LS 460/460L, and 2008 - 2009 LS 600h models may exhibit a discolored and/or “striped” condition inside the inner rear view mirror glass as shown in Figure 1. An improved service part has been developed to correct this condition.

- Remove the inner rear view mirror. Refer to the Technical Information System (TIS), applicable model and model year Repair Manual:
 - [2008](#) / [2009](#) LS 600h
Vehicle Interior – Mirror (Int) – “Mirror: Inner Rear View Mirror: Removal”

- [2007](#) / [2008](#) / [2009](#) GS 450h
Vehicle Interior – Mirror (Int) – “Mirror: Inner Rear View Mirror: Removal”
- Install the NEW inner rear view mirror.
Torque: 1.8 N•m (18 kgf•cm, 16in•lbf)
