2AZ-FE Engine Oil Consumption

Service Category Engine/Hybrid System

Section Lubrication

Some 2006 – 2011 model year vehicles equipped with the 2AZ-FE engine may exhibit engine oil consumption. The piston assembly has been changed to minimize oil consumption. Use the following repair procedure to address this condition.

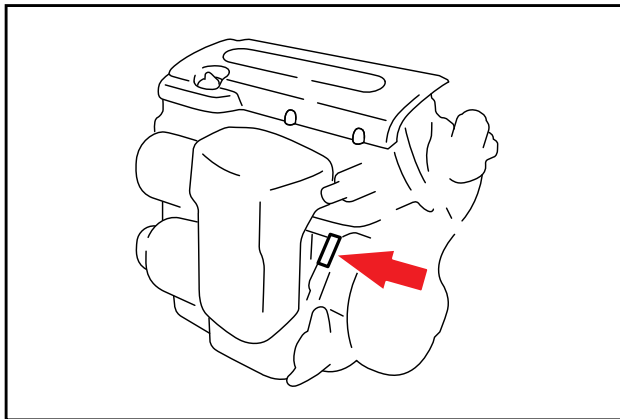
Figure 1. 2AZ-FE Engine Serial Number Location

* NAP engines have serial numbers starting with the numbers 7, 8, or 9.

** CBU engines have serial numbers starting with the letters H, J, K, or numbers between 0 – 6.

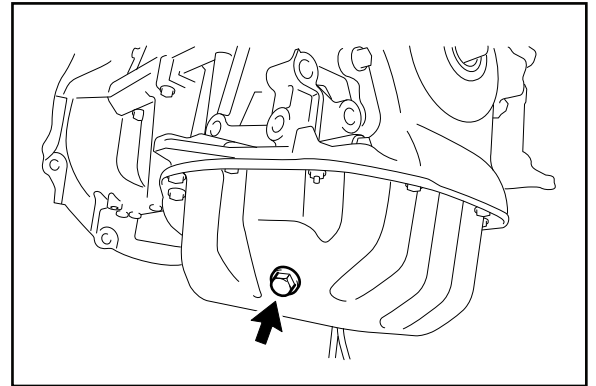
Figure 3.

A. Remove the oil pan drain plug and gasket.

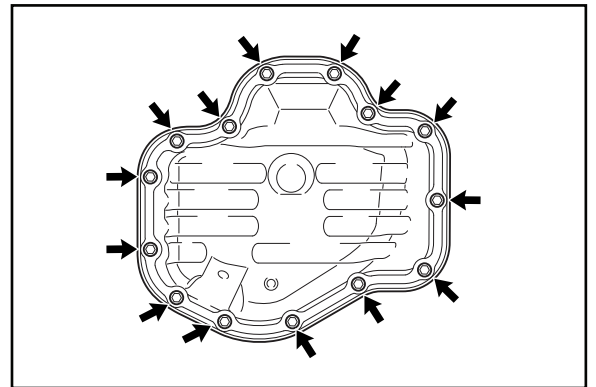
Figure 4.

B. Remove the oil pan sub-assembly.

(1) Remove the 12 bolts and 2 nuts.

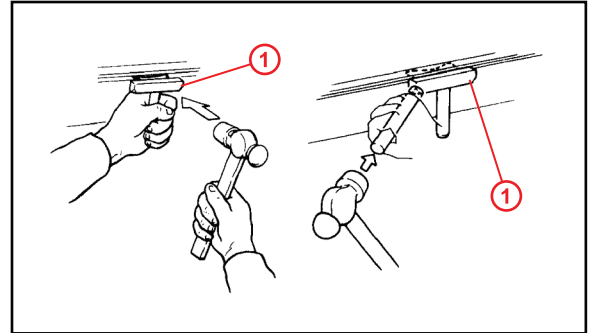
Figure 5.

- (2) Insert the blade of the SST between the crankcase and oil pan. Cut through the sealer and remove the oil pan.

Be careful **NOT** to damage the contact surfaces of the crankcase, chain cover, and oil pan.

1	SST (P/N 09032-00100)
----------	------------------------------

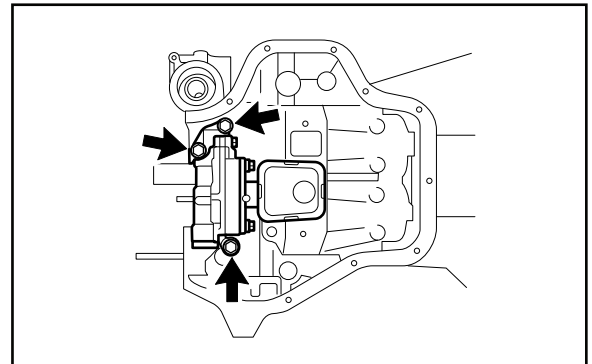
Figure 6.

- C. Remove the oil pump assembly by removing the 3 bolts and gasket.

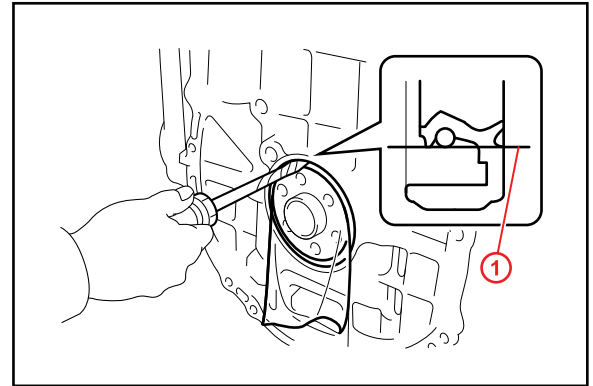
Figure 7.

- (1) Using a knife, cut off the oil seal lip.
- (2) Using a screwdriver (with a taped tip), pry out the oil seal.

After removing the oil seal, check the crankshaft for damage. If the crankshaft is damaged, smooth the surface with 400-grit sandpaper.

1 Cut Position

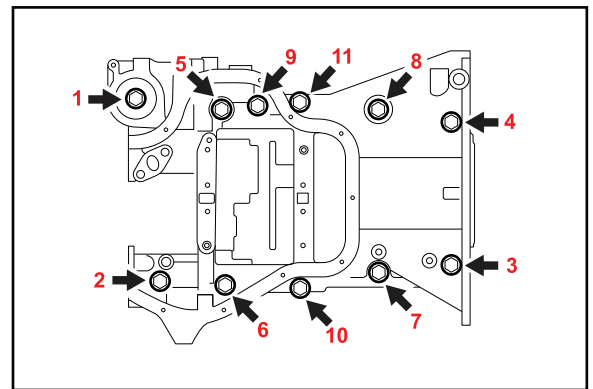
Figure 8.

Remove the stiffening crankcase as a unit. Do NOT separate the halves of the assembly, exposing the balance shaft bearings.

- (1) Uniformly loosen and remove the 11 bolts in the sequence shown in the illustration.

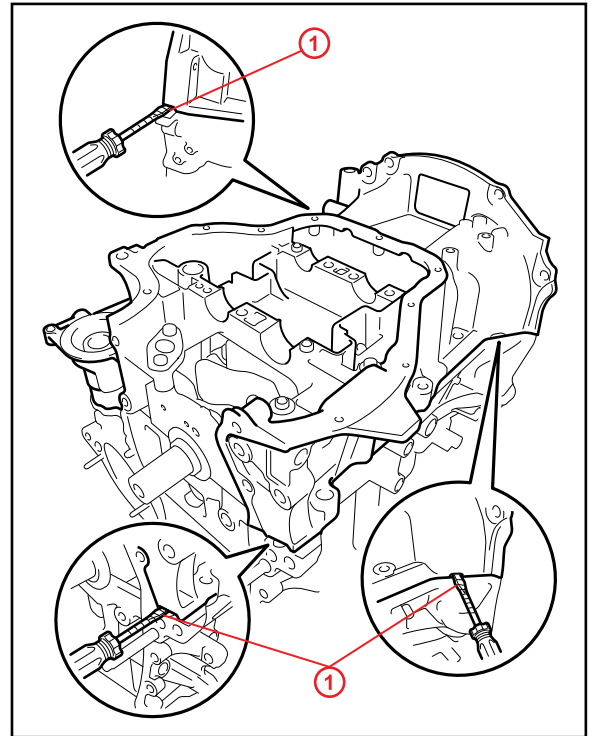
Figure 9.

- (2) Using a screwdriver (with a taped tip), remove the crankcase by prying between the crankcase and cylinder block.

Be careful **NOT** to damage the contact surfaces of the crankcase and cylinder block.

1 Protective Tape

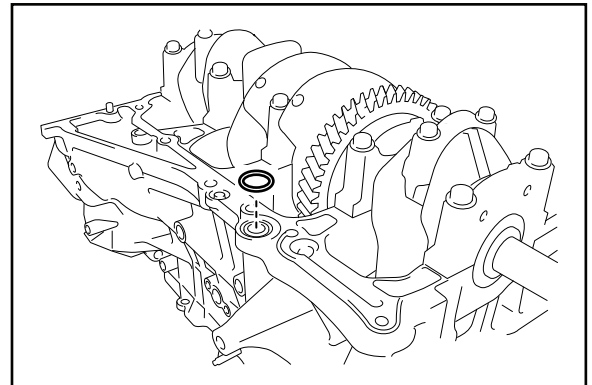
Figure 10.

- (3) Remove the O-ring from the cylinder block.

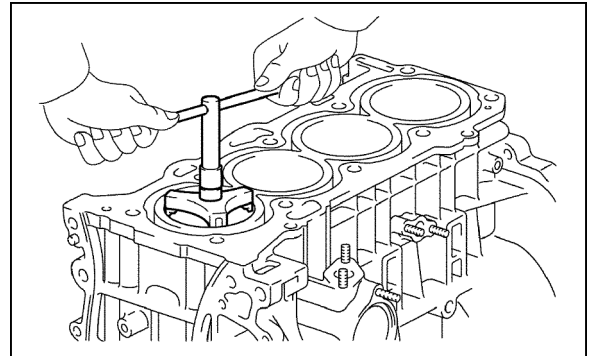
Figure 11.

- (1) Using a ridge reamer, remove all the carbon from the top of the cylinder.

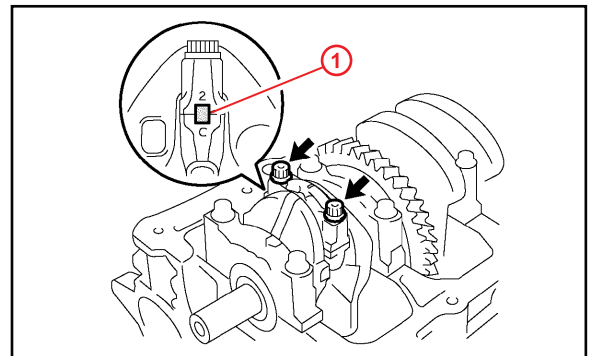
Figure 12.

- (2) Check that the matchmarks on the connecting rod and cap are aligned to ensure correct reassembly.

The matchmarks on the connecting rods and caps are provided for ensuring correct reassembly.

1 Matchmark

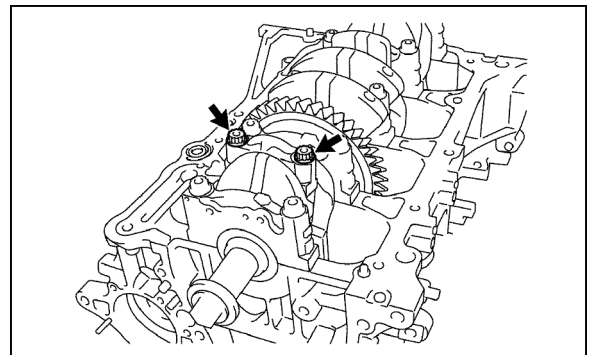
Figure 13.

- (3) Using a 12 mm socket wrench, uniformly loosen the 2 bolts.

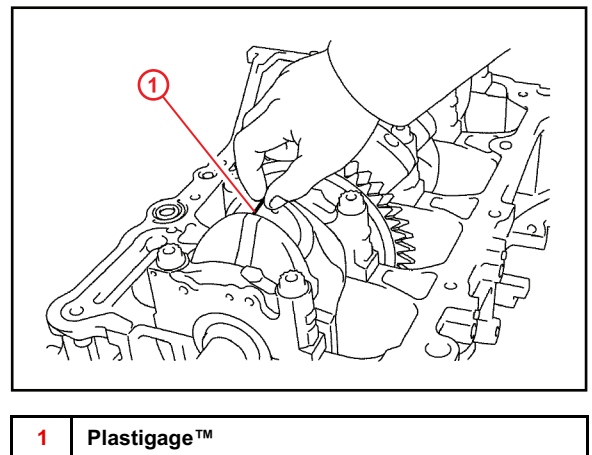
Figure 14.

- (5) Inspect the connecting rod oil clearance.
 1. Clean the crank pin and bearing.
 2. Check the crank pin and bearing for pitting and scratches.
 3. Lay a strip of Plastigage™ on the crank pin.

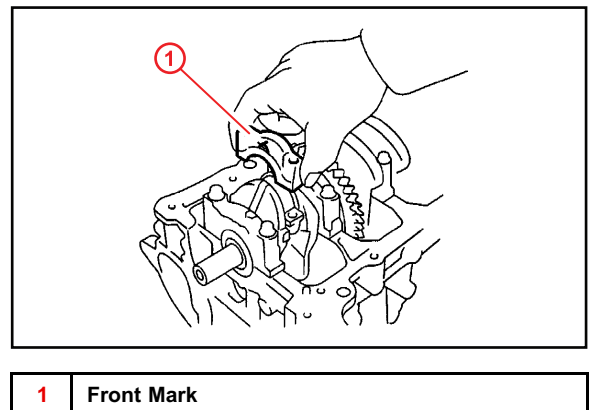
Figure 15.

4. Check that the front mark of the connecting rod cap is facing forward.

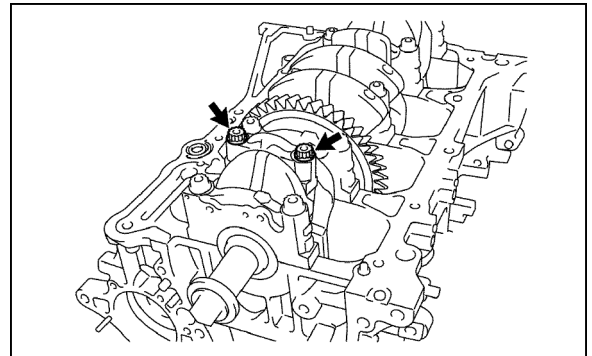
Figure 16.

5. Install and alternately tighten the bolts of the connecting rod cap in several steps.

Torque: 25 N*m (250 kgf*cm, 18 ft*lbf)

NOTE
The connecting cap bolts should be tightened in 2 progressive steps.

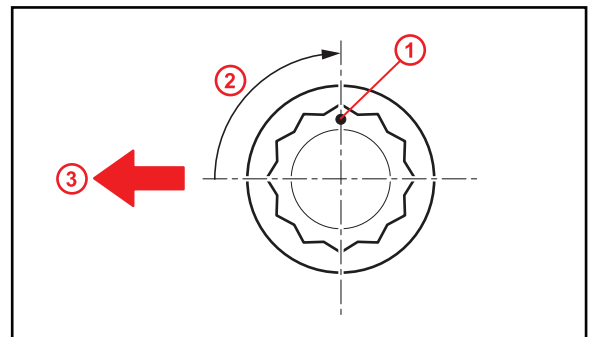
Figure 17.

6. Mark the front of the connecting rod cap bolts with paint.
 Retighten the cap bolts by 90° as shown in the illustration.

1	Paint Mark
2	90°
3	Engine Front

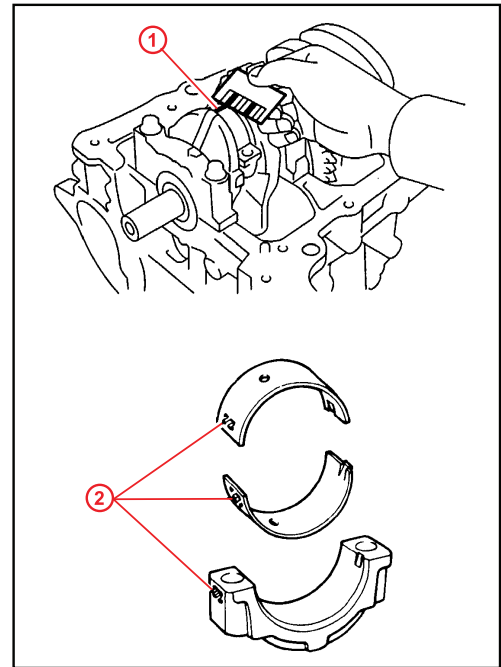
Figure 18.

7. Remove the 2 bolts and connecting rod cap.
8. Measure the Plastigage™ at its widest point.

Standard Oil Clearance: 0.024 to 0.048 mm (0.0009 to 0.0019 in.)

Maximum Oil Clearance: 0.08 mm (0.0032 in.)

If the oil clearance is greater than the maximum, replace the connecting rod bearings. If necessary, inspect the crankshaft.

If replacing a bearing, replace it with one that has the same number as its respective connecting rod cap. Each bearing's standard thickness is indicated by a 1, 2, or 3 mark on its surface.

1	Plastigage™
2	1, 2, or 3 Mark

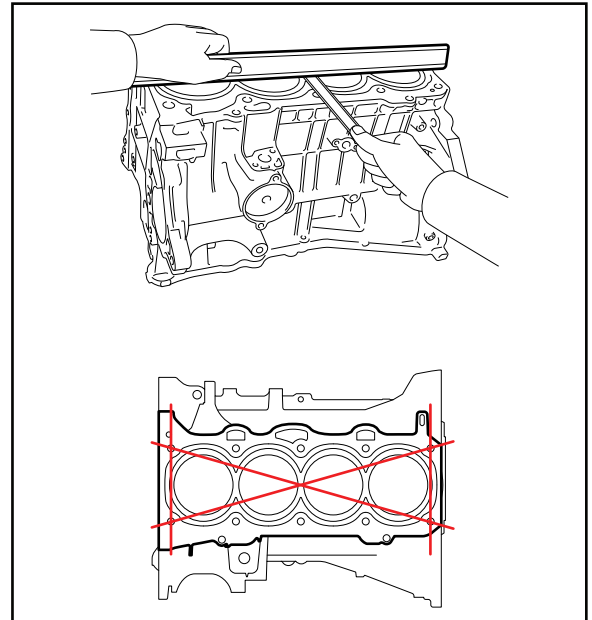
Figure 19.

Using a precision straightedge and feeler gauge, measure the warpage of the surface that is in contact with the cylinder head gasket.

Camry, Camry HV, Corolla, Matrix, RAV4, Solara:
Maximum Warpage: 0.05 mm (0.002 in.)

If the warpage is greater than the maximum, replace the short block assembly.

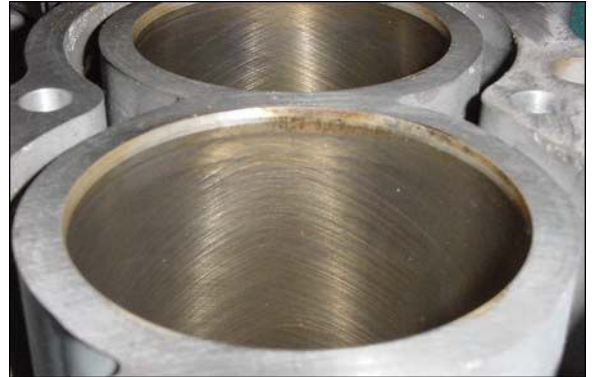
Figure 20.

Visually check the cylinder bore for the presence of crosshatch and/or vertical scratches.

- If the cylinder bore has visible crosshatch and no vertical scratches, the cylinder block is OK to re-use.
- If vertical scratches are present and can be felt with a fingernail, or if the crosshatch is not visible, replace the short block assembly.

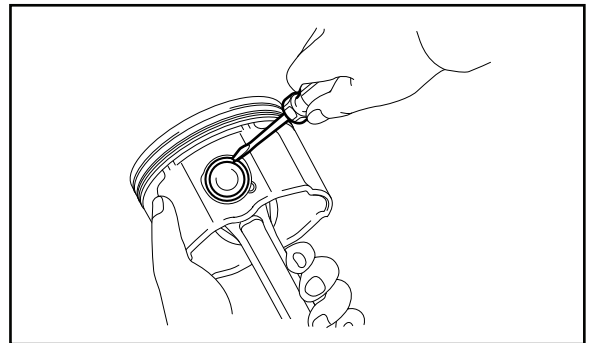
Figure 21.

J. Using a screwdriver, pry out the 2 piston pin hole snap rings.

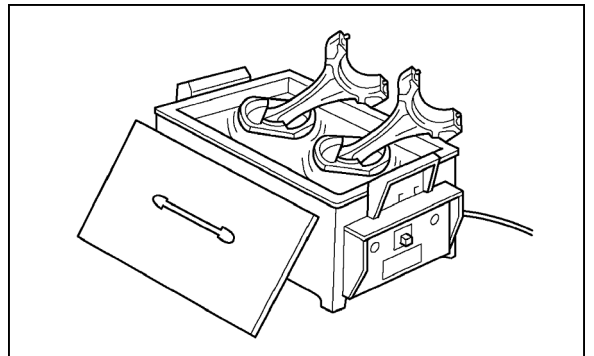
Figure 22.

- (1) Gradually heat the piston to approximately 176 to 194°F (80 to 90°C).

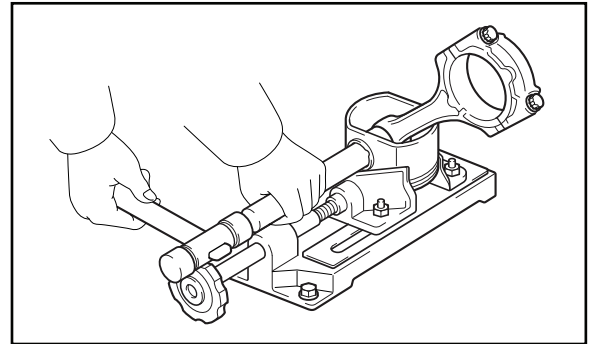
Figure 23.

- (2) Using a plastic hammer and brass bar, lightly tap out the piston pin and remove the connecting rod.

- The piston and pin are a matched set.
- Arrange the pistons, pins, rings, connecting rods, and bearings in the correct order.

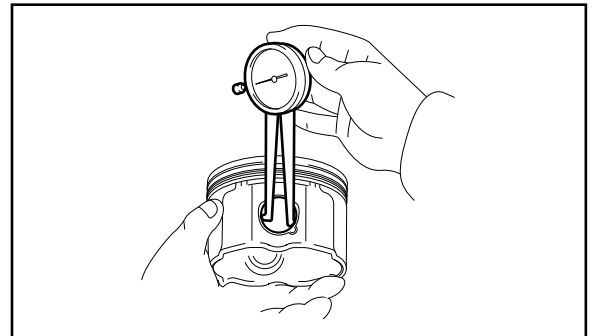
Figure 24.

- (1) Using a caliper gauge, measure the piston pin bore diameter.

**Standard Piston Pin Bore Diameter:
22.001 to 22.010 mm (0.8662 to 0.8665 in.)**

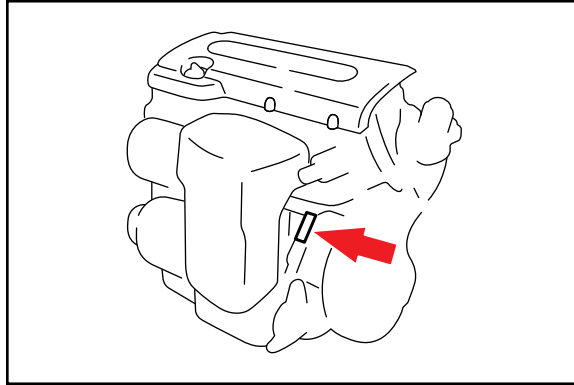
Figure 25. 2AZ-FE Engine Serial Number Location

* NAP engines have serial numbers starting with the numbers 7, 8, or 9.

** CBU engines have serial numbers starting with the letters H, J, K, or numbers between 0 – 6.

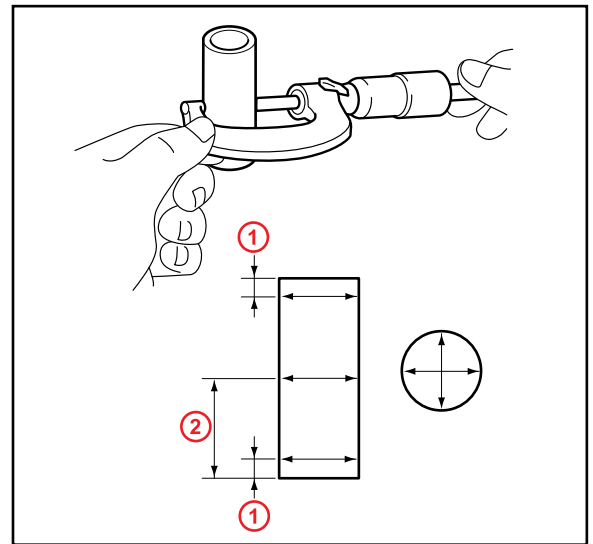
Figure 27.

- (2) Using a micrometer, measure the piston pin diameter.

Standard Piston Pin Diameter: 21.997 to 22.006 mm (0.8660 to 0.8664 in.)

If the diameter is NOT as specified, replace the piston pin.

1	5 mm (0.20 in.)
2	30 mm (1.18 in.)

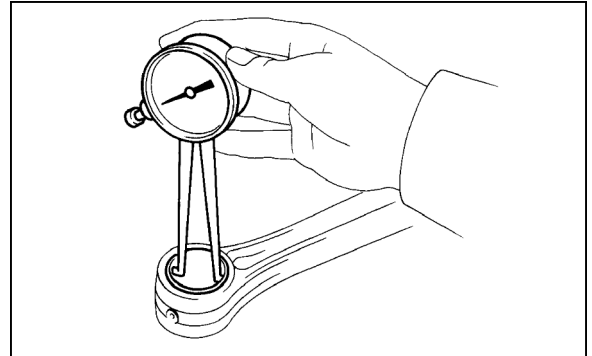
Figure 28.

- (3) Using a caliper gauge, measure the connecting rod small end bore diameter.

Standard Connecting Rod Small End Bore Diameter:
22.005 to 22.014 mm (0.8663 to 0.8667 in.)

If the diameter is NOT as specified, replace the connecting rod.

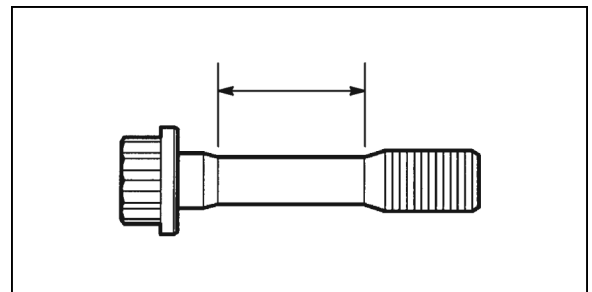
Figure 29.

Using vernier calipers, measure the tension portion diameter of the bolt.

Standard Diameter: 7.2 to 7.3 mm (0.283 to 0.287 in.)

Minimum Diameter: 7.0 mm (0.276 in.)

If the diameter is less than the minimum, replace the connecting rod bolt.
