X-TYPE

XT308-02

TECHNICAL BULLETIN

Clutch Pedal Sticking Down –
Install Additional Spring –
Repair

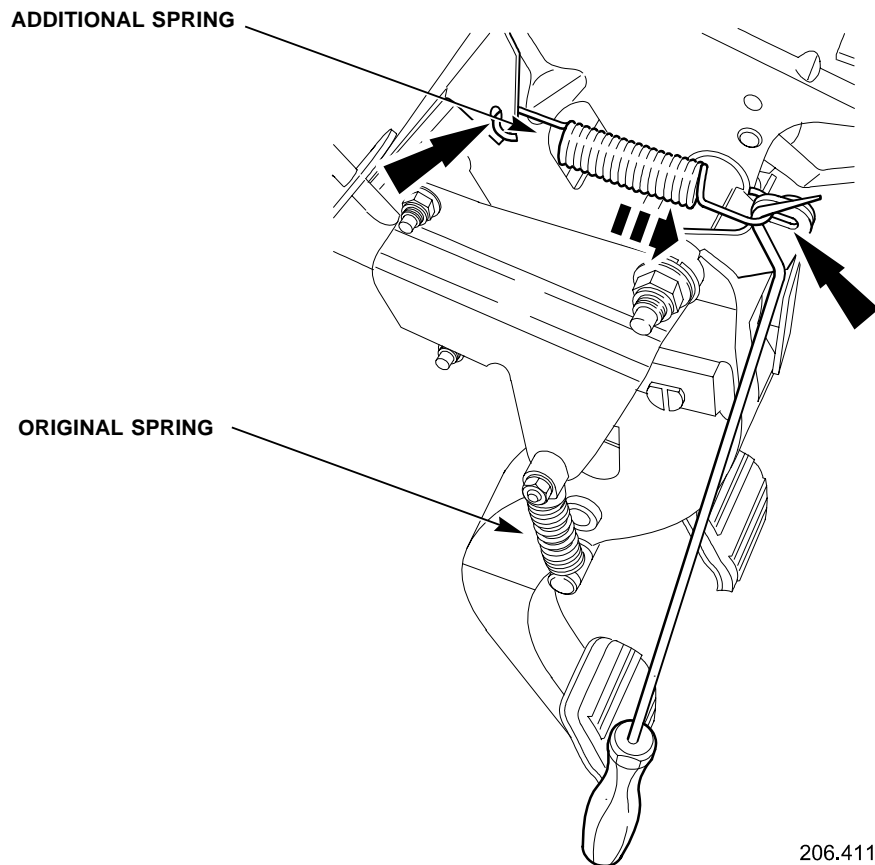
ILLUSTRATION 1

INSTALLATION OF ADDITIONAL SPRING

3. Install one end of the new spring to the clutch pedal housing bracket. Install the other end of the new spring to the clutch pedal bracket (Illustration 1).

Note: A suitable tool ('Snap On' A1710 or similar) will be required to aid with the installation of the new spring to the clutch pedal. The tool should be long enough to be used by both hands to generate enough force to expand the spring.
