© 2010 Mazda Motor of America, Inc.

Subject: WATER ACCUMULATION IN FOOTWELL / PLUGGED SOFT TOP DRAINS	Bulletin No: 09-046/10
	Last Issued: 10/15/2010

Some vehicles equipped with the folding soft top may experience water accumulation in the foot wells due to the soft top drains becoming clogged with leaves and other debris.

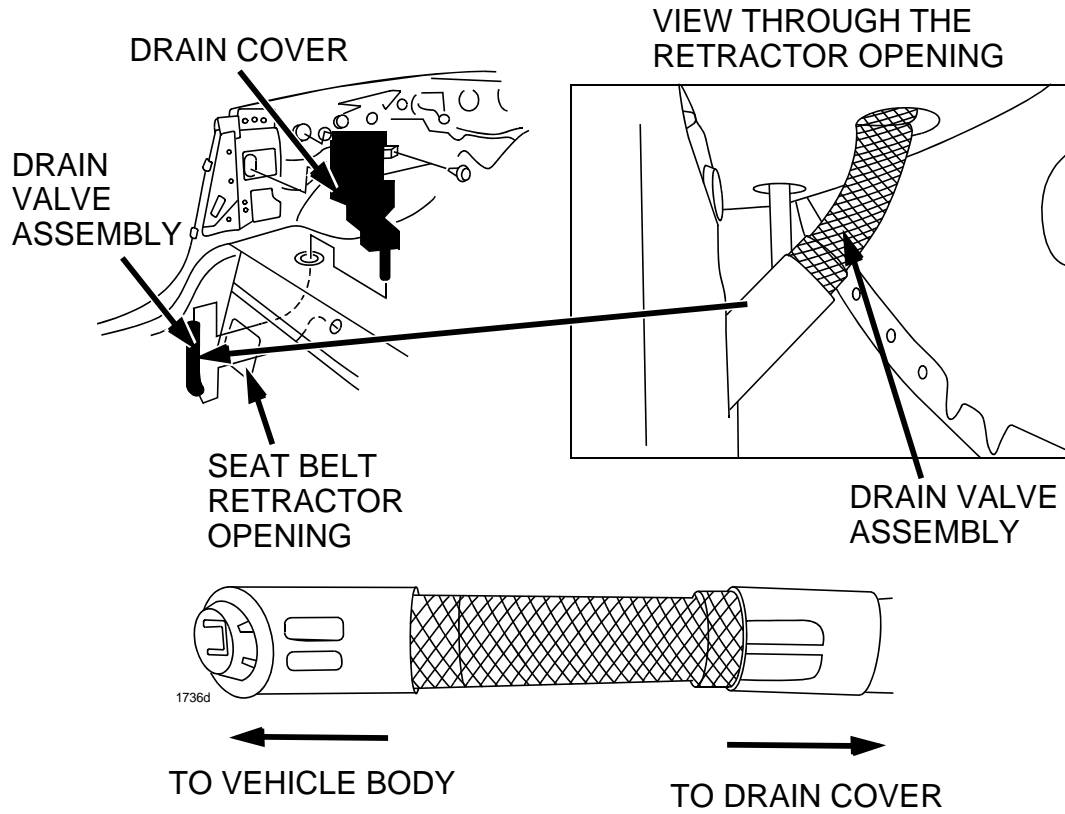
- TYPE A VEHICLES: Proceed to next step.
 - TYPE B VEHICLES: Proceed to "TYPE B VEHICLES" under DRAIN VALVE REPLACEMENT.
4. Using seat belt retractor holes for access, remove the drain valve assemblies.

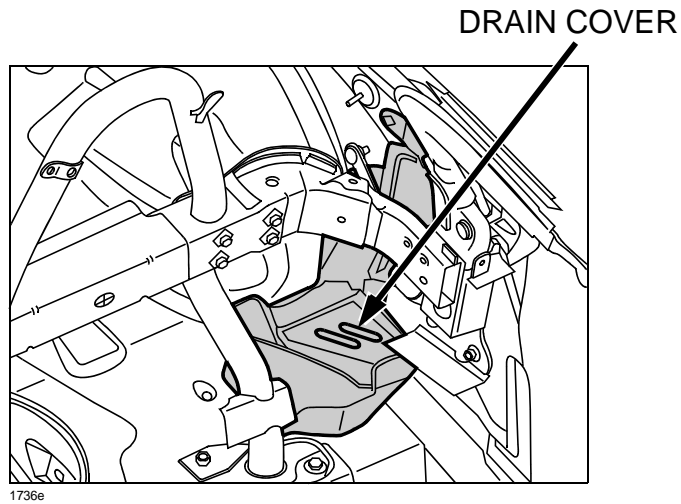
1. Clean and degrease the drain cover assemblies.

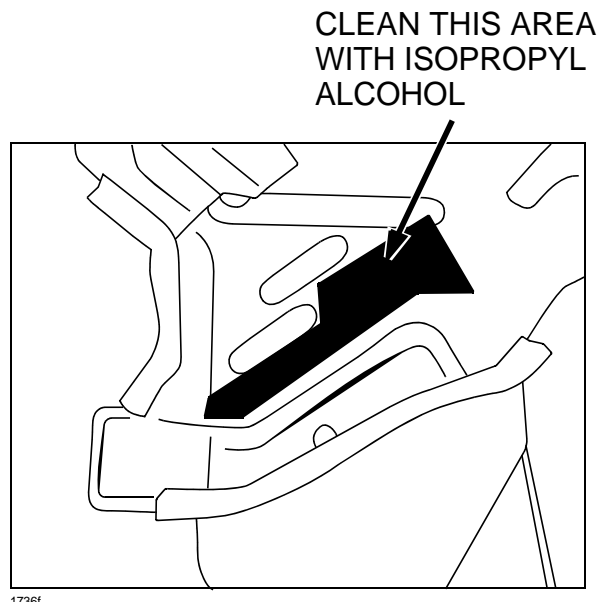
2. To ensure proper adhesion of the filter to drain cover assemblies, wipe down contact area with Isopropyl alcohol.

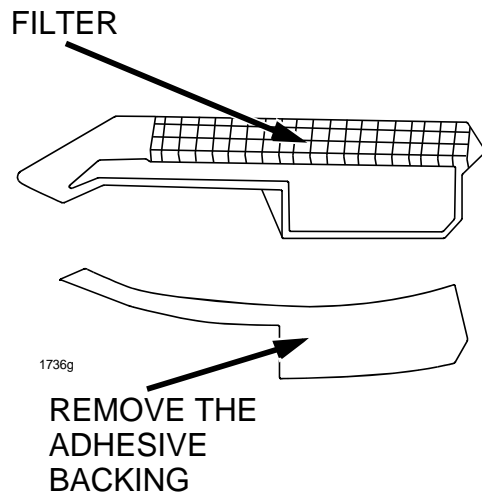
3. Peel the adhesive backing sheet from the filter and affix it to the bottom of the drain cover.

INSTALL THE FILTER TO THE DRAIN COVER AS SHOWN

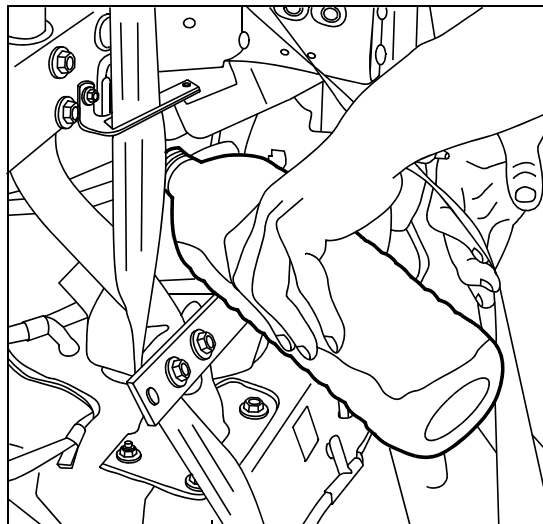
7. Verify repair by pouring water into the drain covers prior to reassembly to confirming water only exits under vehicle and does not leak from drain valve tubes assemblies into retractor holes and/or overflow drain cover assemblies.

POUR WATER INTO THE DRAIN COVER TO MAKE SURE THE WATER DOES NOT OVERFLOW.

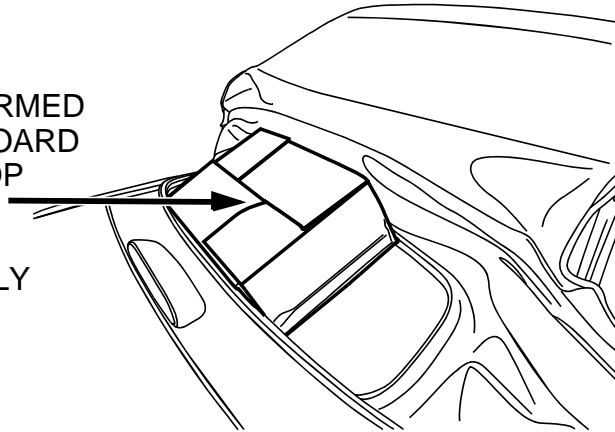
1663b

1. Using or cardboard box or equivalent to keep the soft top in the half-open position will allow this procedure to be performed by a single person.

PLACING A FULLY FORMED AND CLOSED CARDBOARD BOX BEHIND SOFT TOP AS SHOWN WILL PREVENT TOP FROM OPENING COMPLETELY

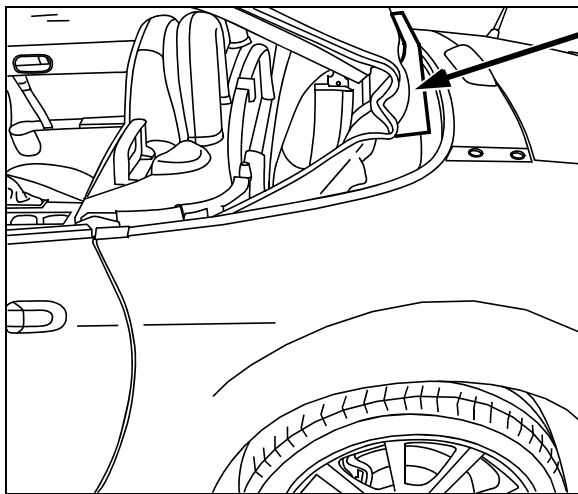
1736n

USE FOLDED BOX TO KEEP TOP FROM OPENING COMPLETELY

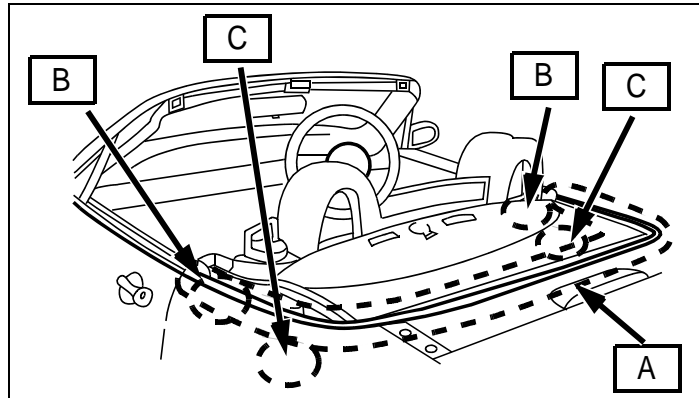
1736o

2. With the soft top down, Using a vacuum cleaner, remove the foreign substances (such as leaves) from around the rear edge of convertible top (A) between the soft top and the vehicle body.

NOTE: Pay special attention to areas "B" and "C" when vacuuming the convertible top filters.
