WC55 - Replacing Oil Separator (Workshop Campaign)

Vehicle Type: **Cayenne S (92A)/Cayenne Turbo (92A)**

Model Year: **As of 2011 up to 2013**

Subject: **Replace oil separator**

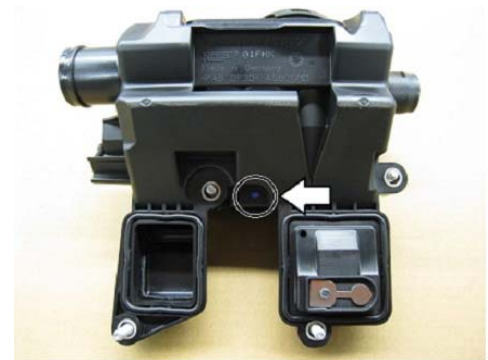
Marking on oil separator

Only oil separators fitted with a diaphragm of the correct size are available from the parts department. These oil separators are marked with a blue dot.

To ensure that oil separators fitted with a diaphragm of the wrong size that may still be in circulation are not installed during the workshop campaign, always check that the **new oil separator is marked with a blue dot** as shown in ⇒ *Marking on oil separator -arrow-* before **installing the new oil separator**.

If the oil separator does **not** have a blue dot, it must be returned via a Parts Withdrawal form which can be found in the Document Repository (See Parts Bulletin Group 13, #D72).
