SERVICE CAMPAIGN BULLETIN

NTB13-014

VOLUNTARY SERVICE CAMPAIGN 2009 – 2011 STEERING LOCK UNIT

CAMPAIGN ID #: P3208
APPLIED VEHICLES: 2009 – 2010 370Z (Z34)
2009 – 2011 GTR (R35)

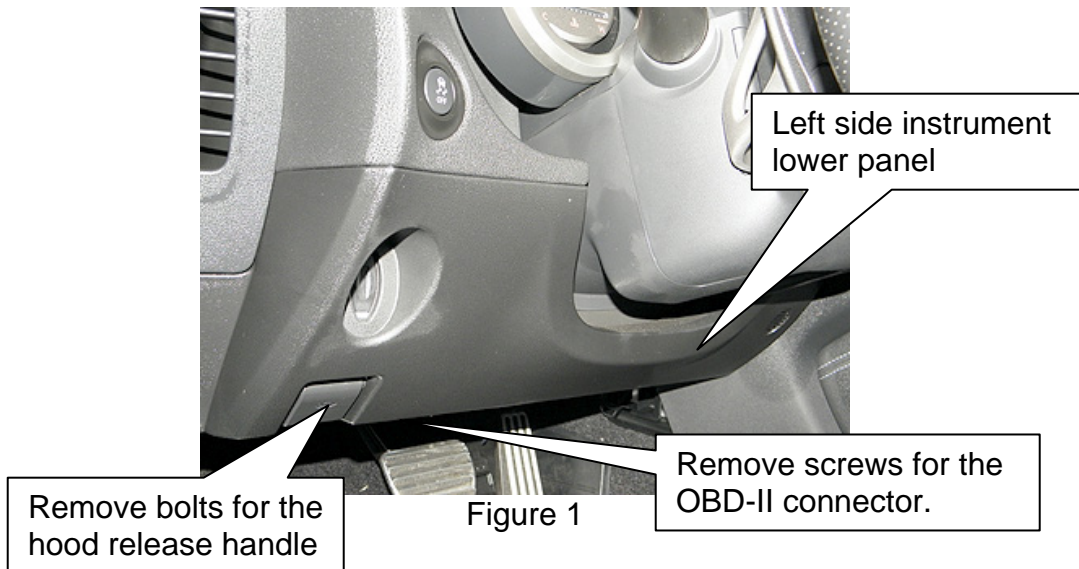
1. Make sure the ignition is OFF.
2. Remove the left side instrument lower panel as follows (see Figures 1 and 2).
 - a. Use a plastic trim tool to snap loose the instrument side finisher LH.
 - b. Remove bolts (1 to 2 depending on model) from the hood release handle.
 - c. Remove screws (1 to 2 depending on model) from the OBD-II connector.
 - d. Use a plastic trim tool to snap loose the left side instrument lower panel.

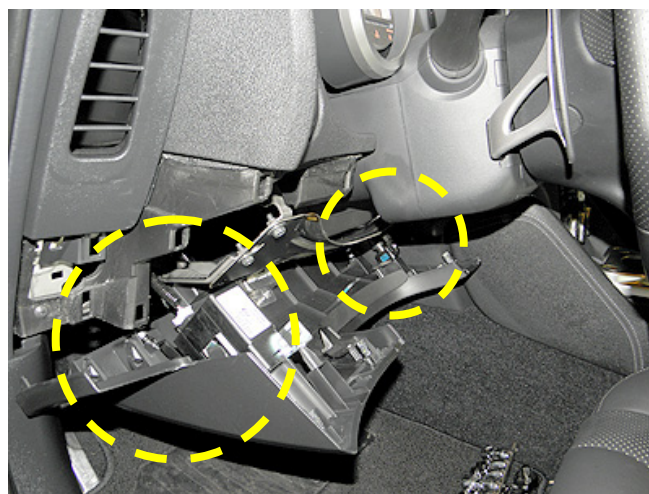
- e. Disconnect the electrical connectors and the climate control tube.
